CERTIFICATE OF APPROPRIATENESS

Location of Work 48 School Street, Acton, MA District: Center West South X

Description of Proposed work: Partial demolition and reconstruction of barn and attached garage located behind residence.

Project: Barn Renovation
Address: 48 School St
Acton, MA 01720
Date: Wednesday 04/16/2025
Prepared by: Studio InSitu Architects, Inc.
RE:

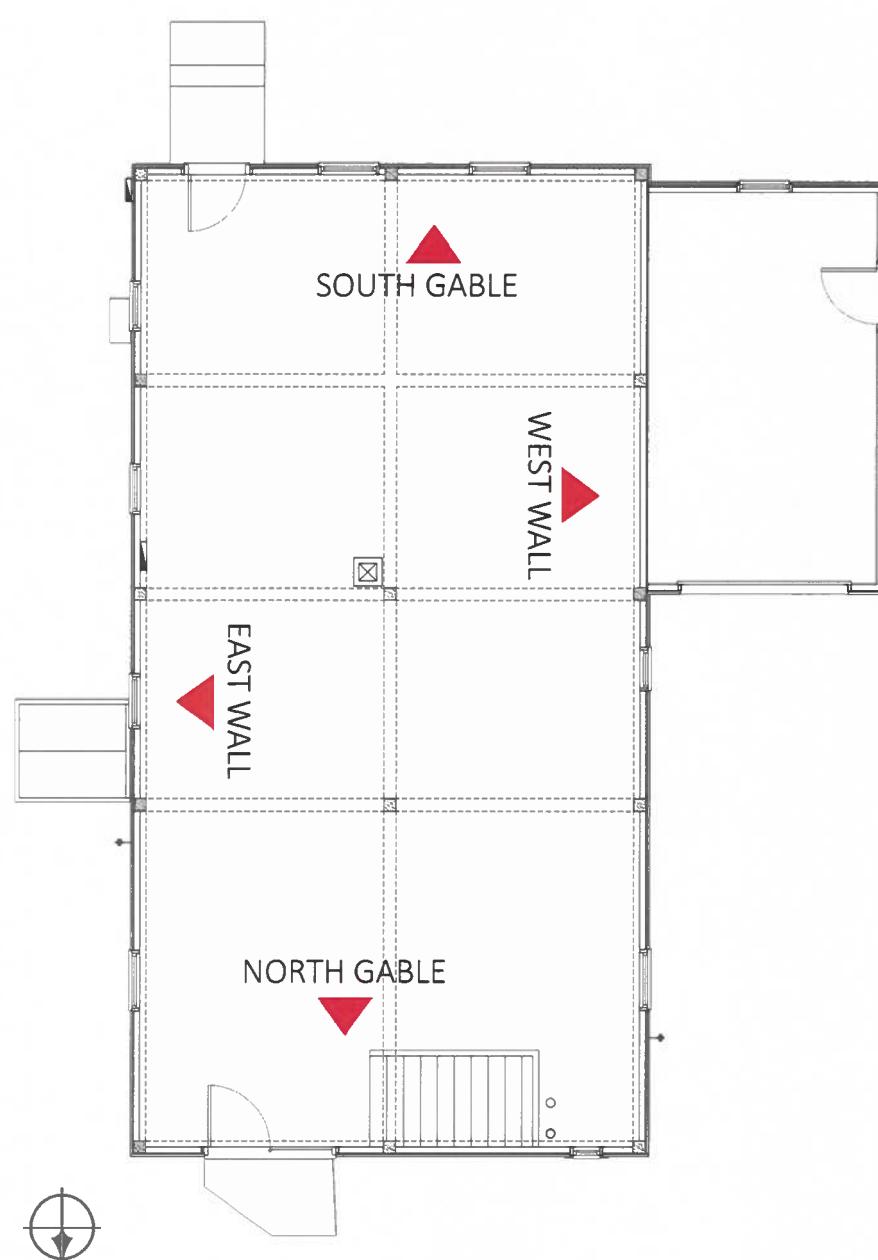
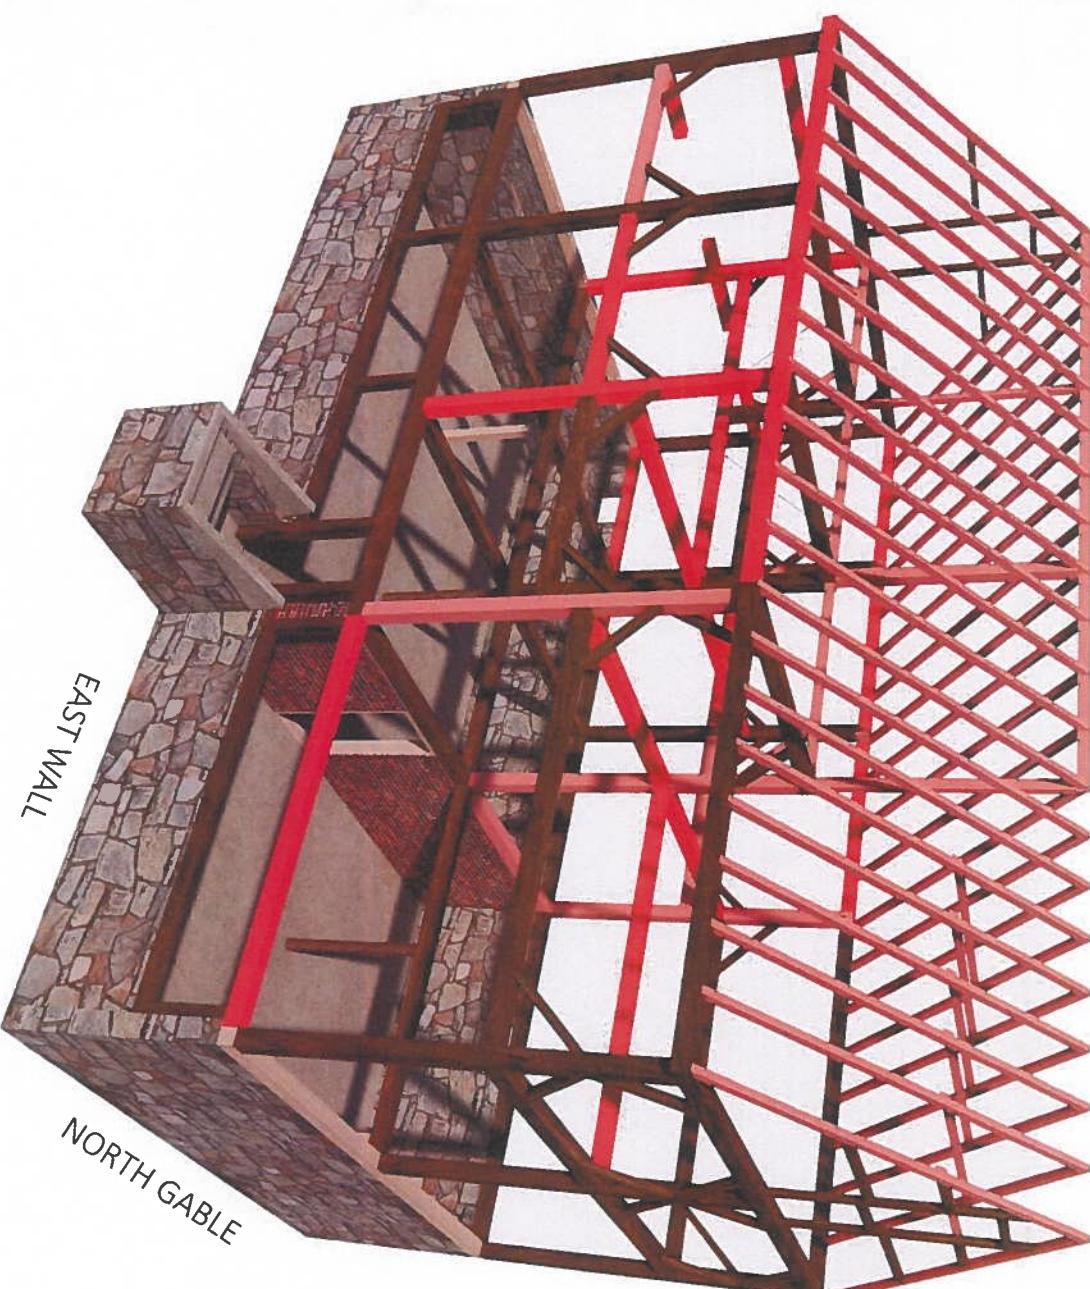
04 EXISTING BARN - STRUCTURAL ANALYSIS

- SOLID WOOD BEAMS/COLUMNS IN FAIR CONDITION
- STANDARD LUMBER IN FAIR CONDITION
- STRUCTURALLY INADEQUATE
- POWDER POST BEETLE DESTRUCTION

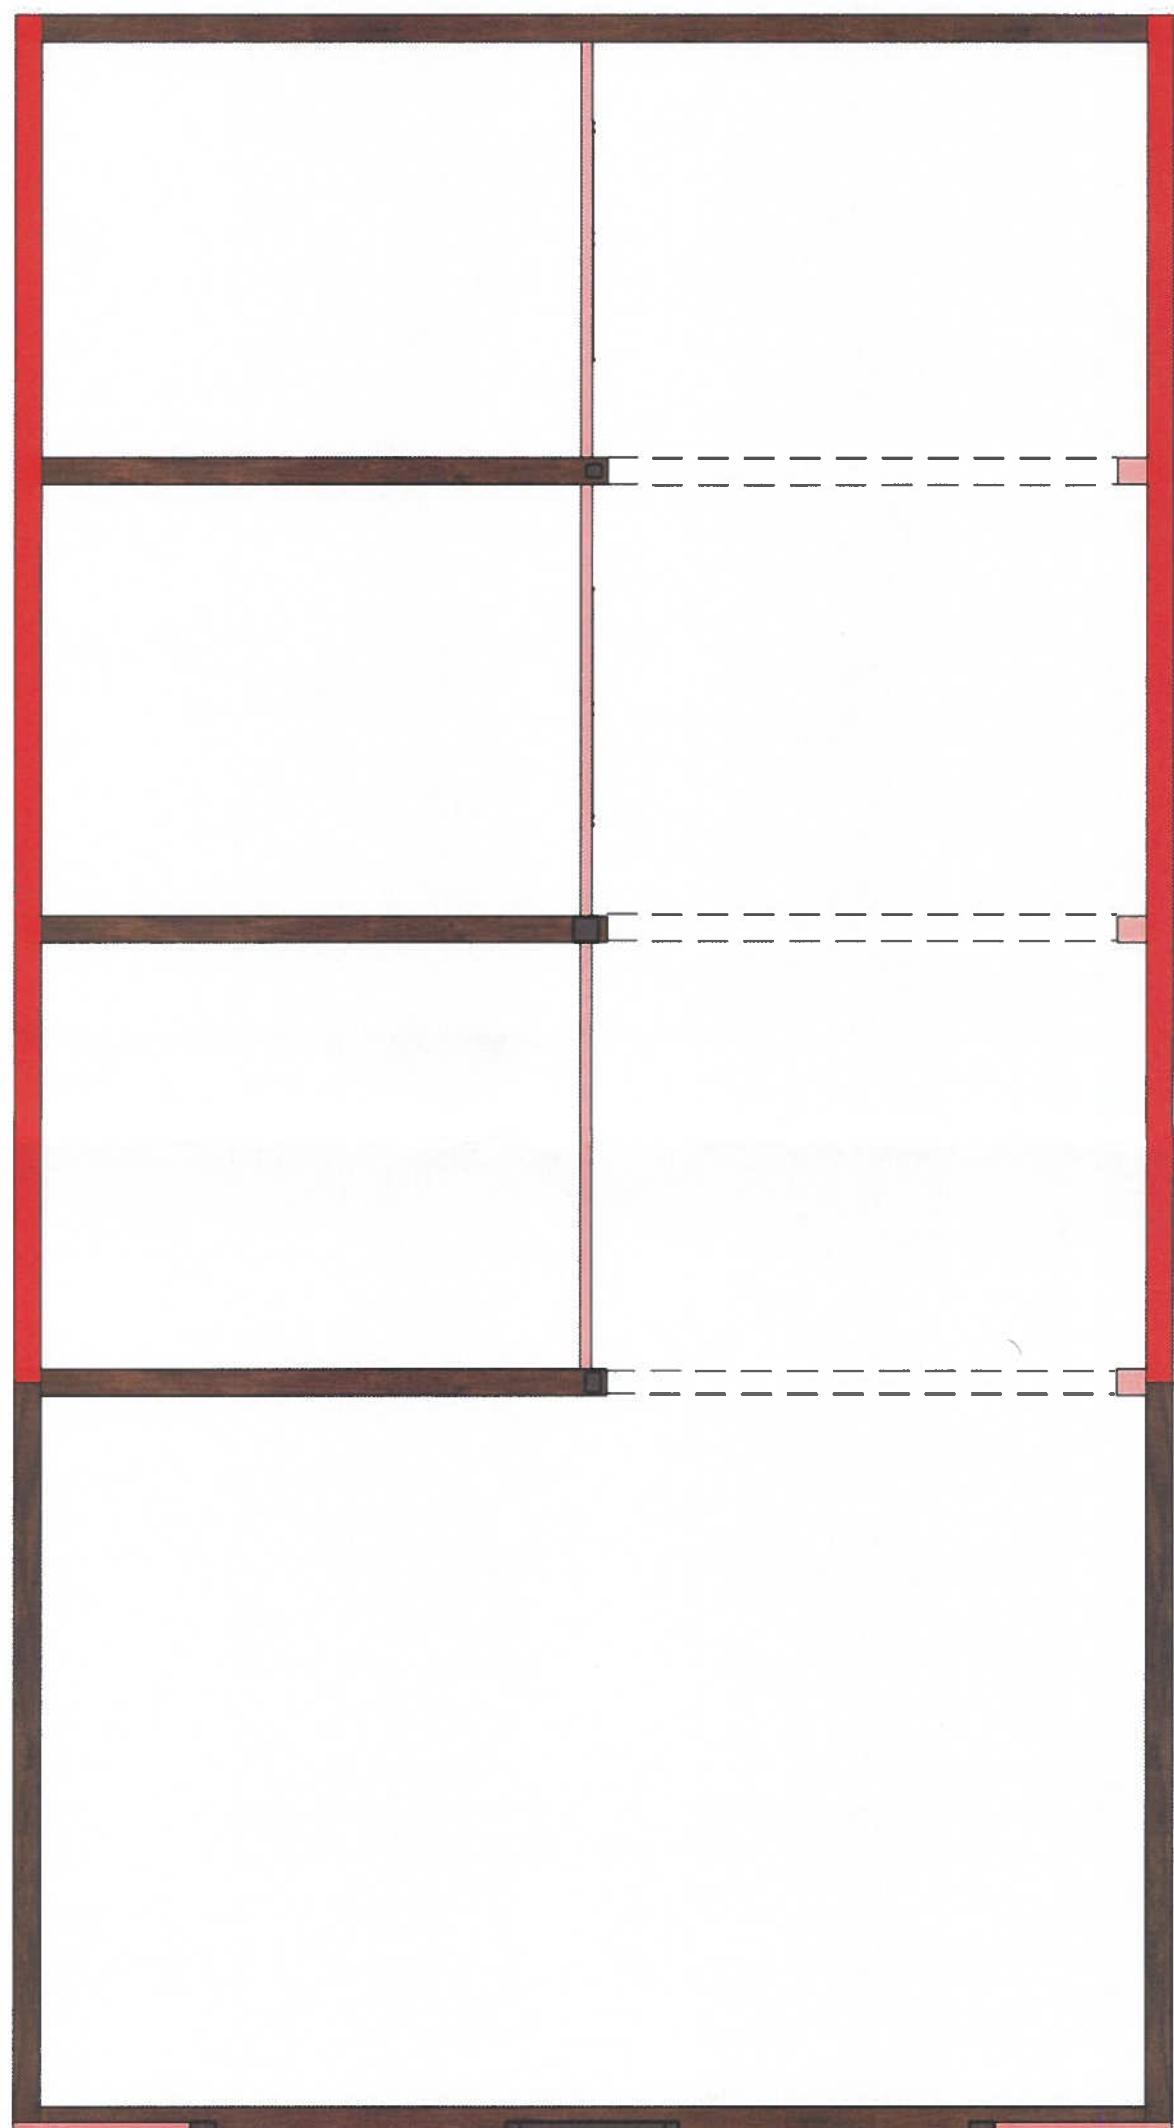
LOFT

- █ SOLID WOOD BEAMS/COLUMNS IN FAIR CONDITION
- █ STANDARD LUMBER IN FAIR CONDITION
- █ STRUCTURALLY INADEQUATE
- █ POWDER POST BEETLE DESTRUCTION

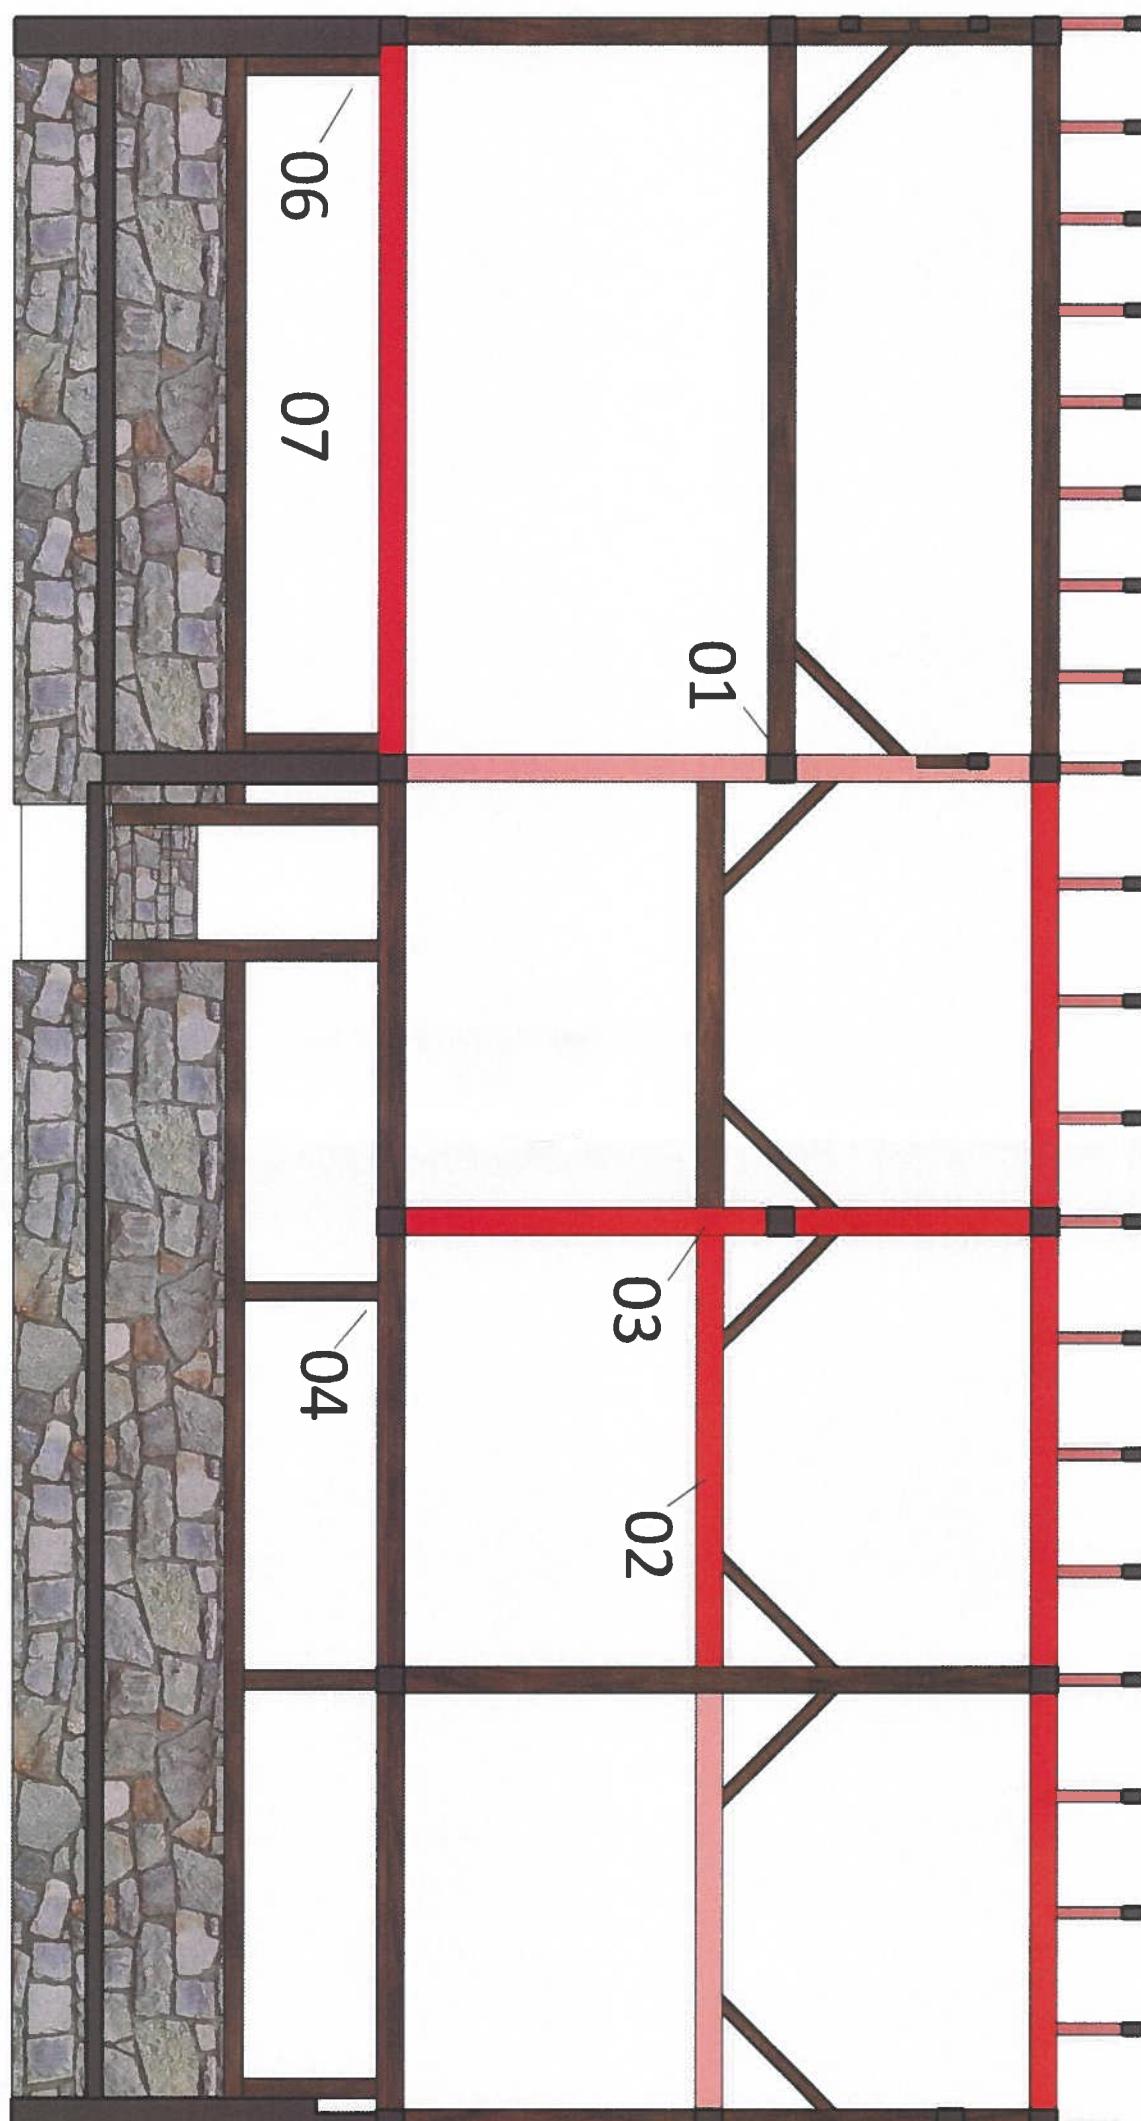
EAST WALL

SOLID WOOD BEAMS/COLUMNS IN FAIR CONDITION
STANDARD LUMBER IN FAIR CONDITION
STRUCTURALLY INADEQUATE
POWDER POST BEETLE DESTRUCTION

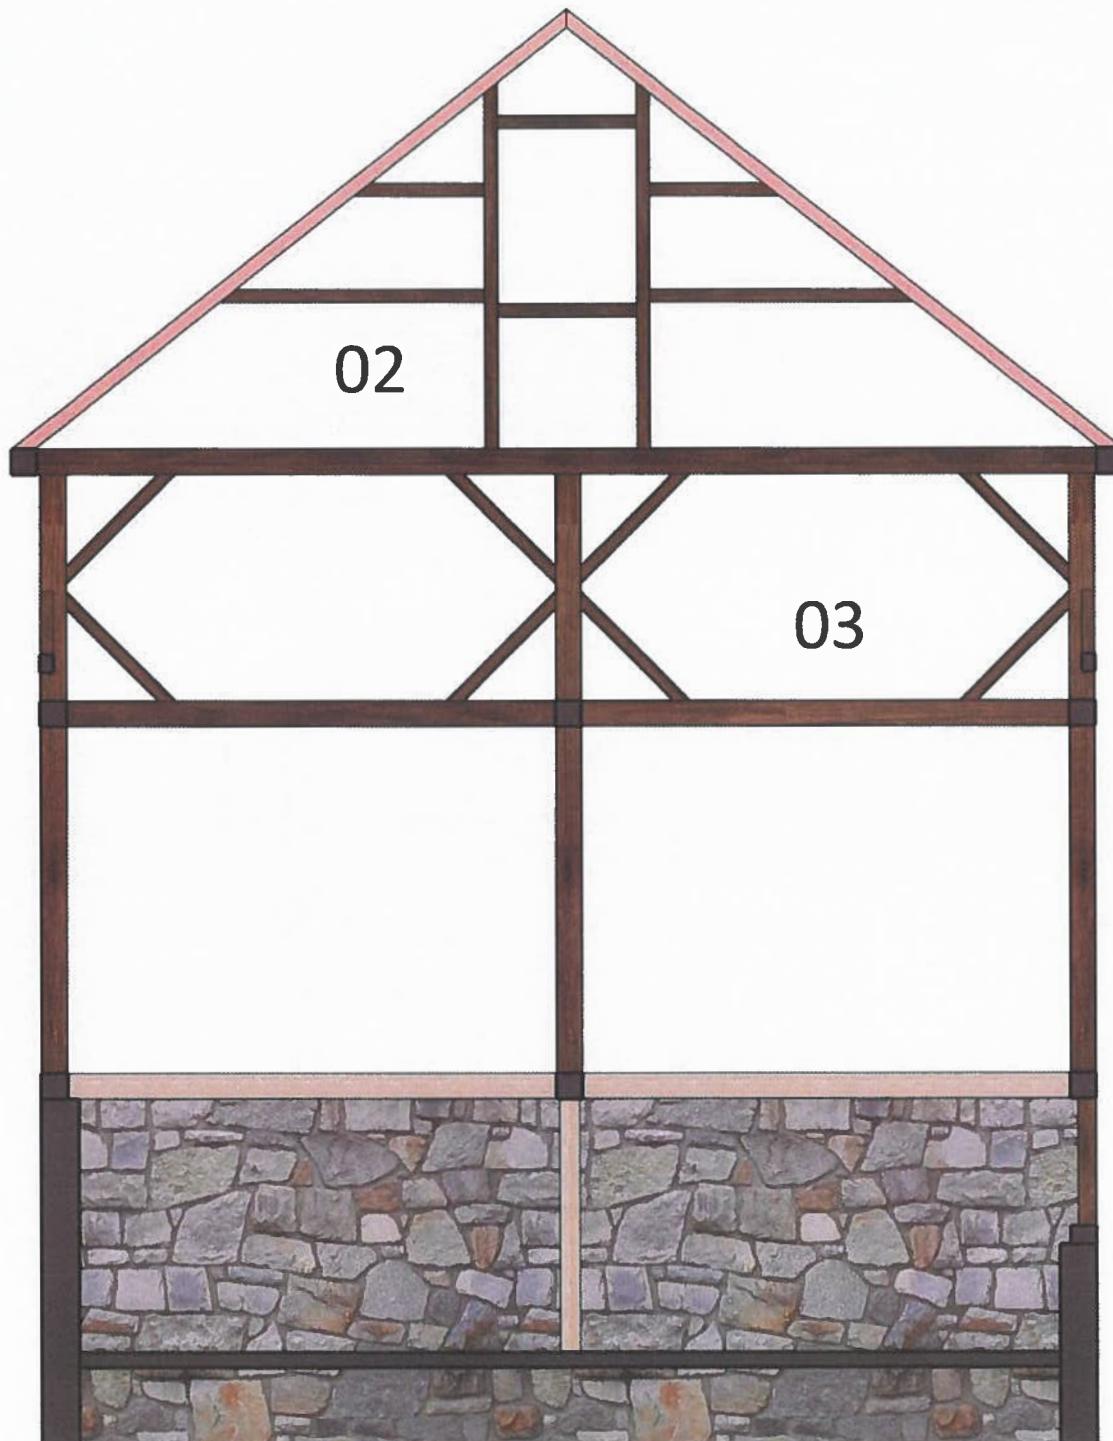
NORTH GABLE

- SOLID WOOD BEAMS/COLUMNS IN FAIR CONDITION
- STANDARD LUMBER IN FAIR CONDITION
- STRUCTURALLY INADEQUATE
- POWDER POST BEETLE DESTRUCTION

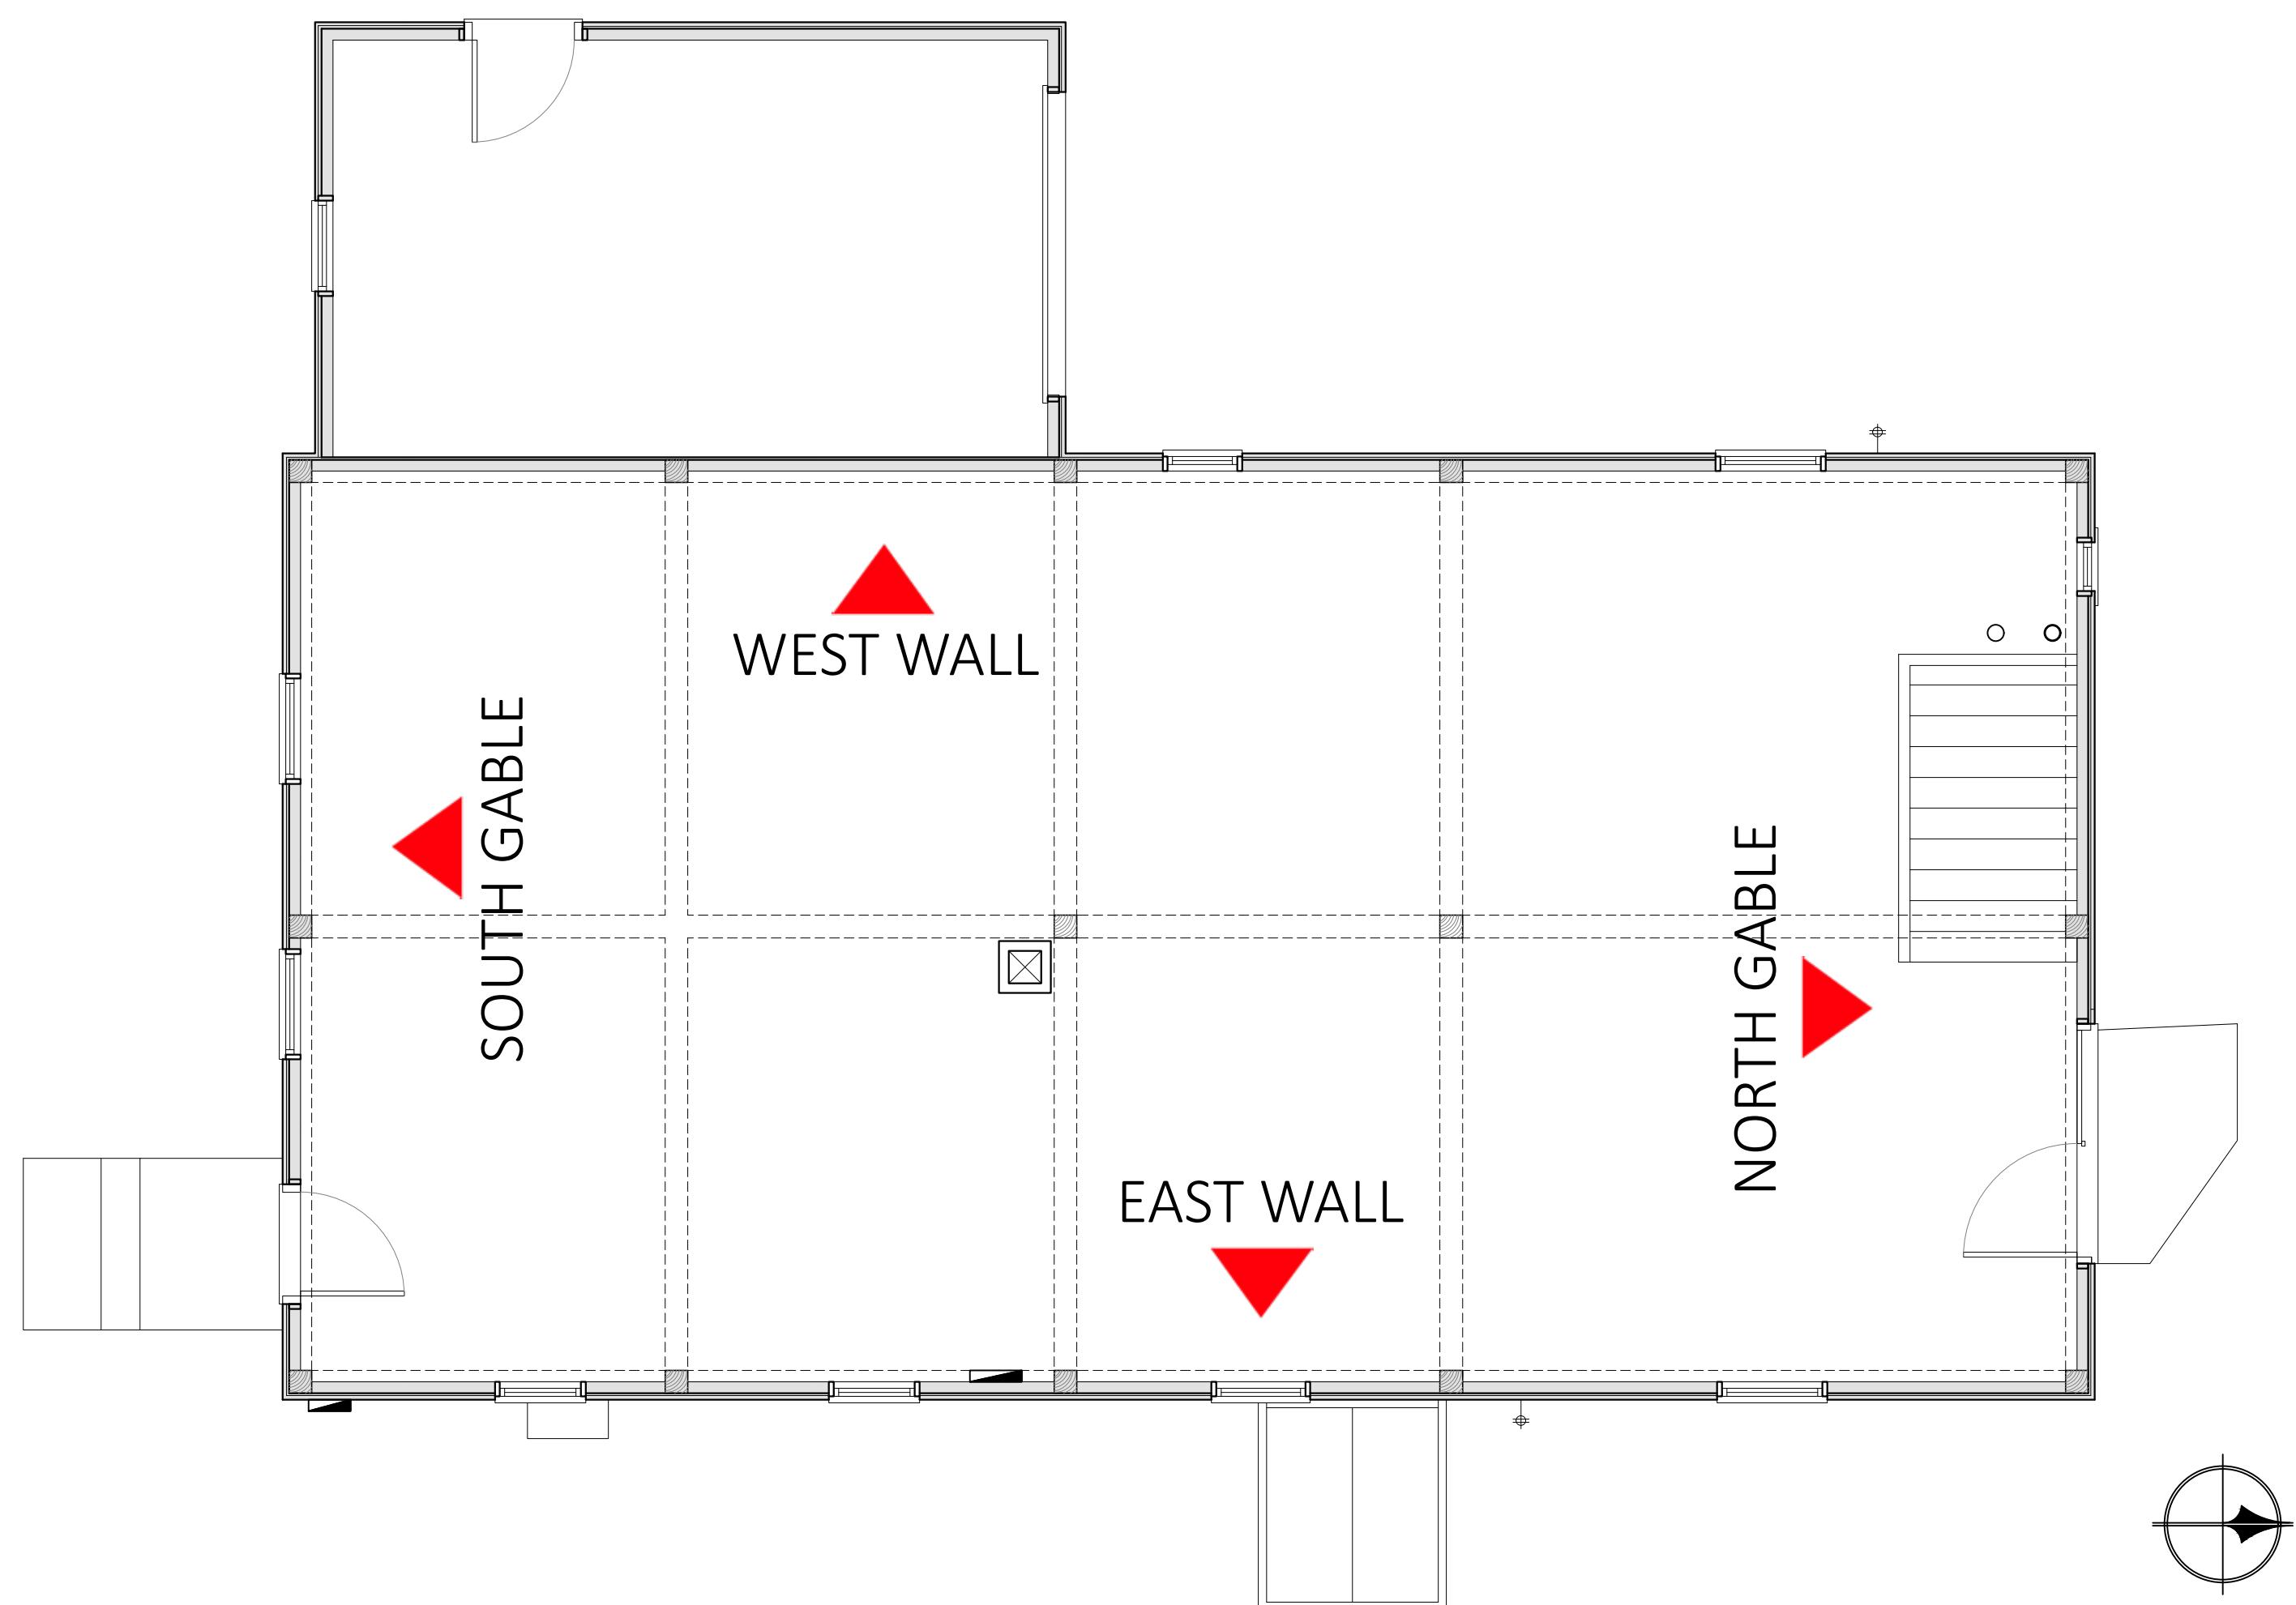
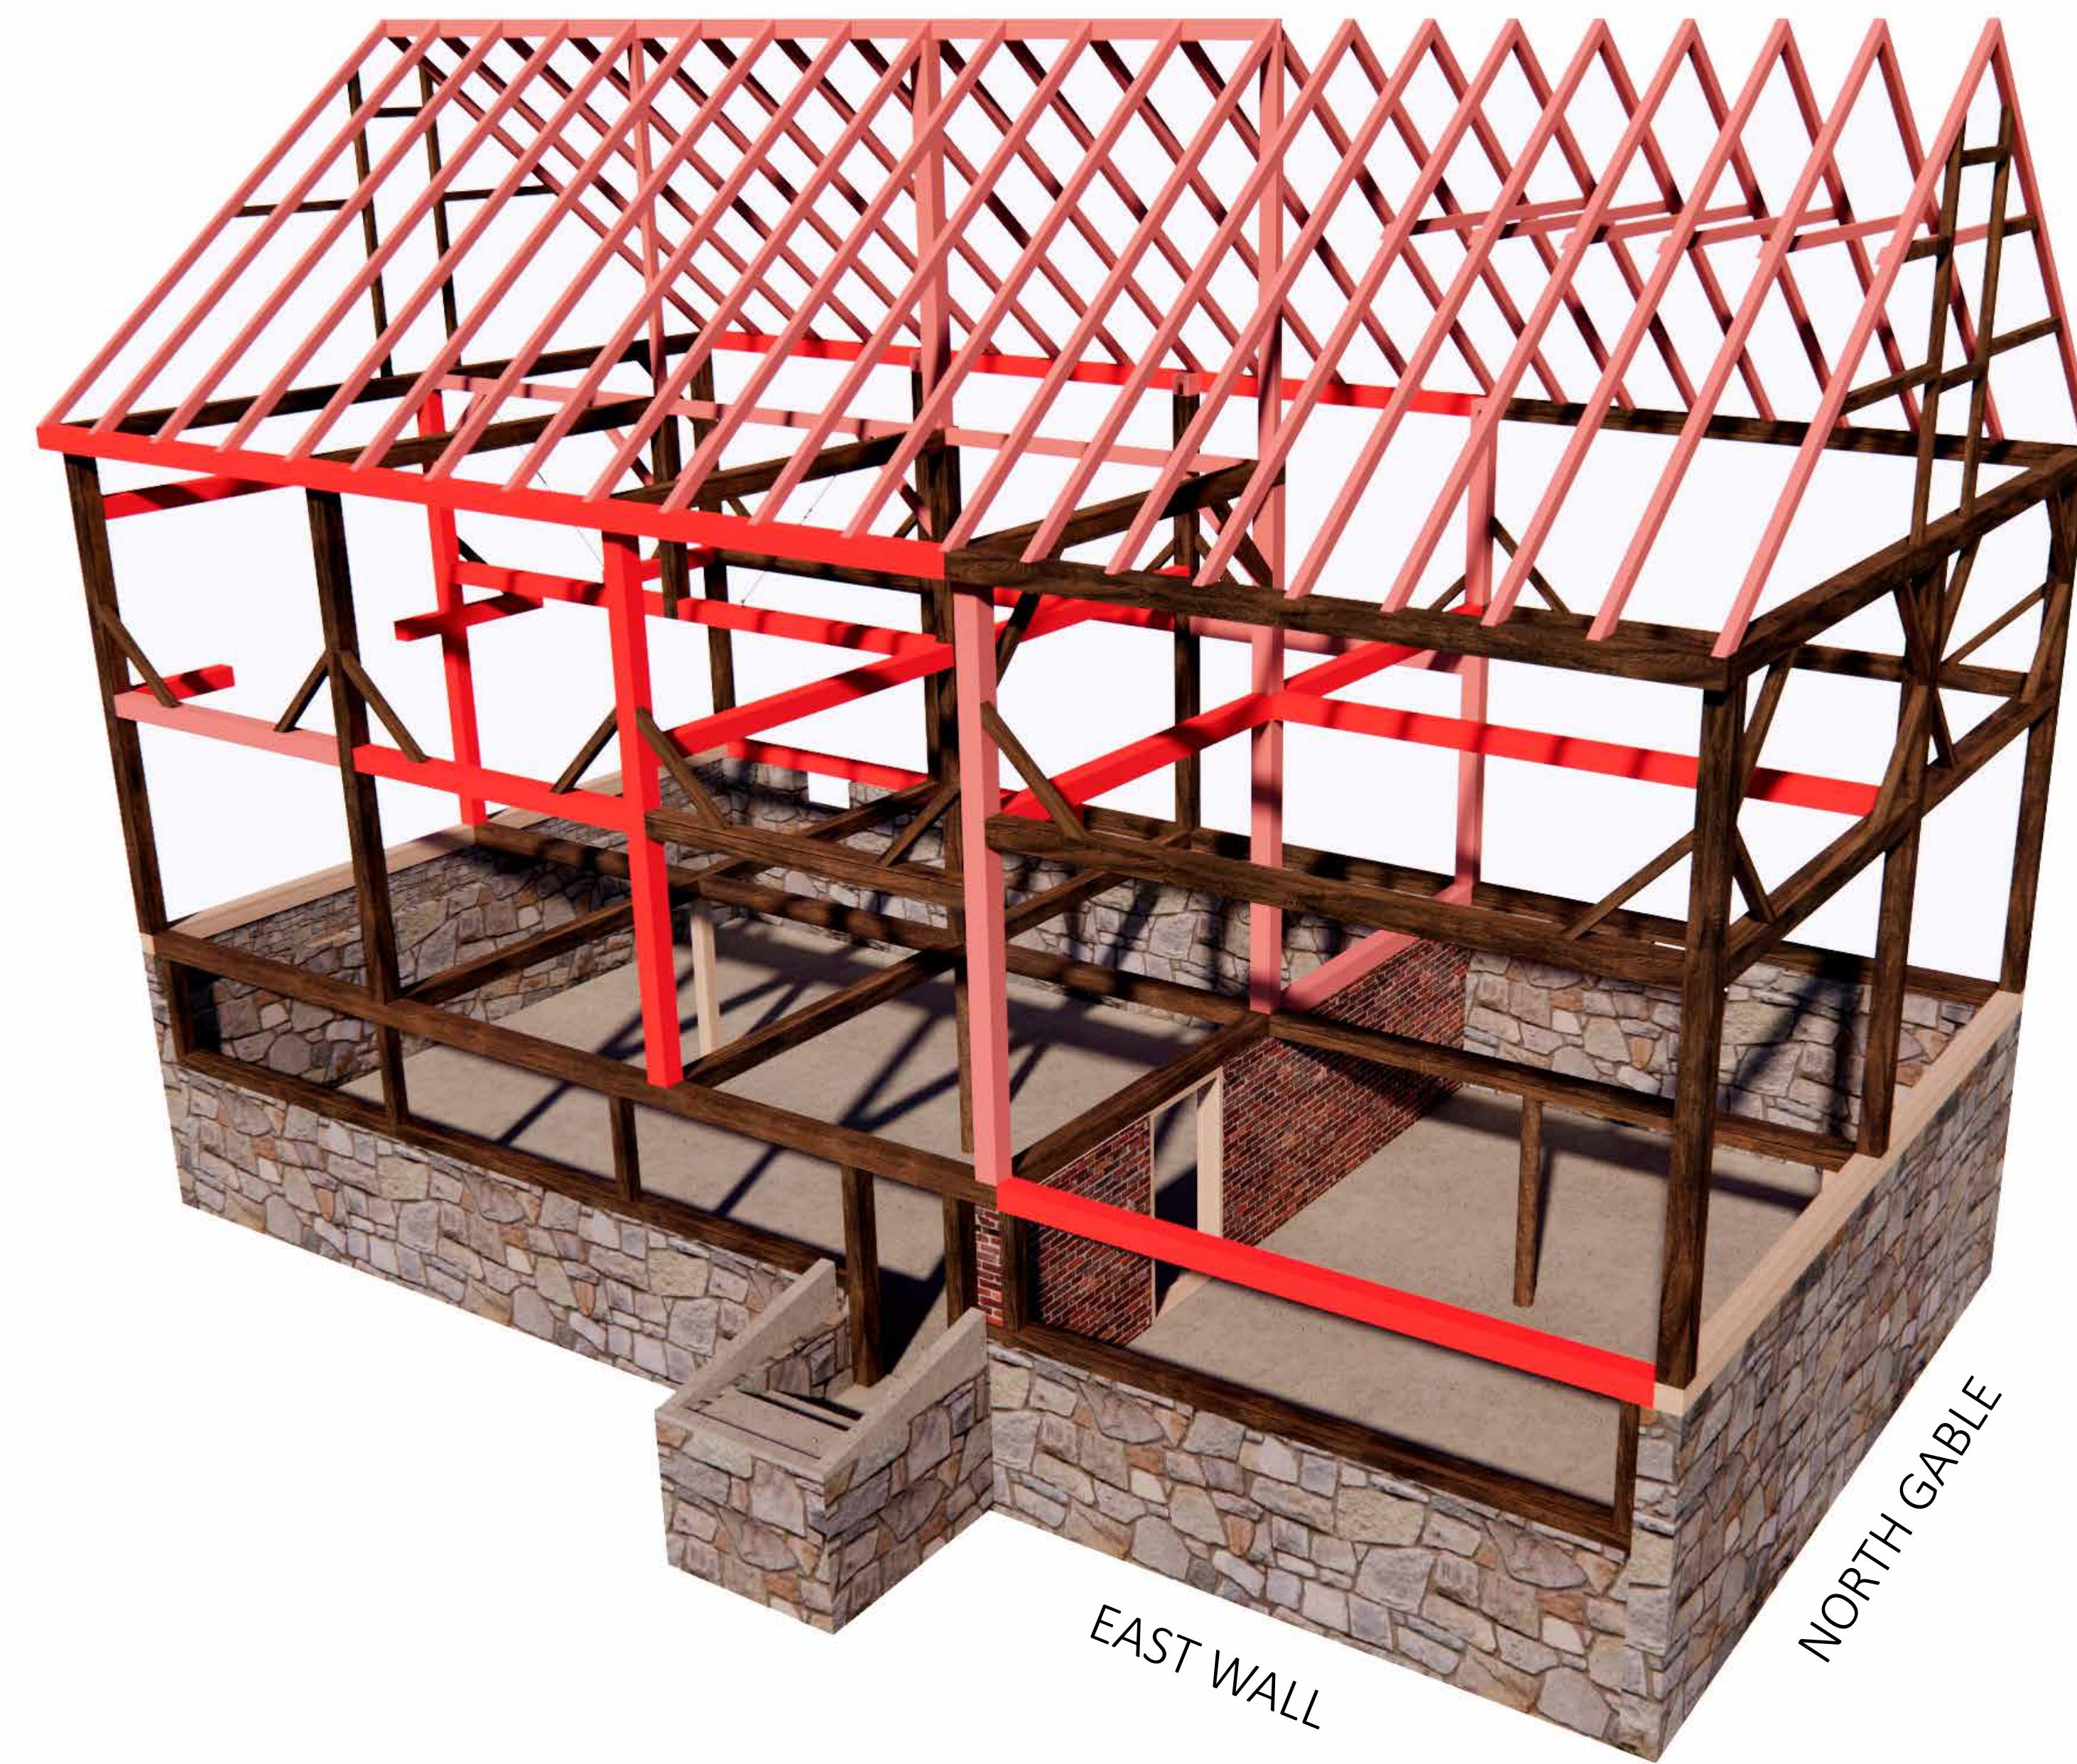
04 EXISTING BARN - STRUCTURAL ANALYSIS

- SOLID WOOD BEAMS/COLUMNS IN FAIR CONDITION
- STANDARD LUMBER IN FAIR CONDITION
- STRUCTURALLY INADEQUATE
- POWDER POST BEETLE DESTRUCTION

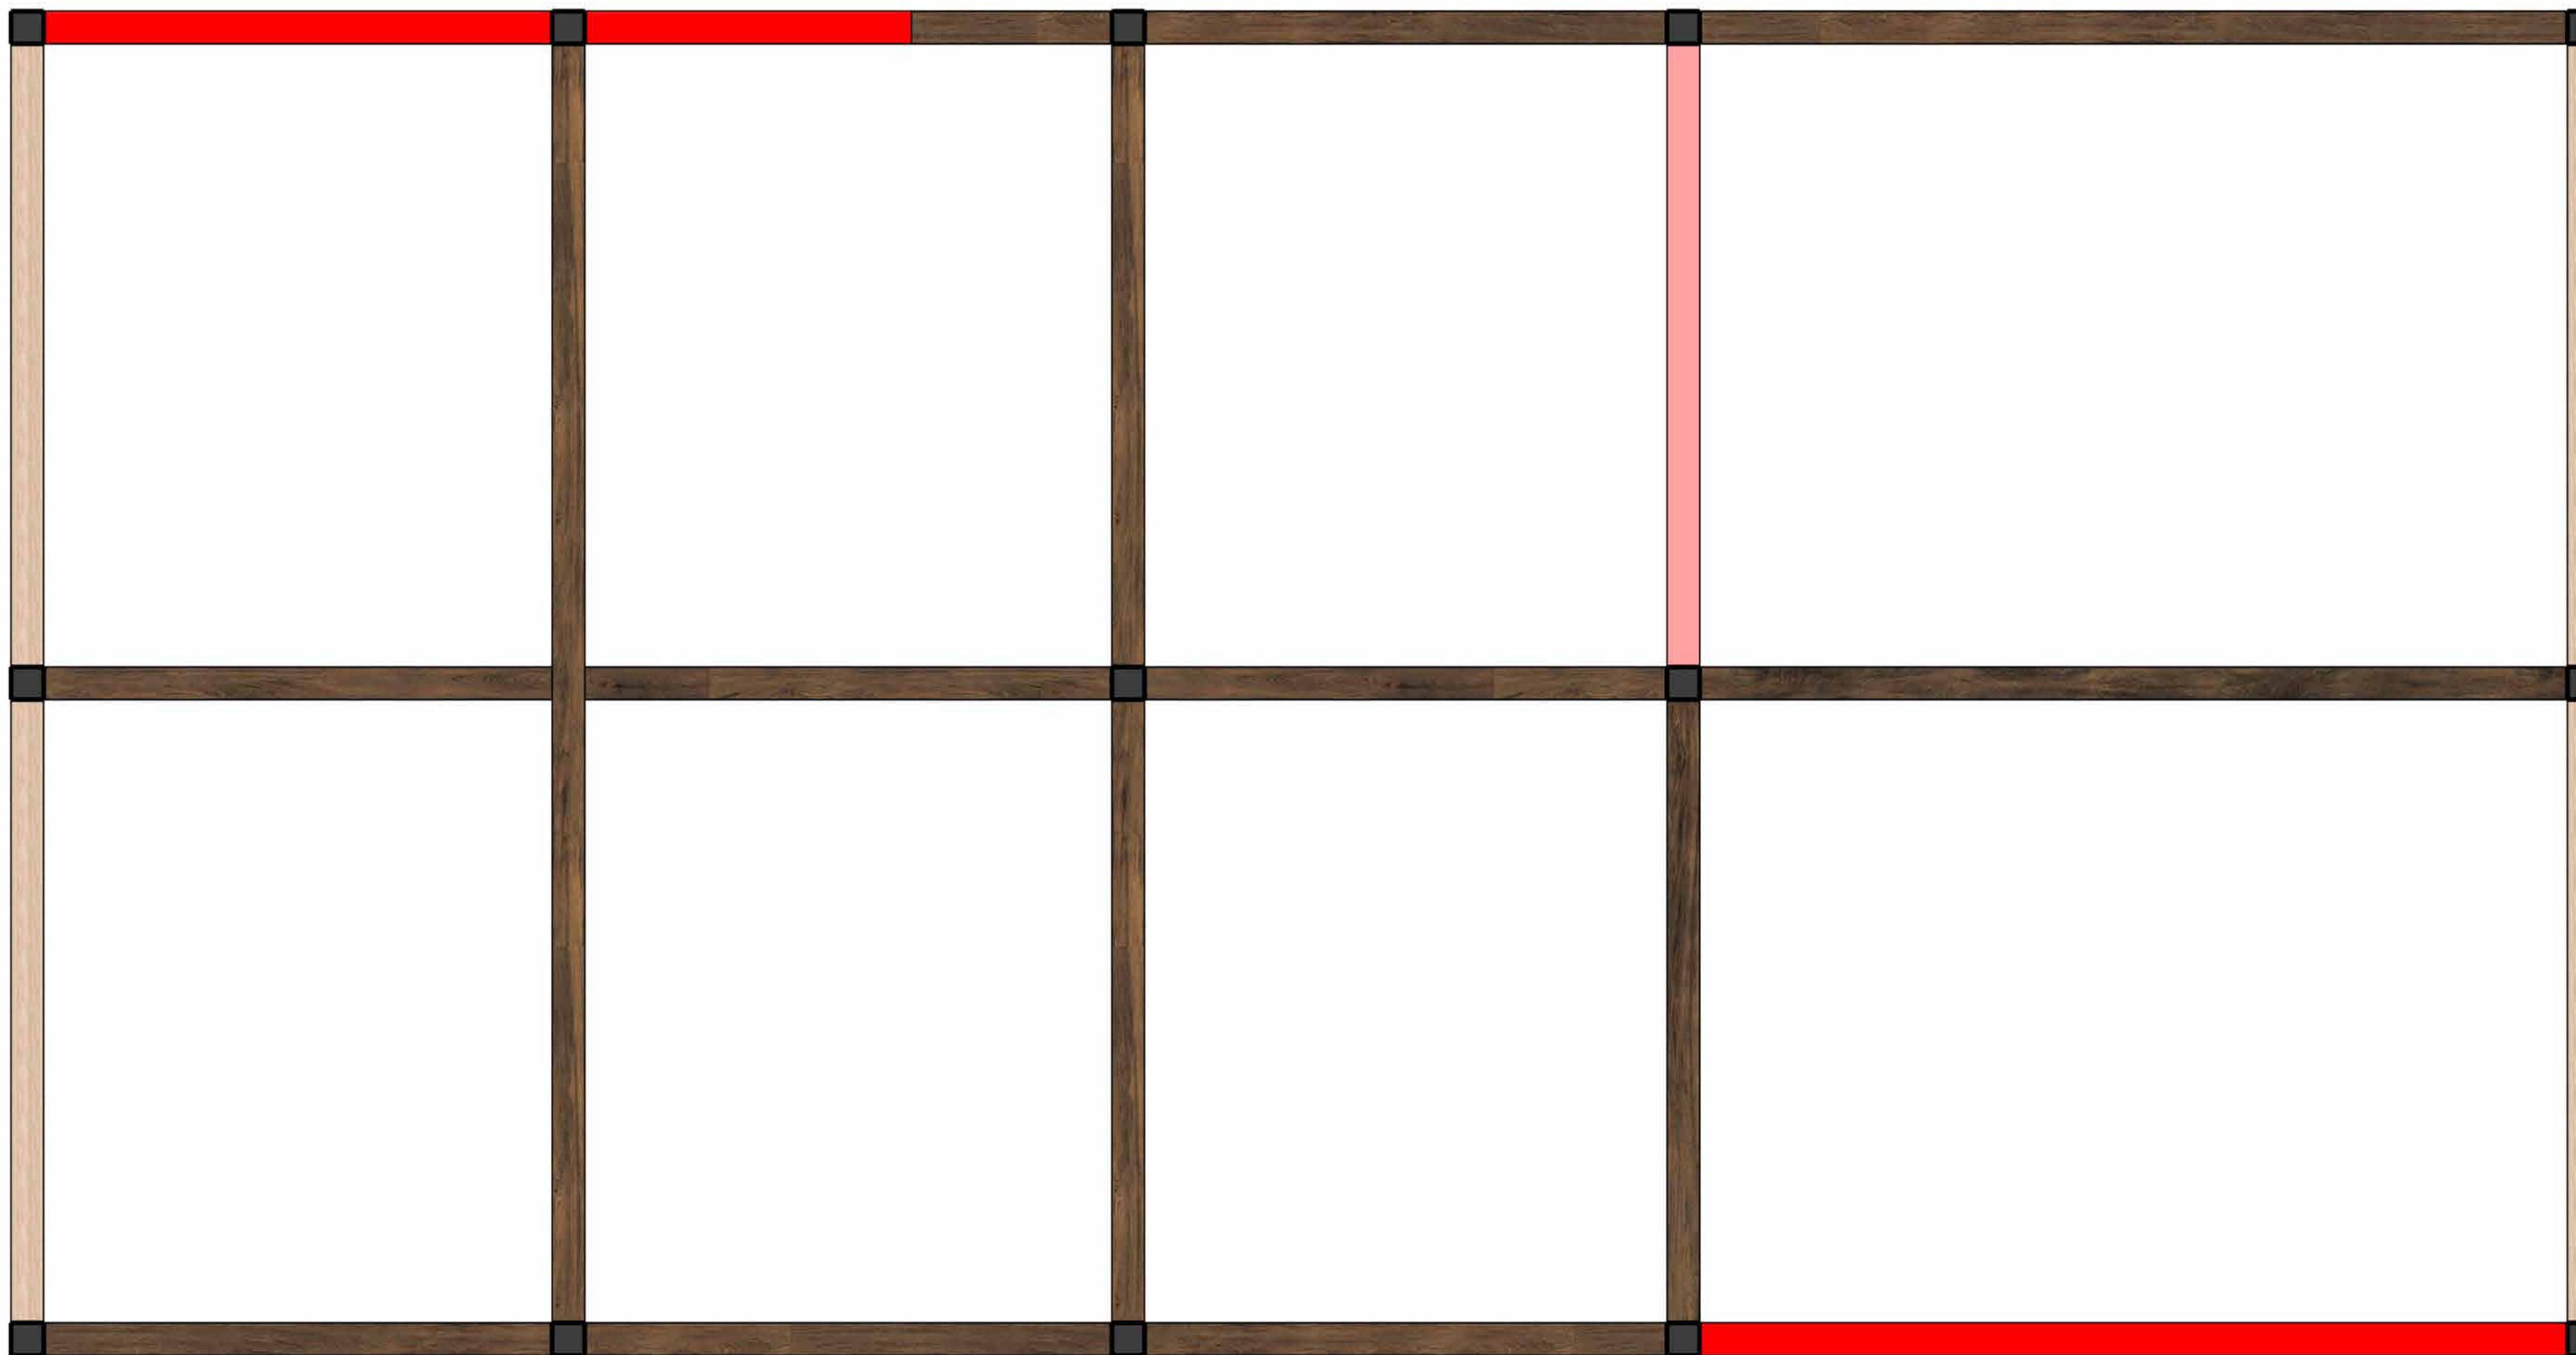
1ST FLOOR

- █ SOLID WOOD BEAMS/COLUMNS IN FAIR CONDITION
- █ STANDARD LUMBER IN FAIR CONDITION
- █ STRUCTURALLY INADEQUATE
- █ POWDER POST BEETLE DESTRUCTION
