CERTIFICATE OF APPROPRIATENESS

Location of Work 48 School Street, Acton, MA District: Center West South X

Description of Proposed work: Partial demolition and reconstruction of barn and attached garage located behind residence.

Project: Barn Renovation
Address: 48 School St
Acton, MA 01720
Date: Wednesday 04/16/2025
Prepared by: Studio InSitu Architects, Inc.
RE:

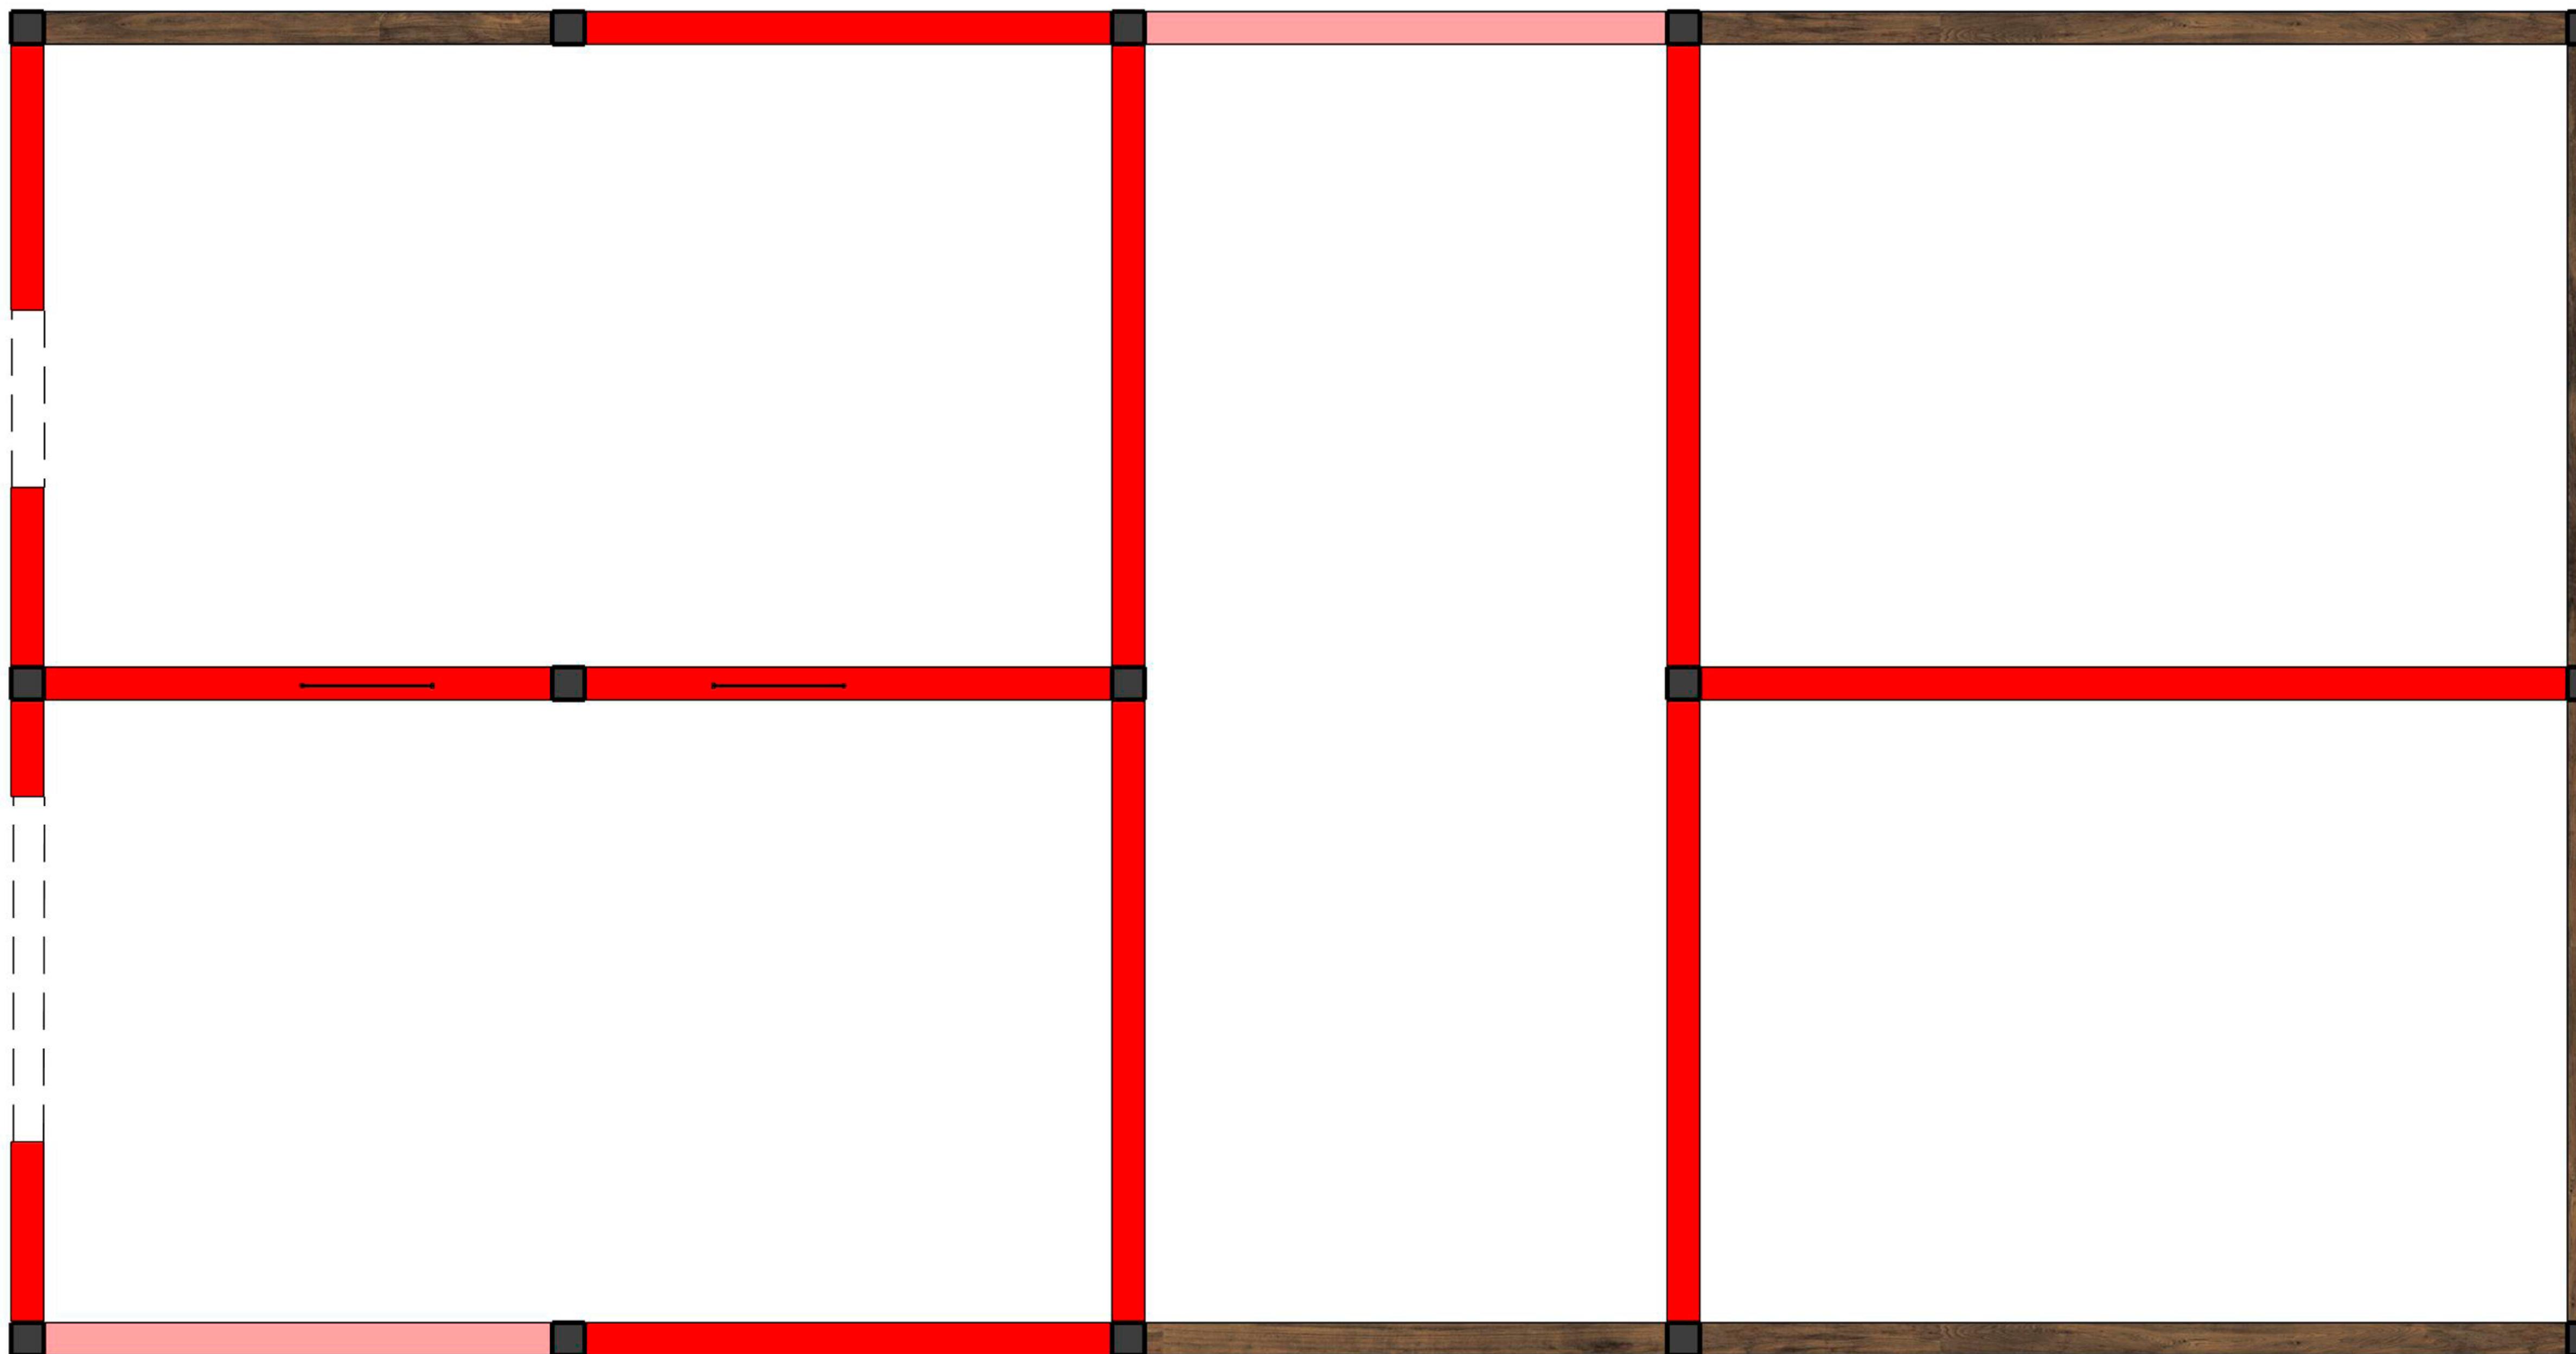
2ND FLOOR

- █ SOLID WOOD BEAMS/COLUMNS IN FAIR CONDITION
- █ STANDARD LUMBER IN FAIR CONDITION
- █ STRUCTURALLY INADEQUATE
- █ POWDER POST BEETLE DESTRUCTION

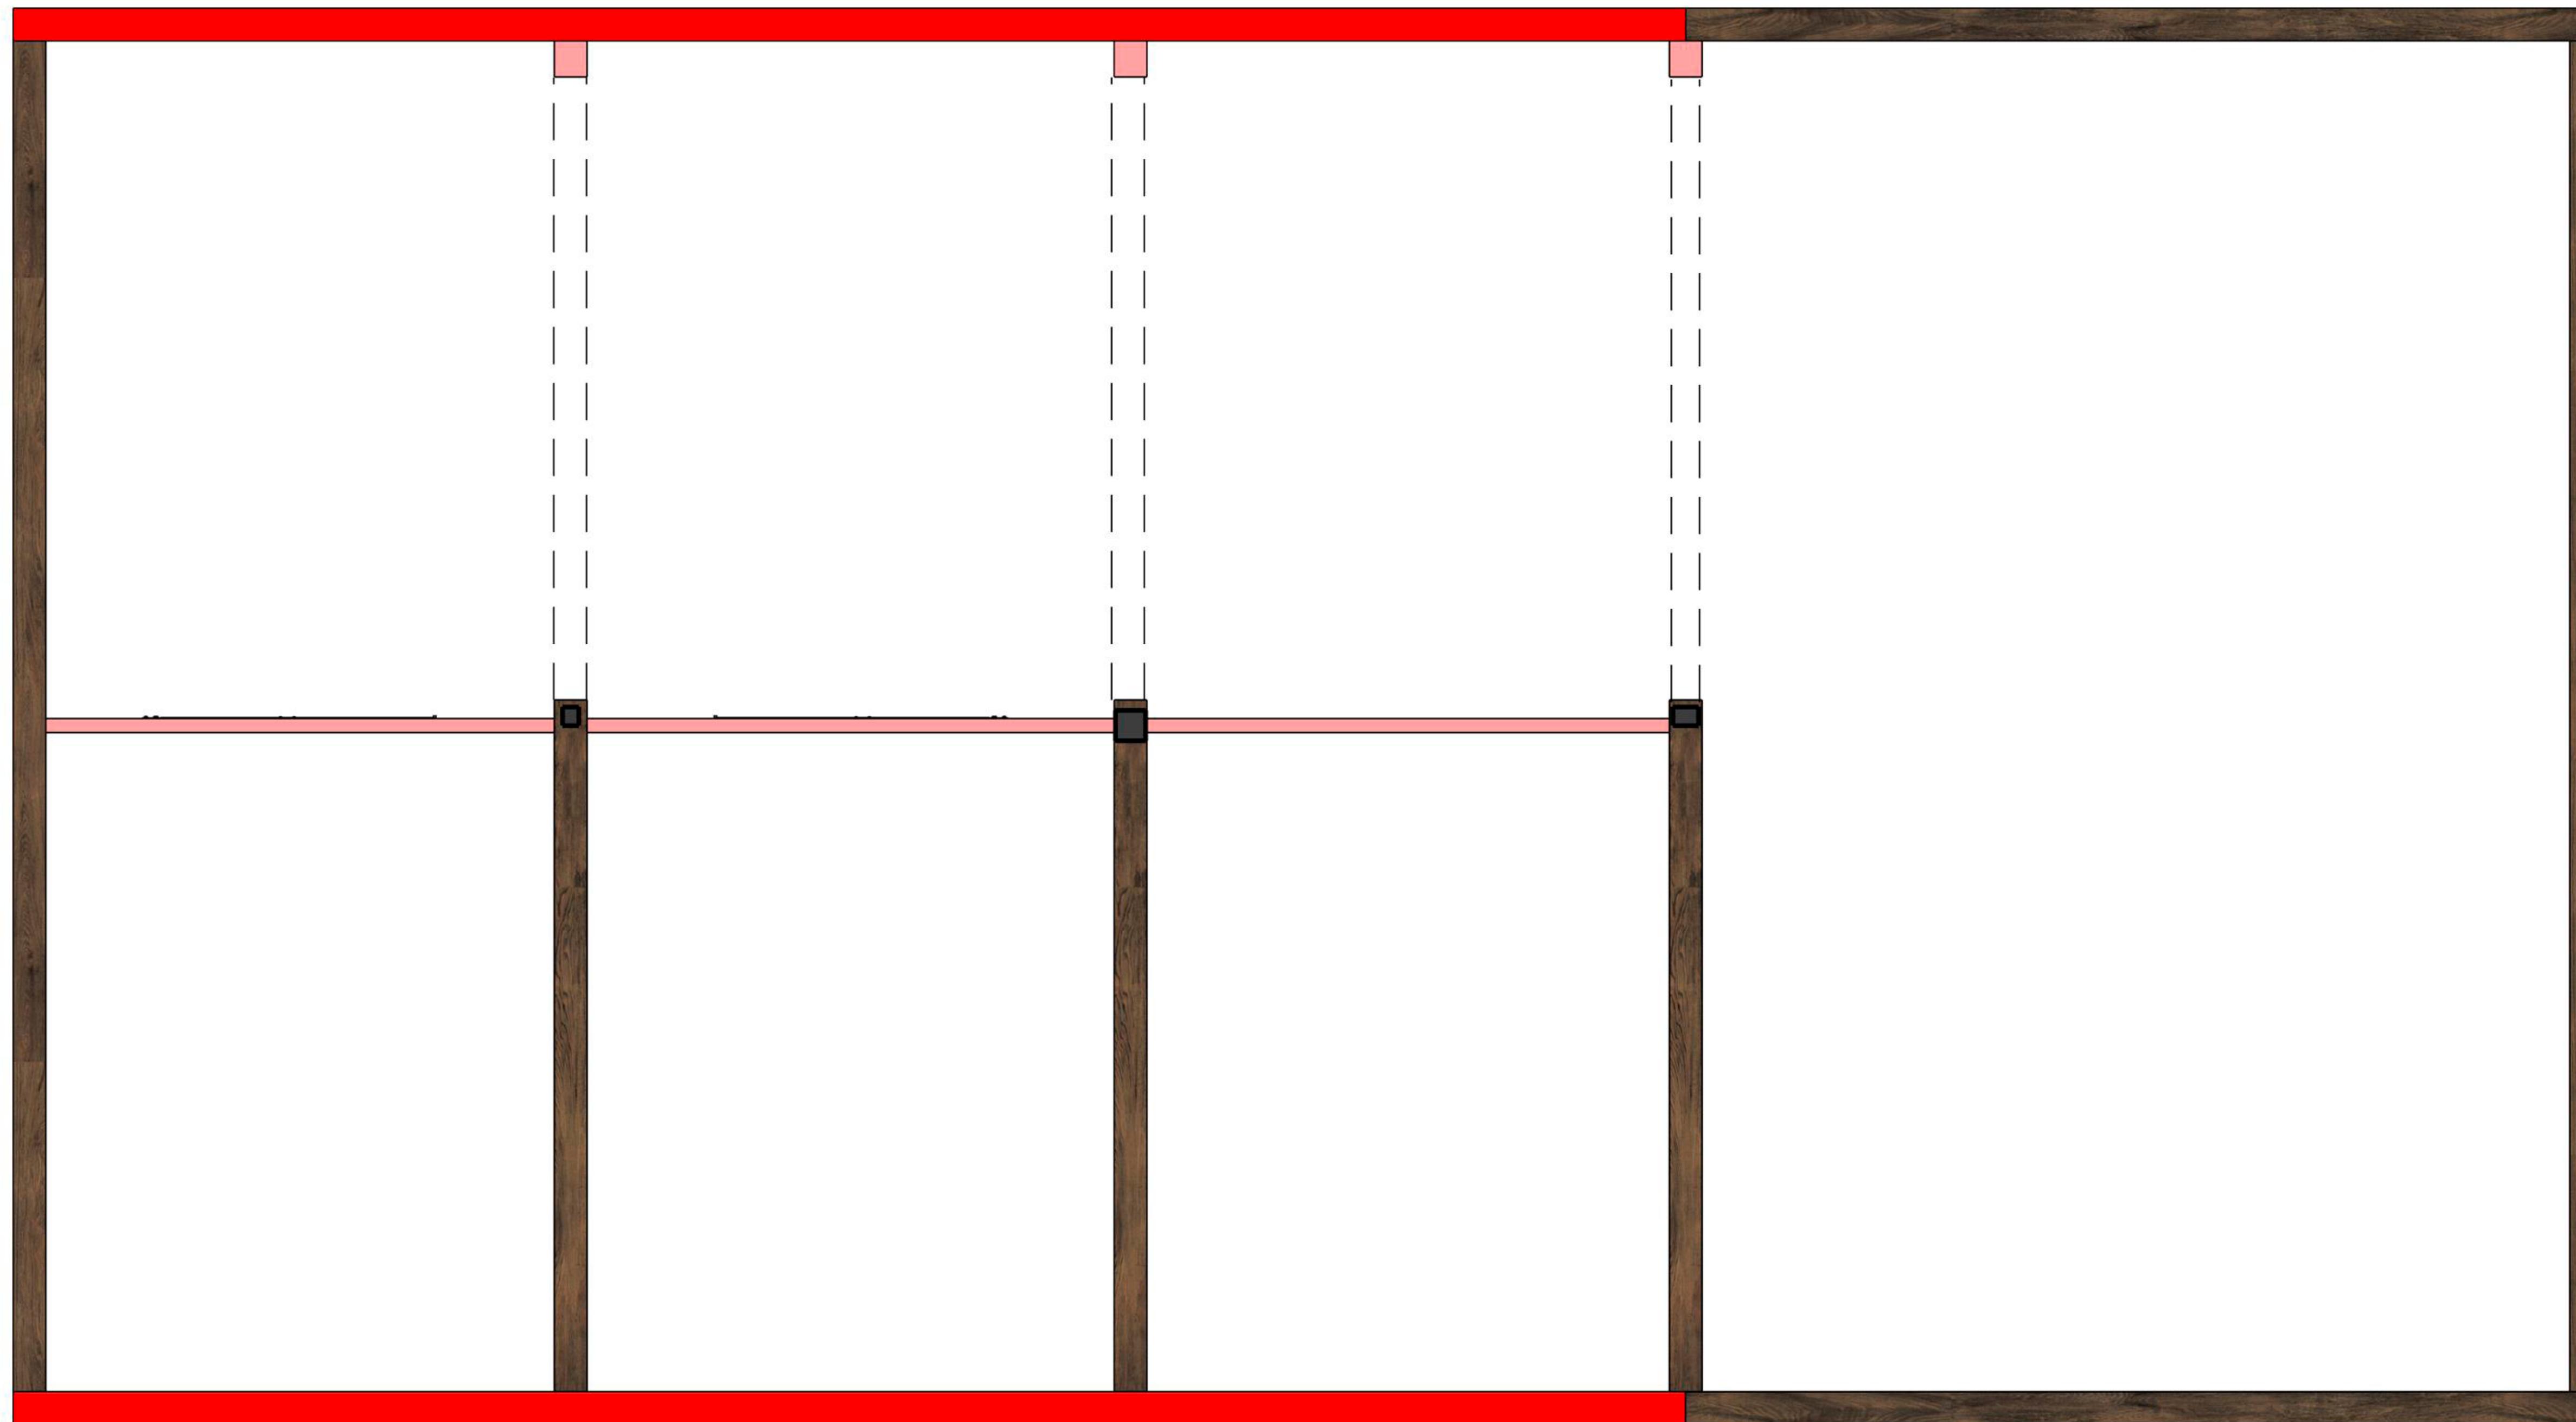
LOFT

- SOLID WOOD BEAMS/COLUMNS IN FAIR CONDITION
- STANDARD LUMBER IN FAIR CONDITION
- STRUCTURALLY INADEQUATE
- POWDER POST BEETLE DESTRUCTION

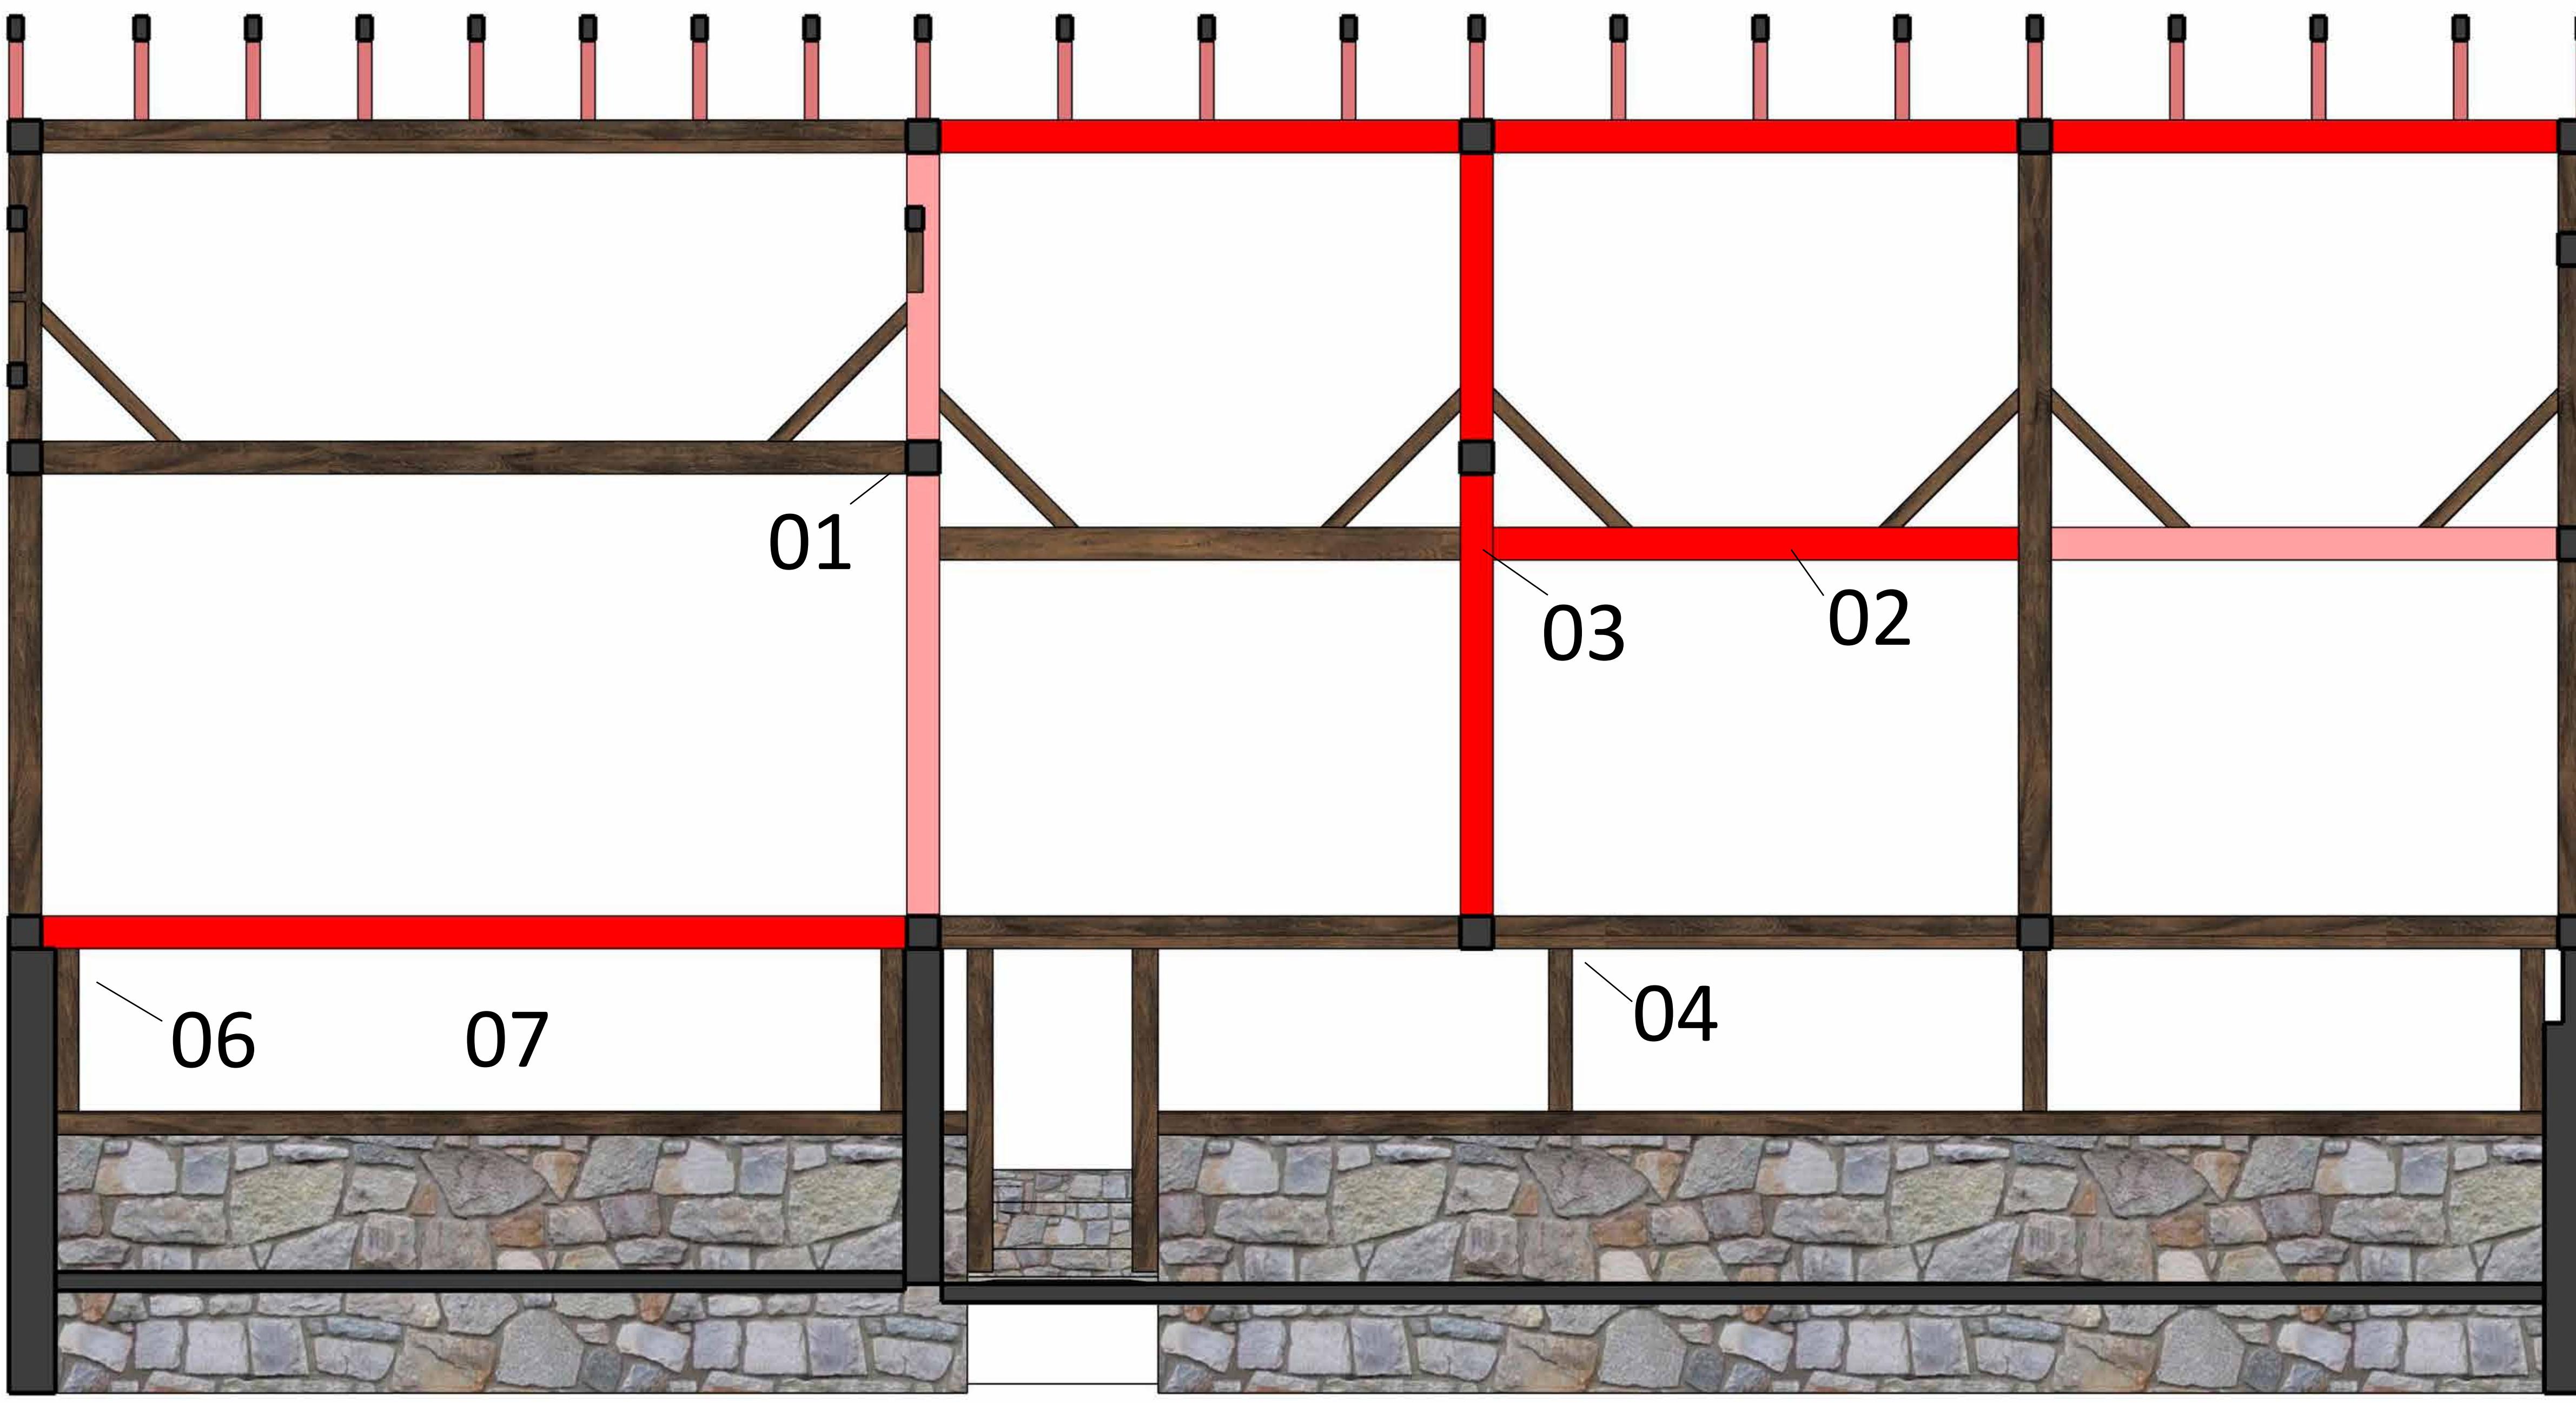
EAST WALL

- SOLID WOOD BEAMS/COLUMNS IN FAIR CONDITION
- STANDARD LUMBER IN FAIR CONDITION
- STRUCTURALLY INADEQUATE
- POWDER POST BEETLE DESTRUCTION

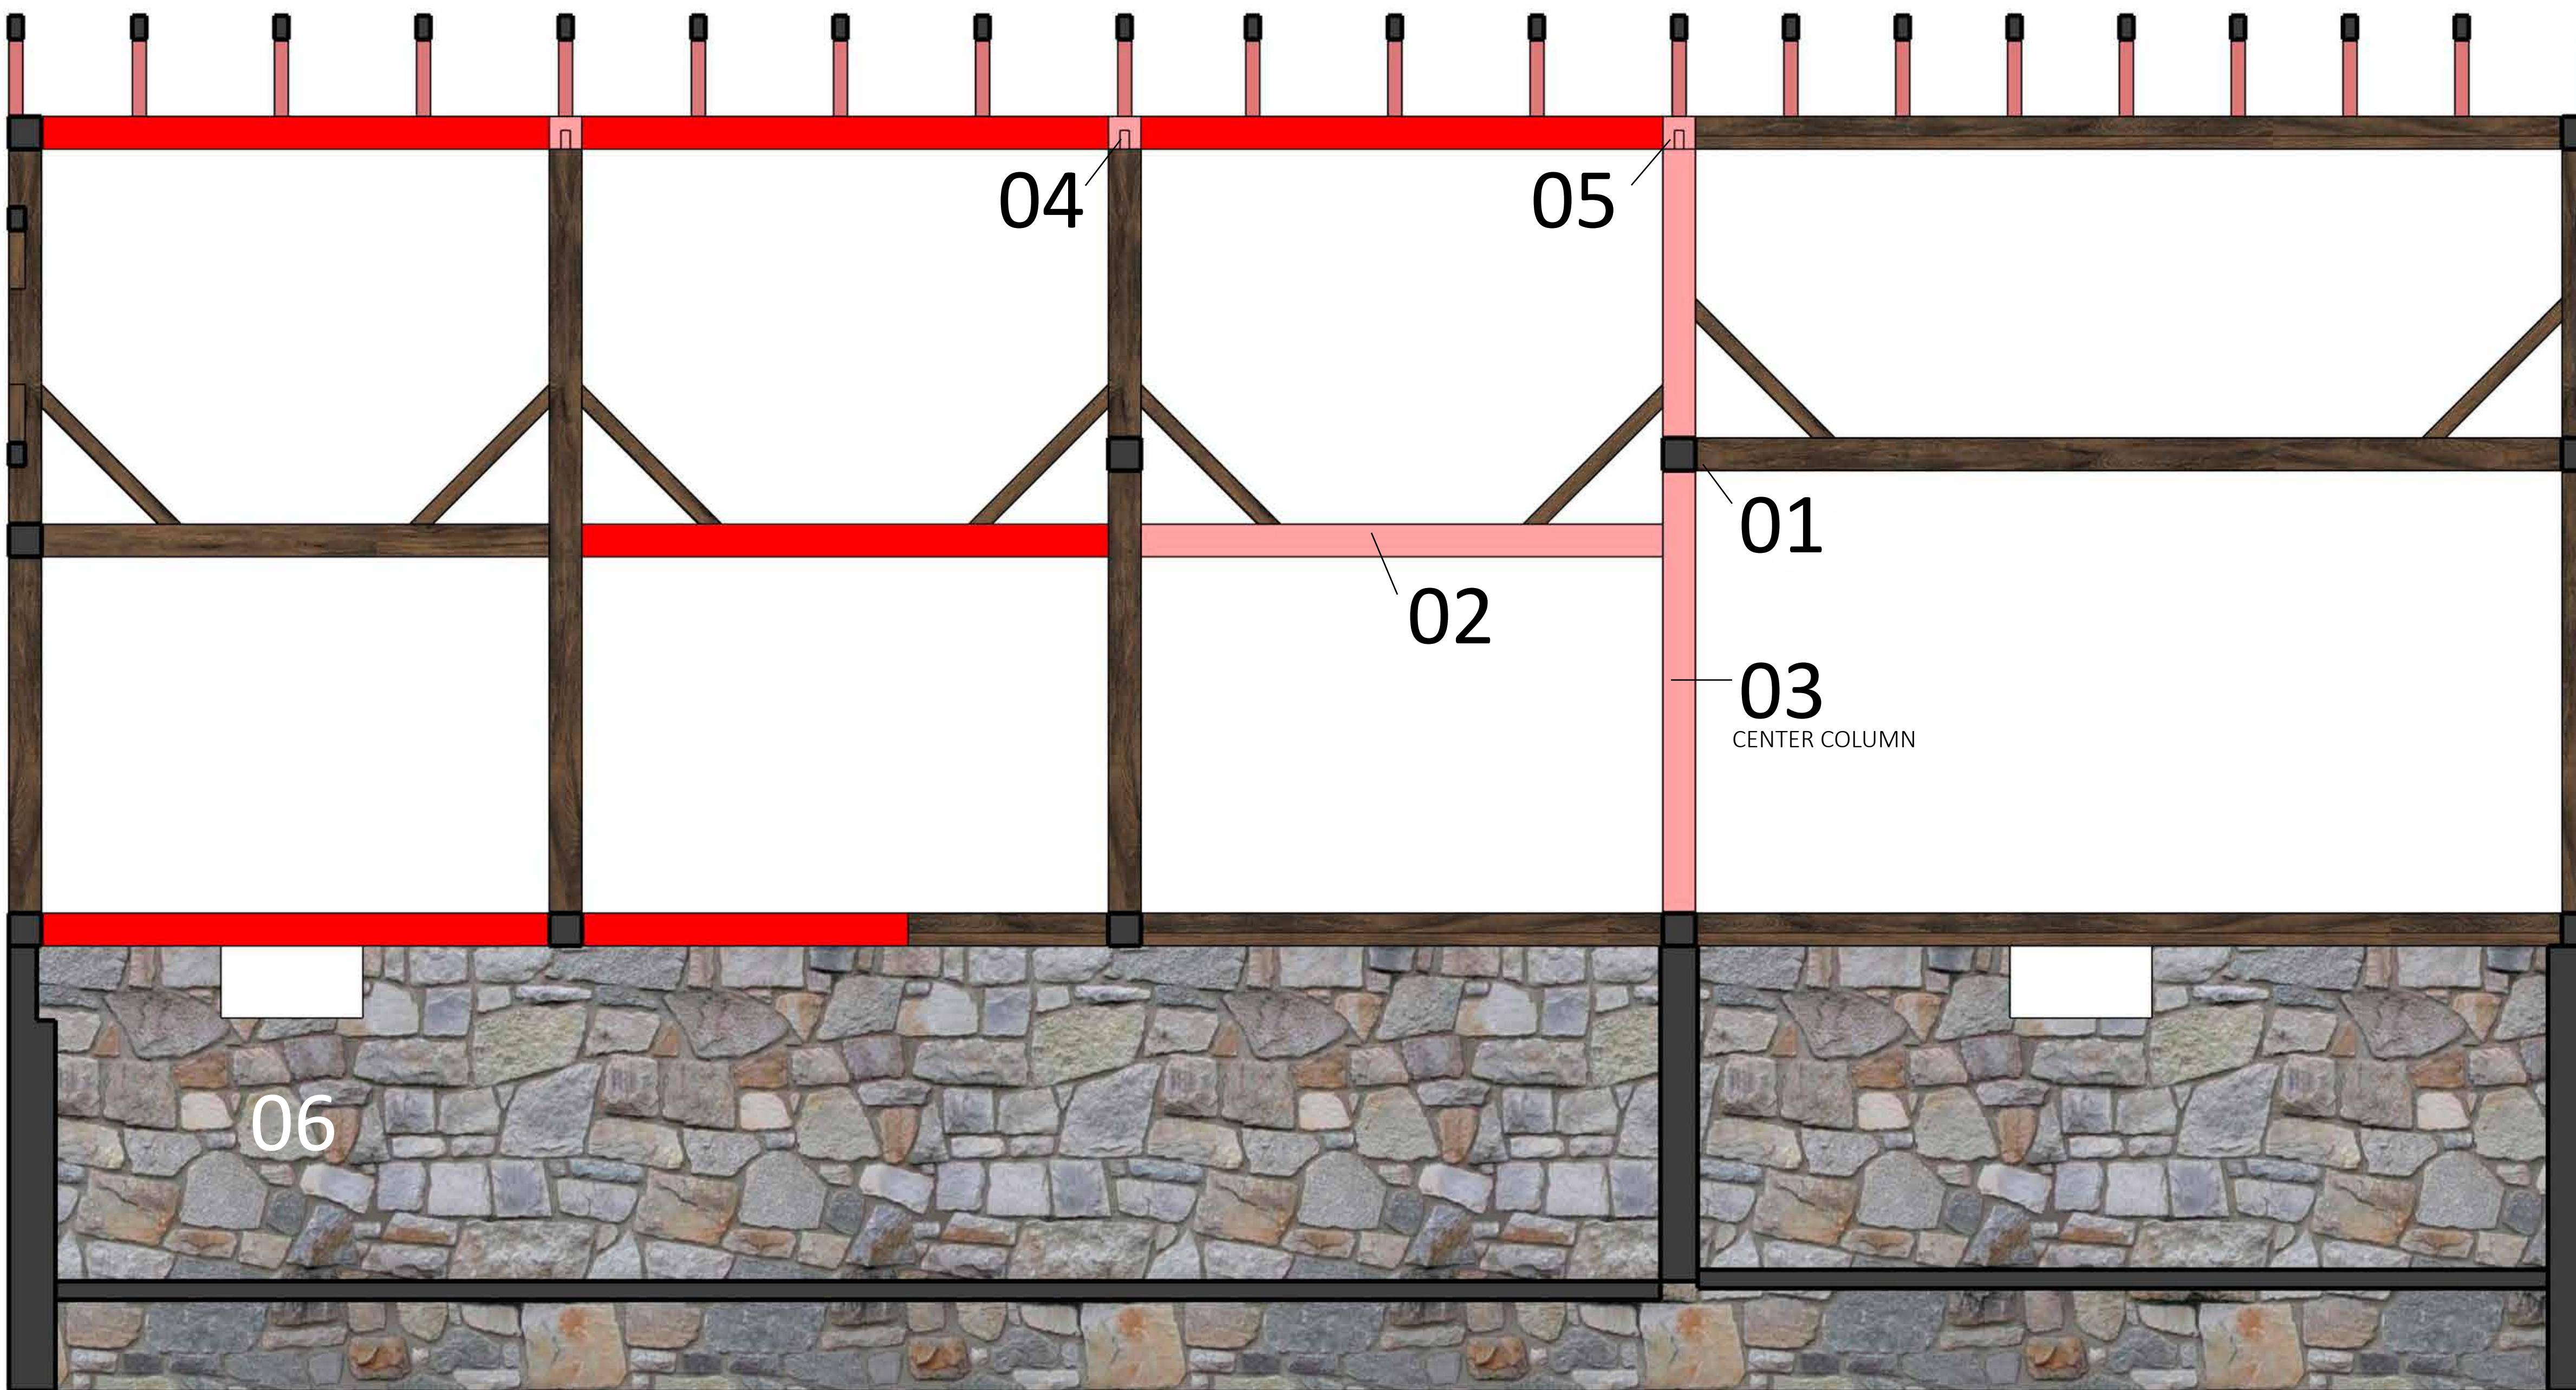
WEST WALL

- SOLID WOOD BEAMS/COLUMNS IN FAIR CONDITION
- STANDARD LUMBER IN FAIR CONDITION
- STRUCTURALLY INADEQUATE
- POWDER POST BEETLE DESTRUCTION

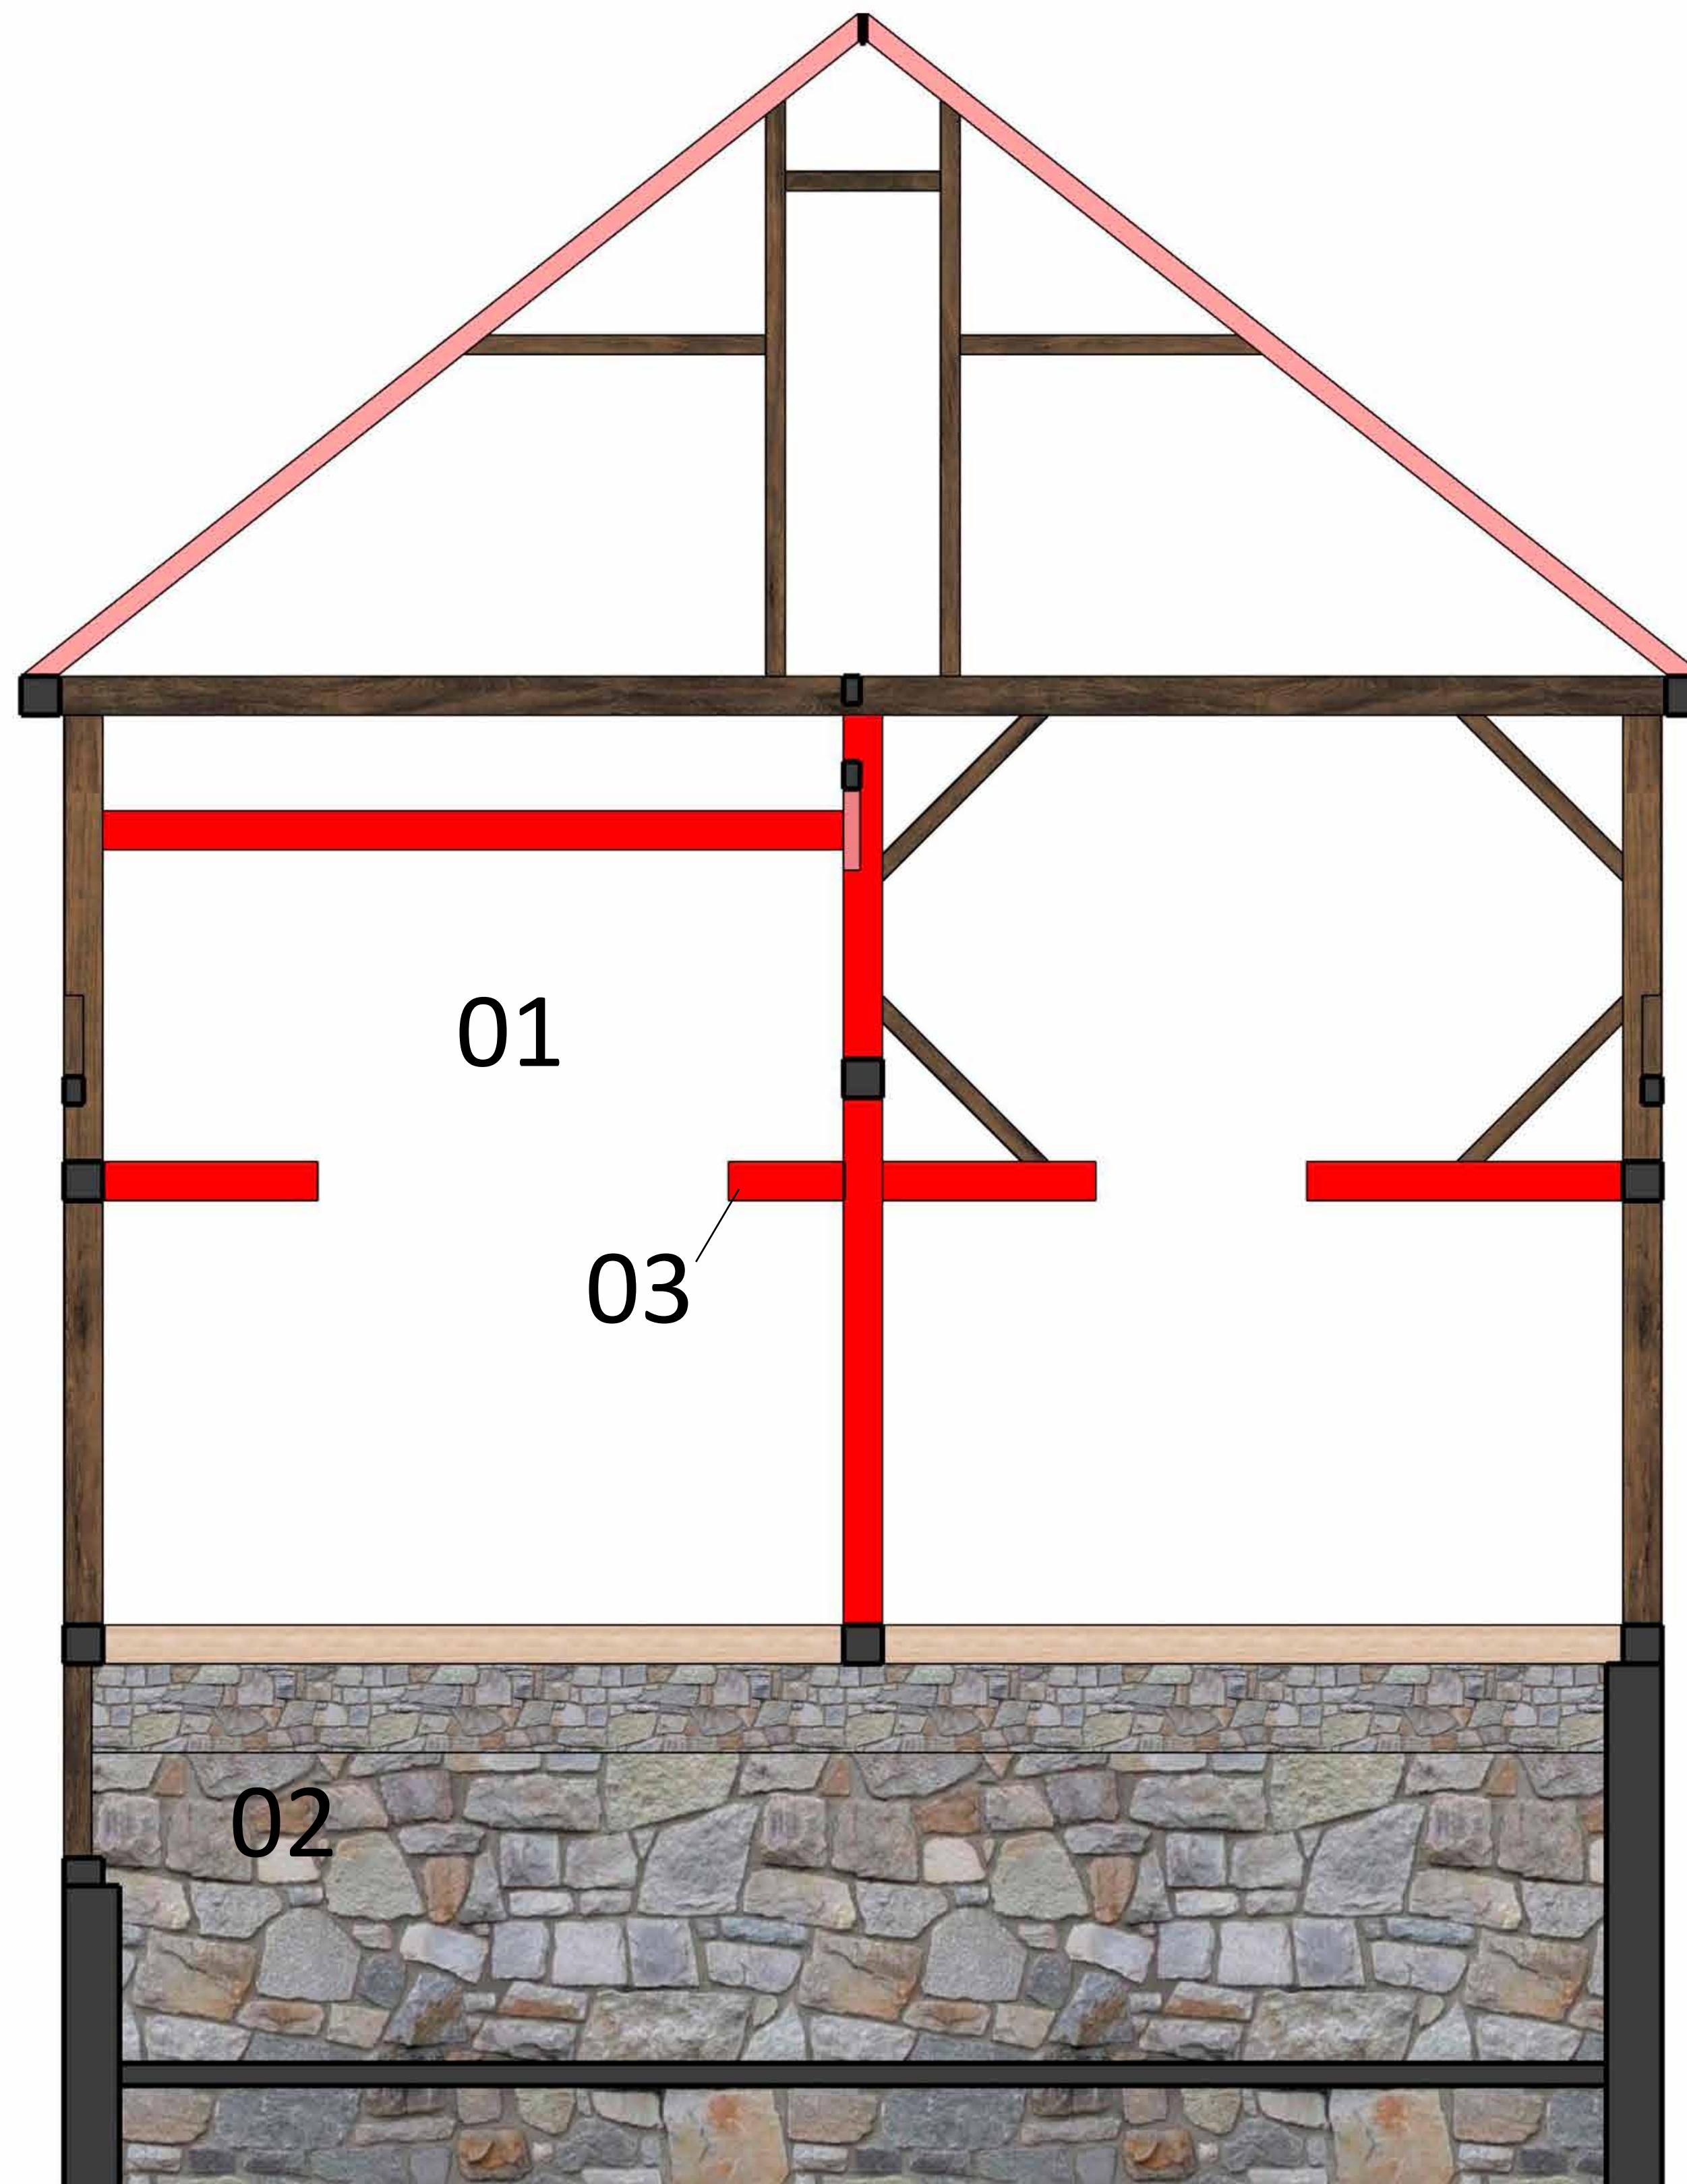
SOUTH GABLE

- SOLID WOOD BEAMS/COLUMNS IN FAIR CONDITION
- STANDARD LUMBER IN FAIR CONDITION
- STRUCTURALLY INADEQUATE
- POWDER POST BEETLE DESTRUCTION

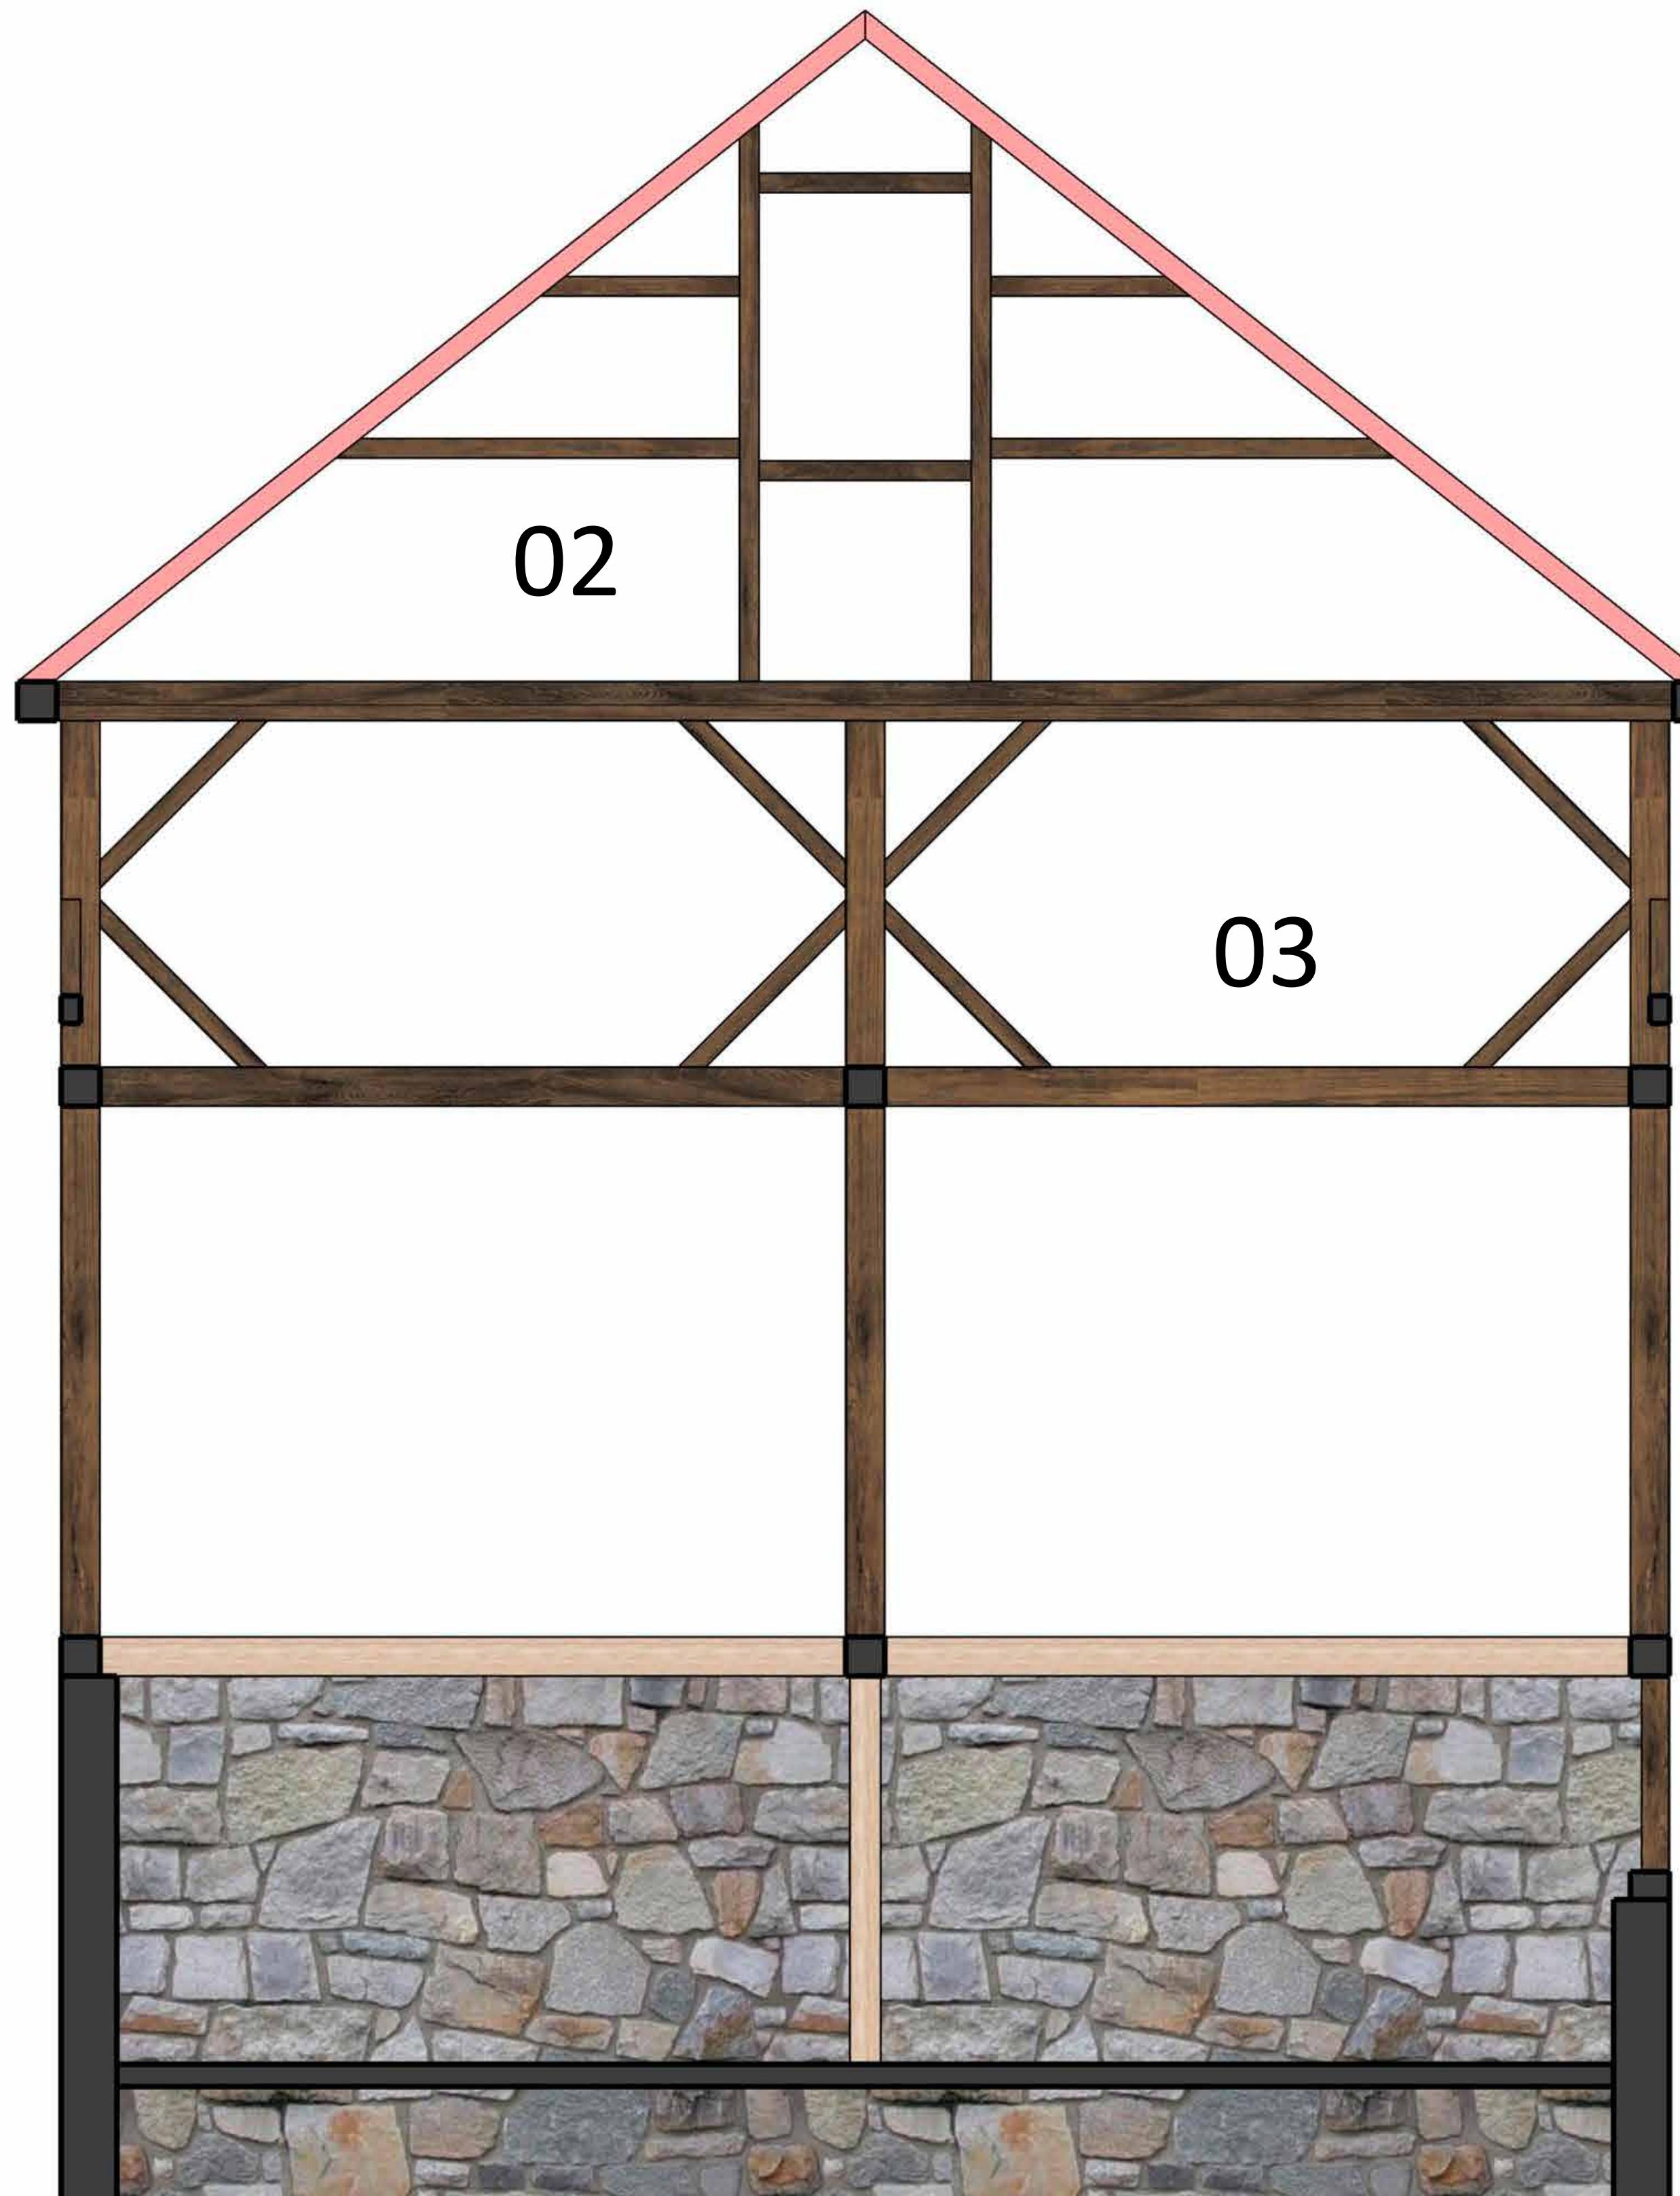
NORTH GABLE

- █ SOLID WOOD BEAMS/COLUMNS IN FAIR CONDITION
- █ STANDARD LUMBER IN FAIR CONDITION
- █ STRUCTURALLY INADEQUATE
- █ POWDER POST BEETLE DESTRUCTION
