**PROJECT PHOTOS**

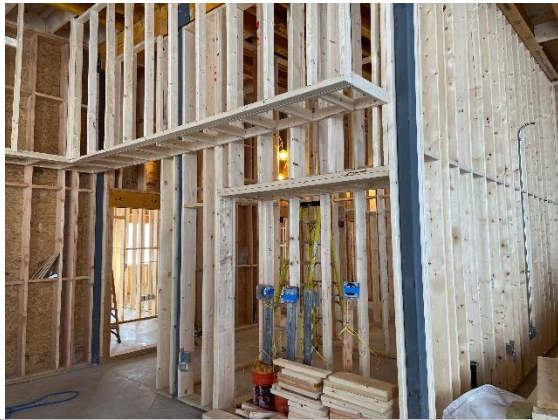
**Interior soffit installation (02/10/2021)**

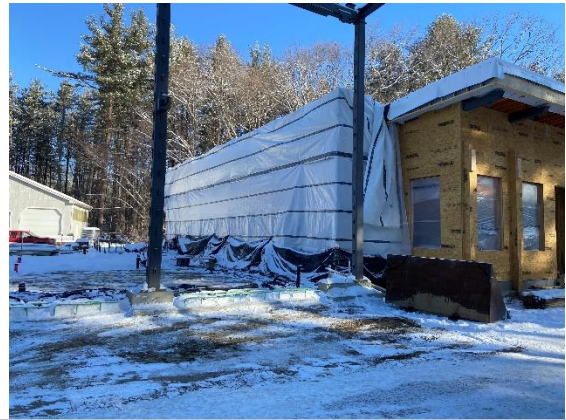
**Enclosure for masonry construction (02/10/2021)**

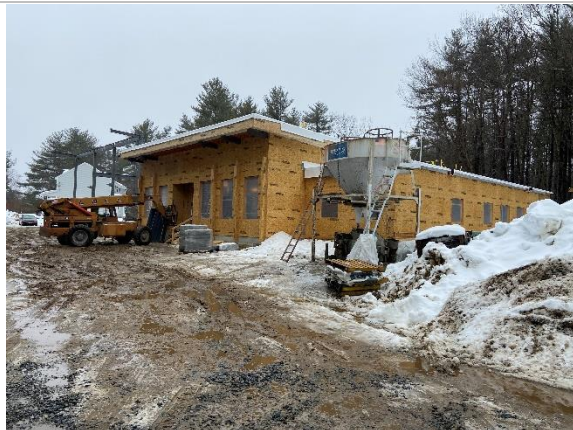
**Overview of east side construction (02/16/2021)**

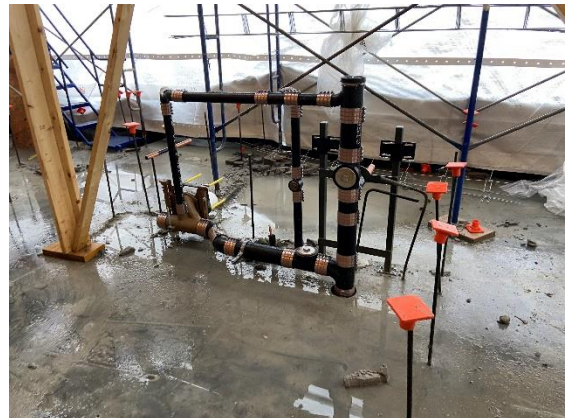
**Plumbing rough-in (02/16/2021)**

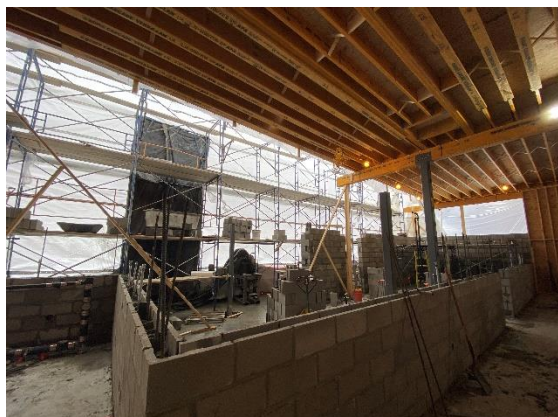
**Masonry construction east of Line 6 (02/18/2021)**

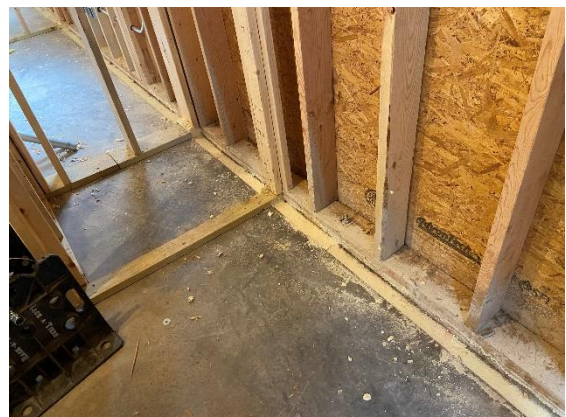
**Foam slab insulation installed on east side (02/18/2021)**

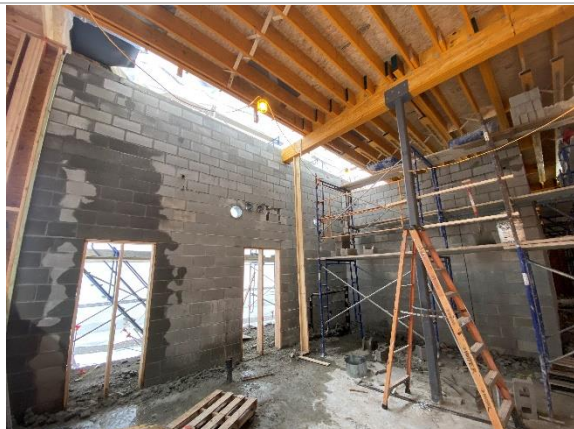
**Masonry construction east of Line 6 (02/23/2021)**

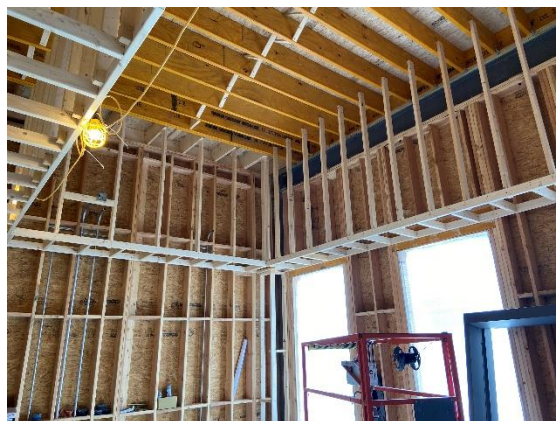
**Interior soffit and time capsule box out installation (02/23/2021)**

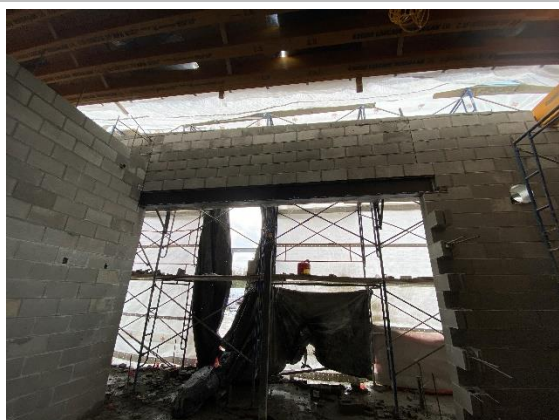
**Masonry construction looking west from gear room (02/23/2021)**

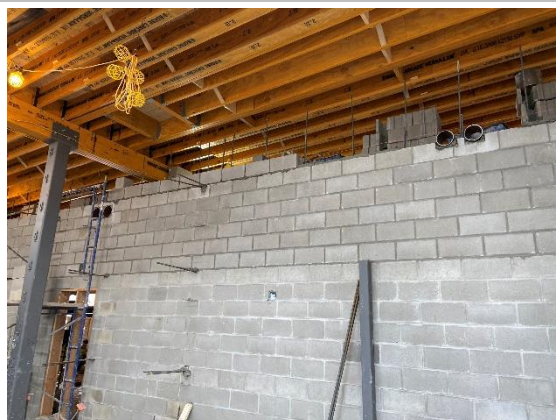
**Masonry construction along Line 9/10 looking east (02/23/2021)**

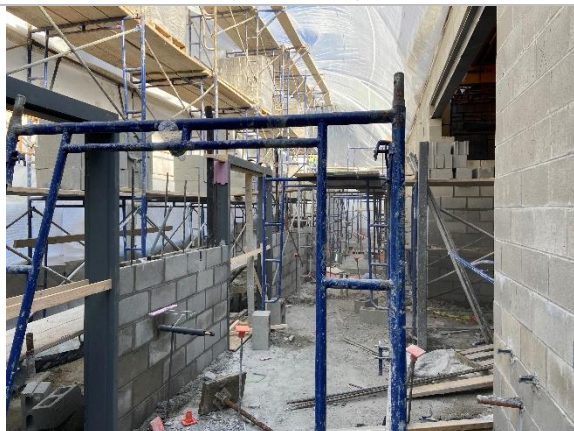
**Masonry construction along Line 5 (02/26/2021)**

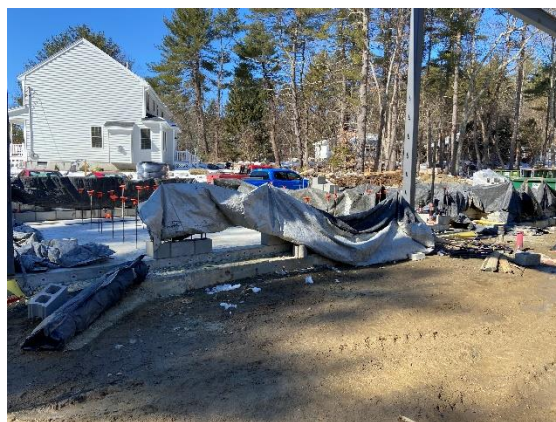
**Masonry construction west of apparatus bay (02/26/2021)**

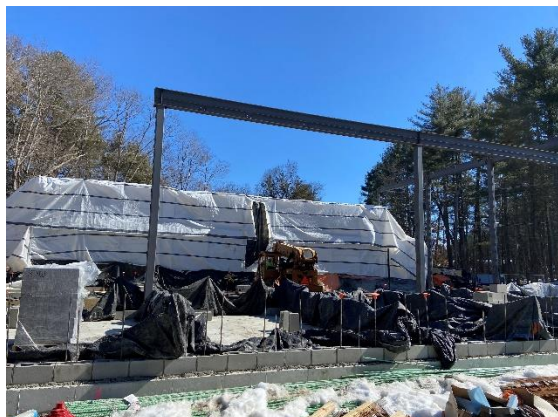
**Overview of construction from west side of site  
(02/26/2021)**

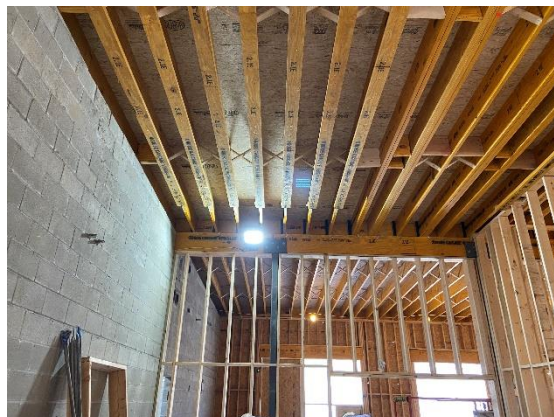
**Interior wood framing (02/26/2021)**

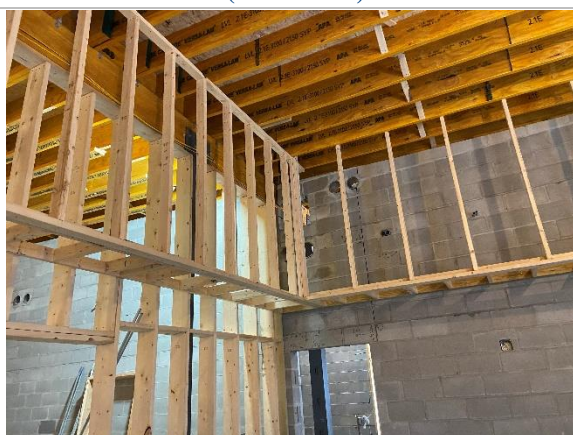
**Interior soffit construction along Line 9/10  
(03/01/2021)**

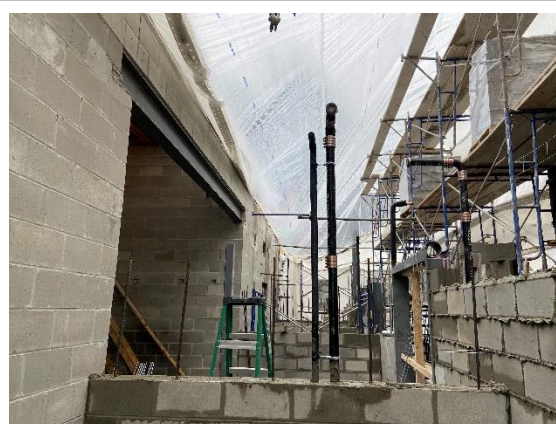
**Masonry construction and rough-ins between Line 5 and  
6 (03/01/2021)**

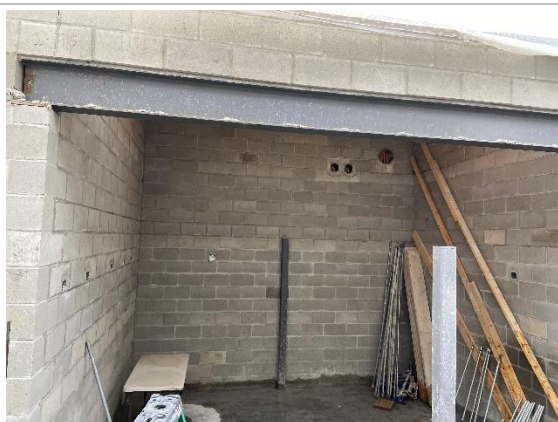
**Gear room looking east (03/01/2021)**

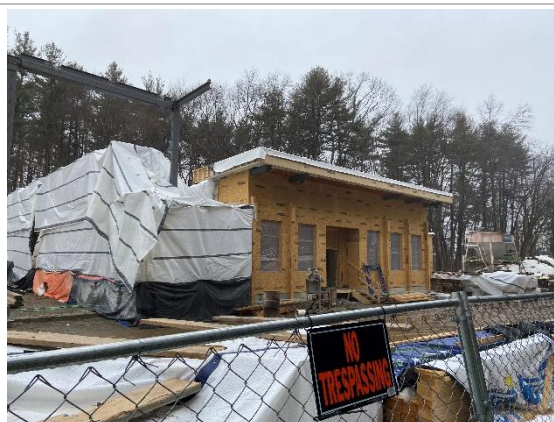
**Overview of east side of building (03/01/2021)**

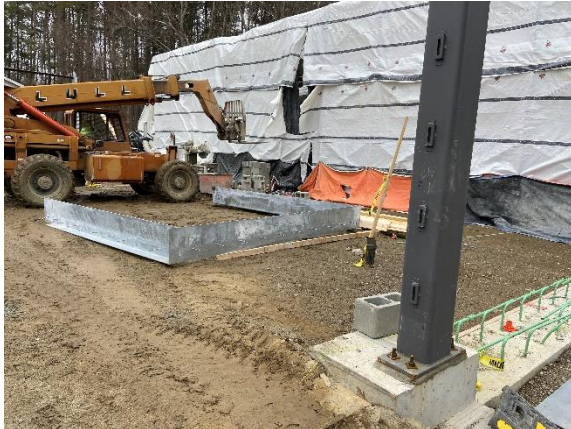
**CMU frame for apparatus bay door (03/04/2021)**

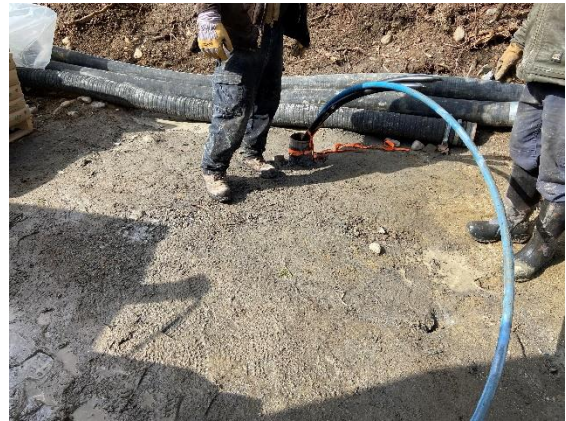
**Grouting operations at geothermal wells (03/04/2021)**

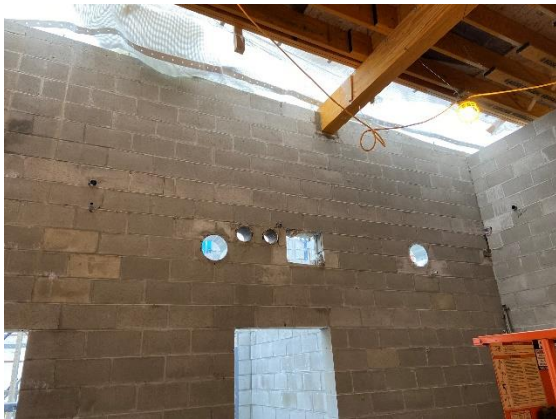
**LVL bearing connection at masonry wall at Line 6.5  
(03/04/2021)**

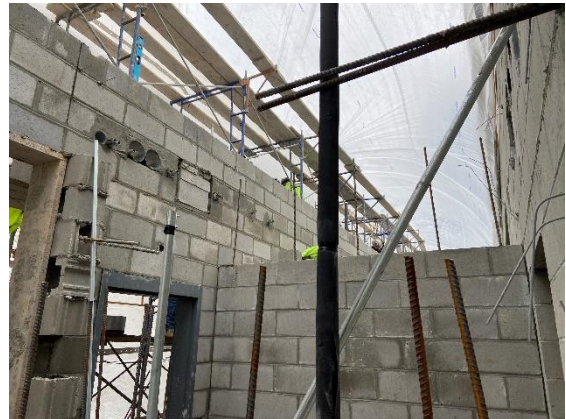
**Masonry construction along Line 5/6 (03/04/2021)**

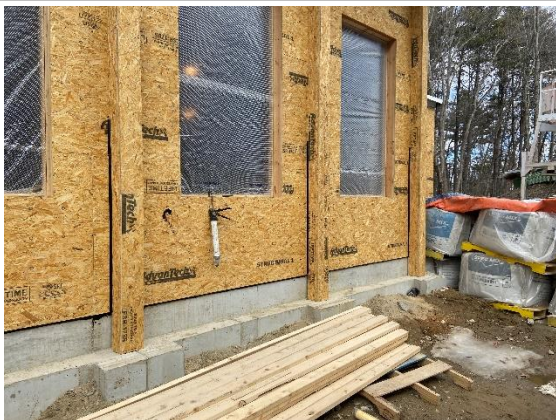
**Waterproofing installation on southeast face  
(03/04/2021)**

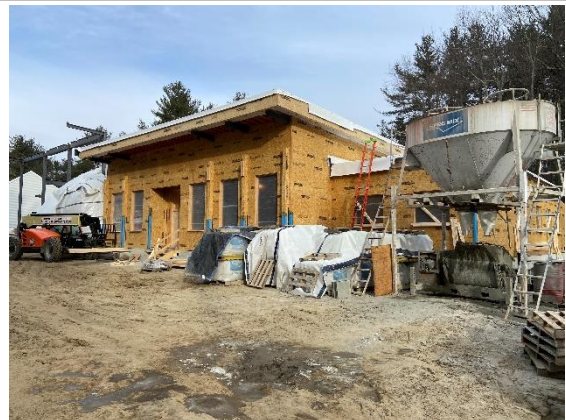
**Waterproofing on east side (03/05/2021)**

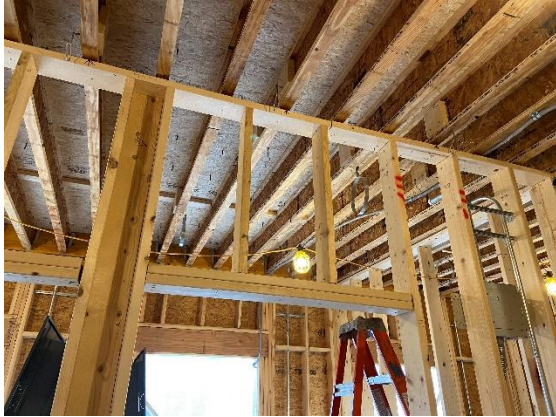
**HVAC hangers installed on east side (03/05/2021)**

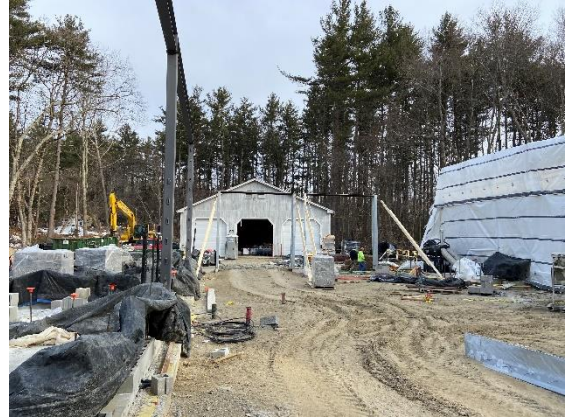
**CMU frames erected on north side of apparatus bay  
(03/05/2021)**

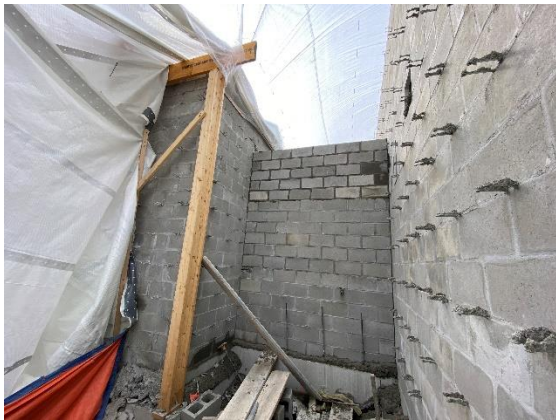
**Northern exterior face of masonry construction along  
Line 5/6 (03/05/2021)**

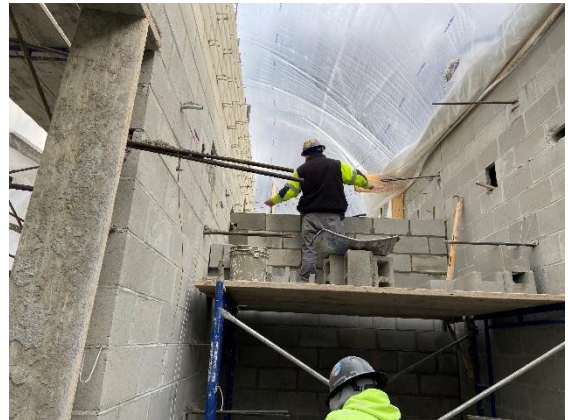
**Masonry construction along Line 5/6 (03/05/2021)**
