PROJECT PHOTOS

Town of Acton, MA
North Acton Fire Station

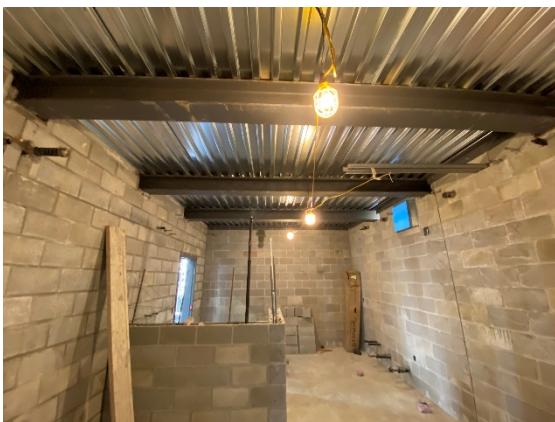
Interior of dirty laundry room (04/13/2021)

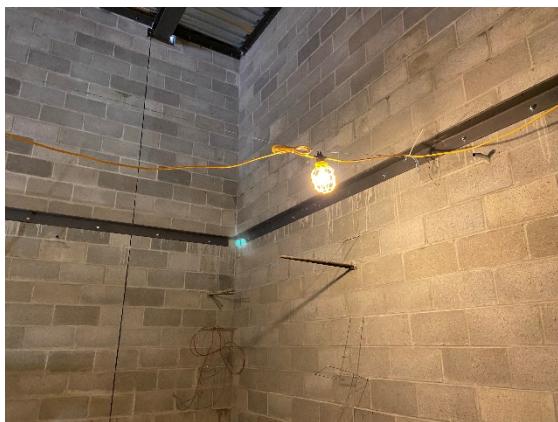
Mezzanine slab edge supports installed (04/13/2021)

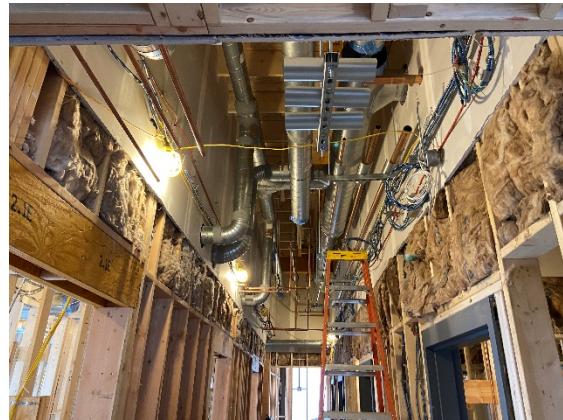
MEP rough-ins on east side (04/13/2021)

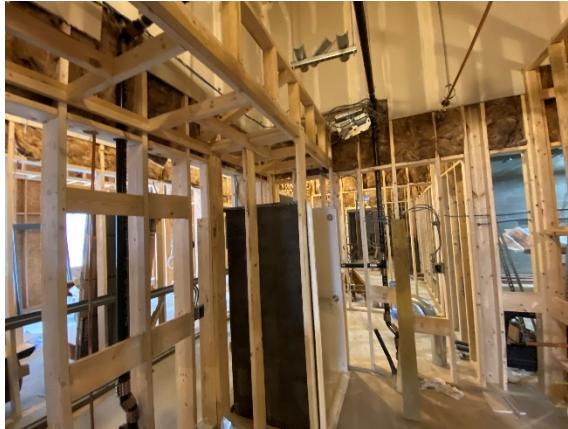
Installation of shower stalls (04/13/2021)

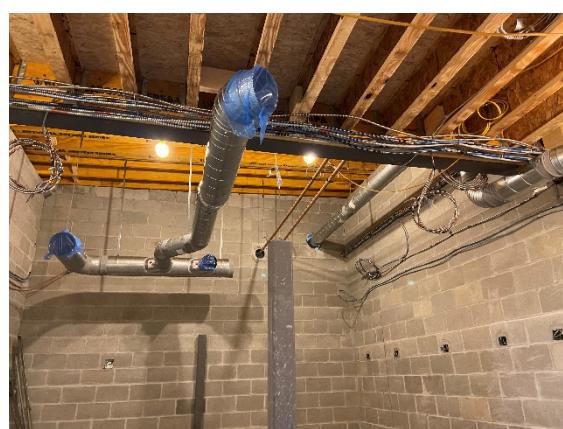
MEP rough-ins in gear room (04/13/2021)

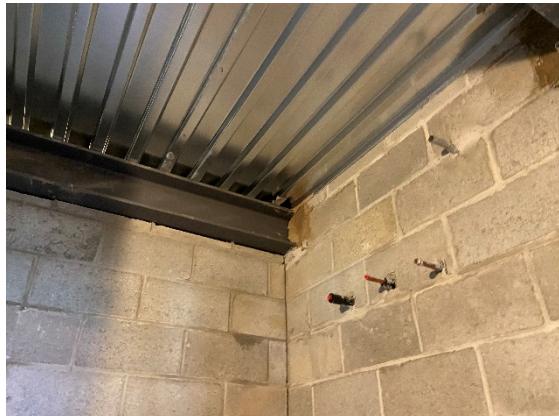
Typical grouted beam pockets at CMU wall (04/23/2021)

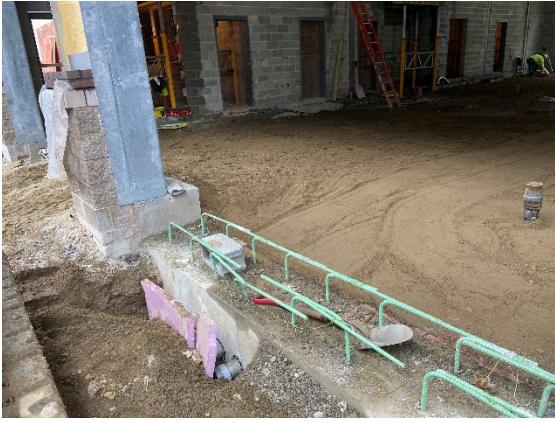
<p>Realigned electrical conduits for emergency power and telecom lines and compacted graded apparatus bay subgrade (04/29/2021)</p>	<p>North side of building (04/29/2021)</p>

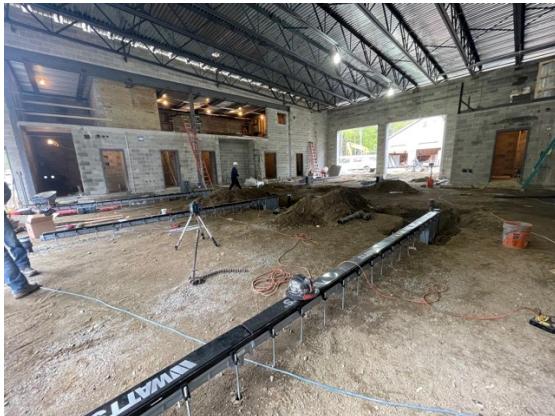
**Installation of apparatus bay trench drains
(05/12/2021)**

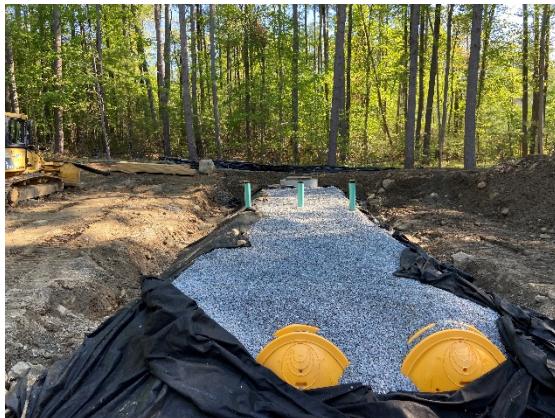
**Installation of stormwater infiltration system 1
(05/17/2021)**

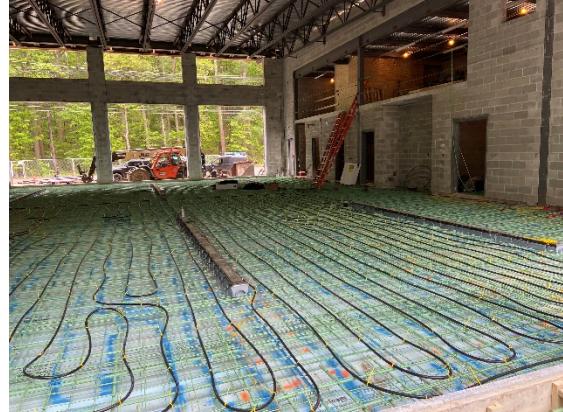
Rooftop units installed on east side. Connections to be made to units. (05/21/2021)	Installation of apparatus bay radiant heating and slab reinforcement (05/21/2021)

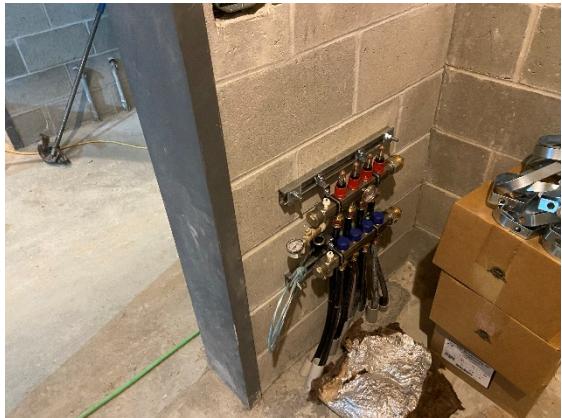
Typical radiant heating manifold. Pump to be installed. (05/28/2021)

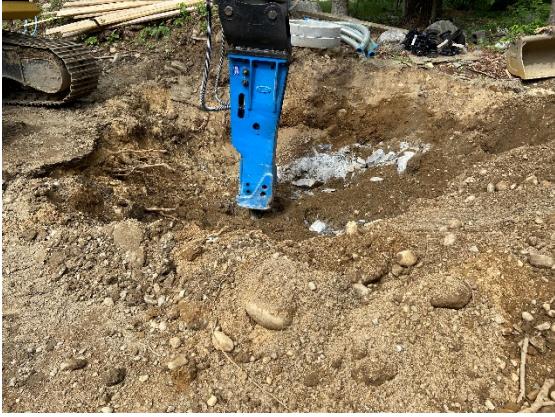
Removal of rock mass at CB 2 (05/28/2021)	Retaining wall installed (05/28/2021)
