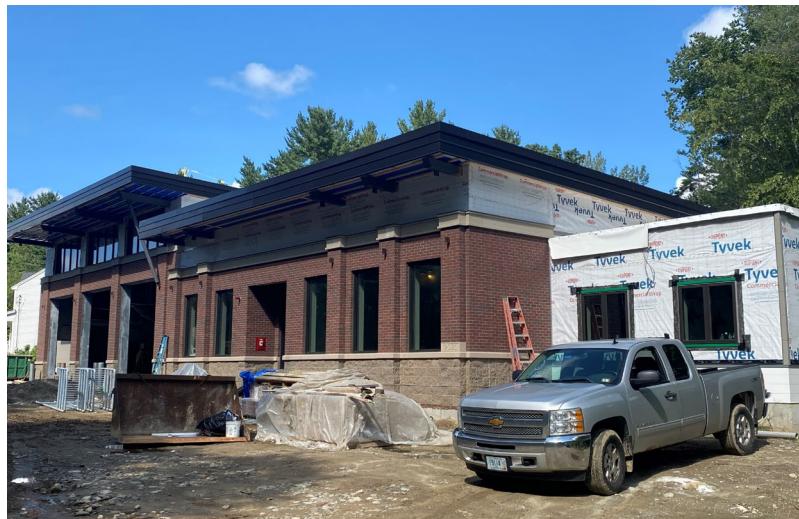
Overview of building from southeast

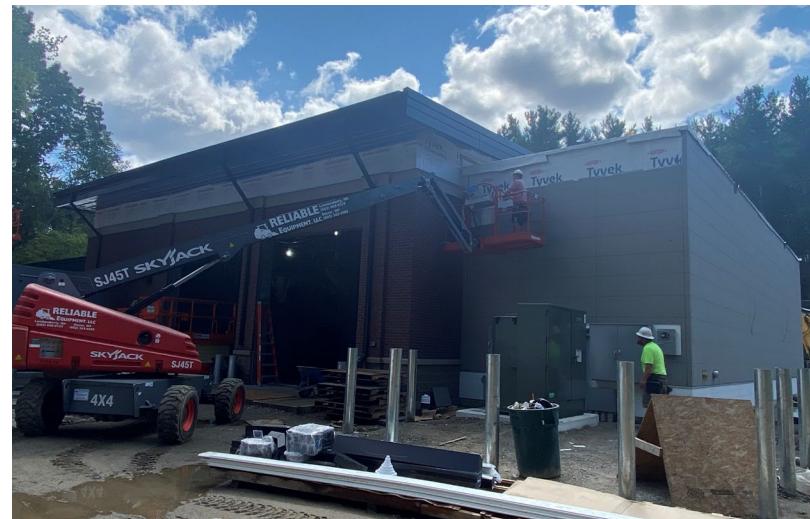
Overview of building from northwest

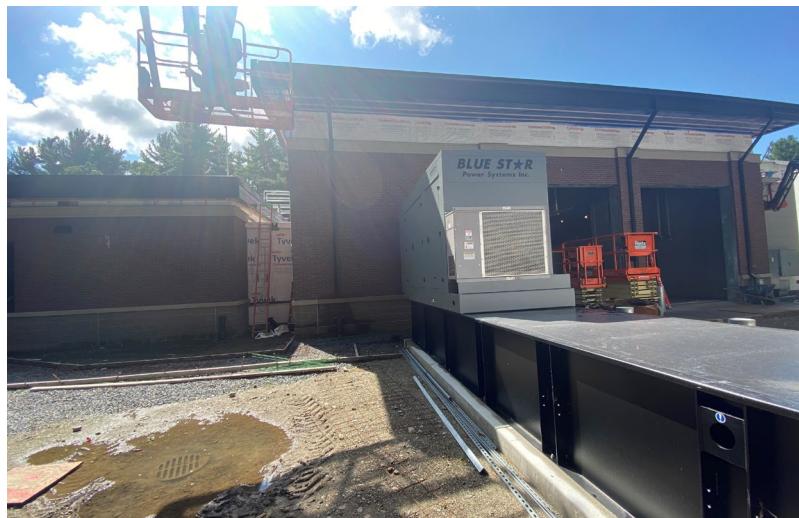
Overview of building from northeast

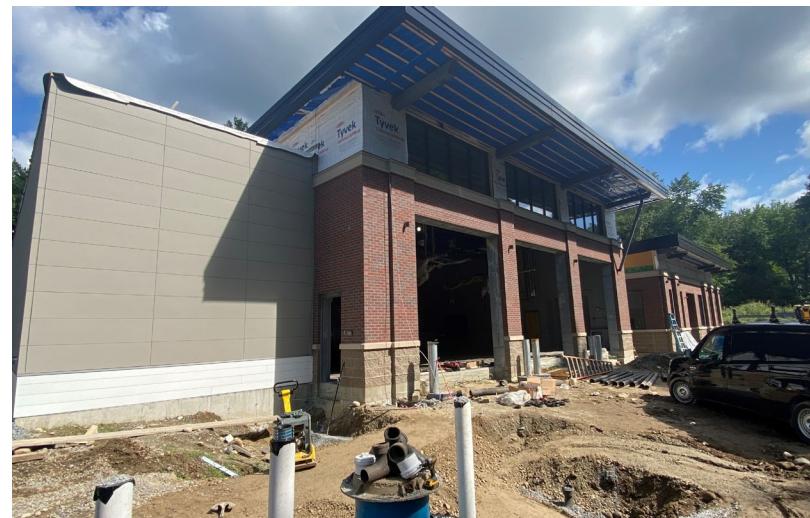
Overview of building from southwest

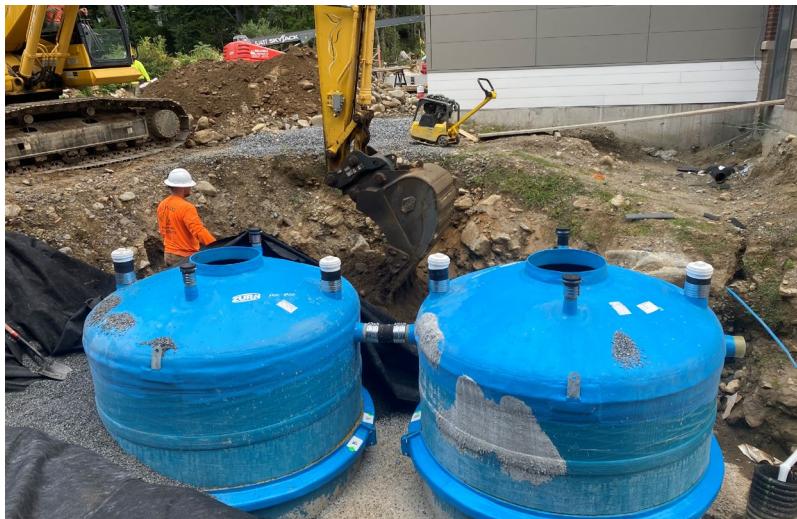
GSI tank backfilling

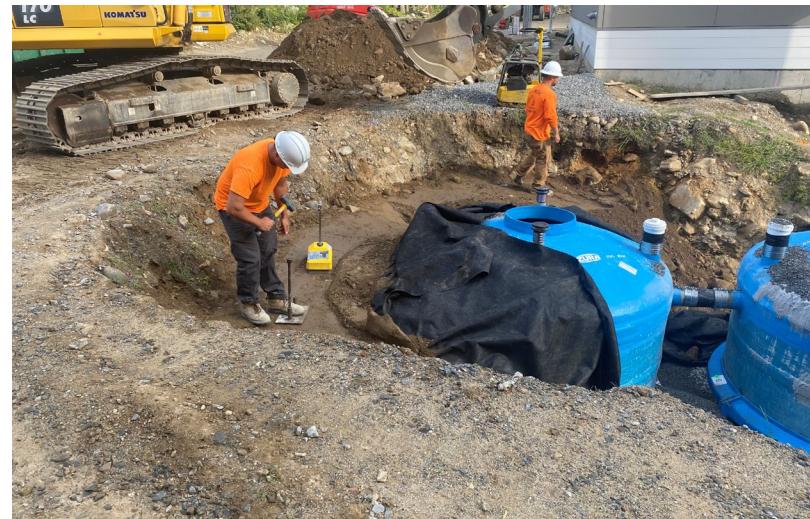
Atane onsite performing test soils

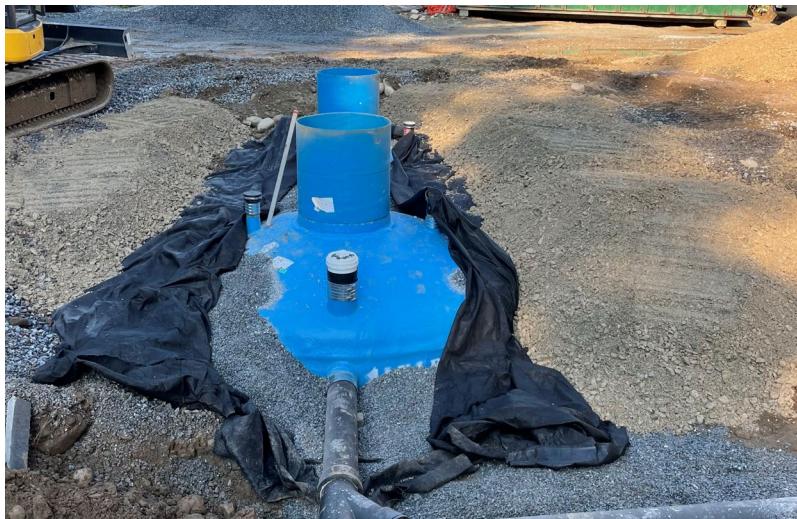
Vent has been installed

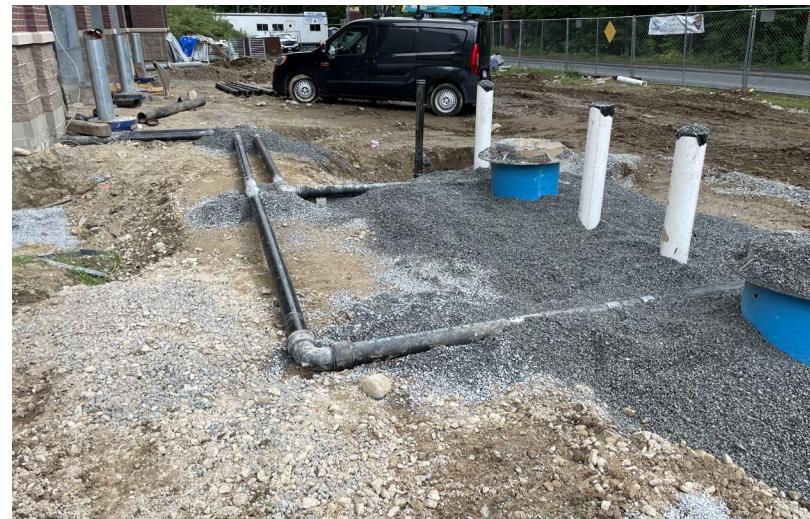
Vent installation

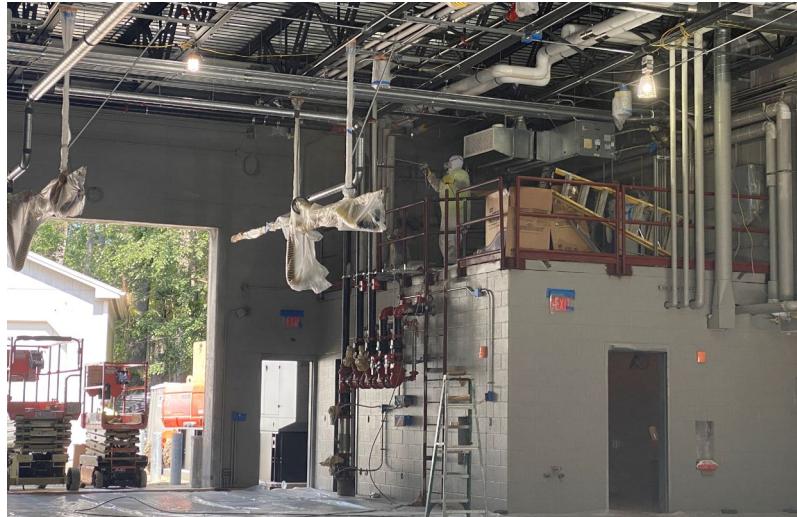
Ceiling Painting

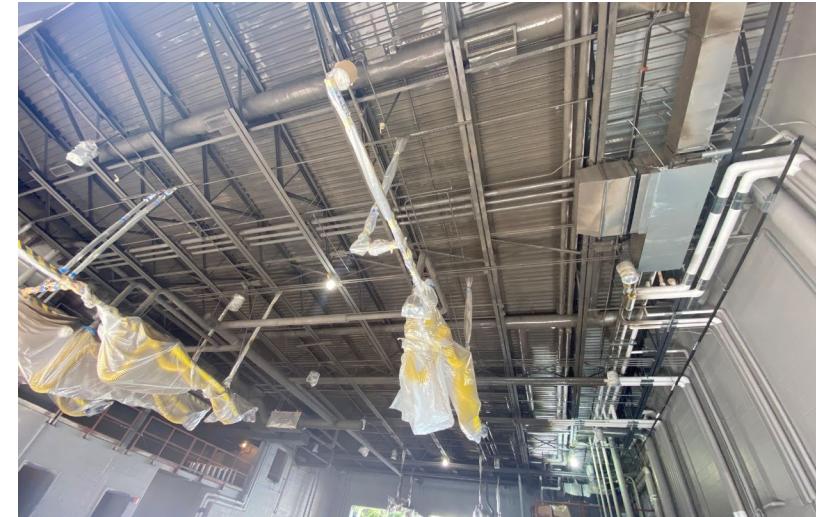
More Ceiling Painting

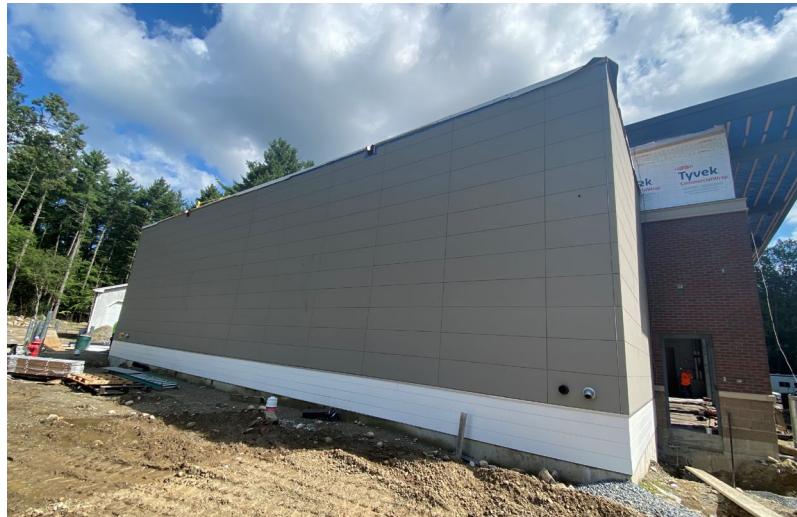
Complete Nichiha siding of the west side of building

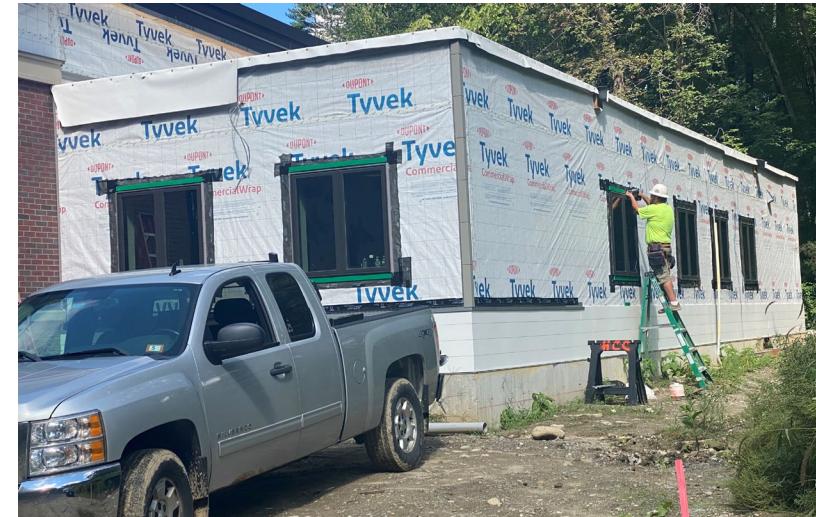
Nichiha siding of the east side of building

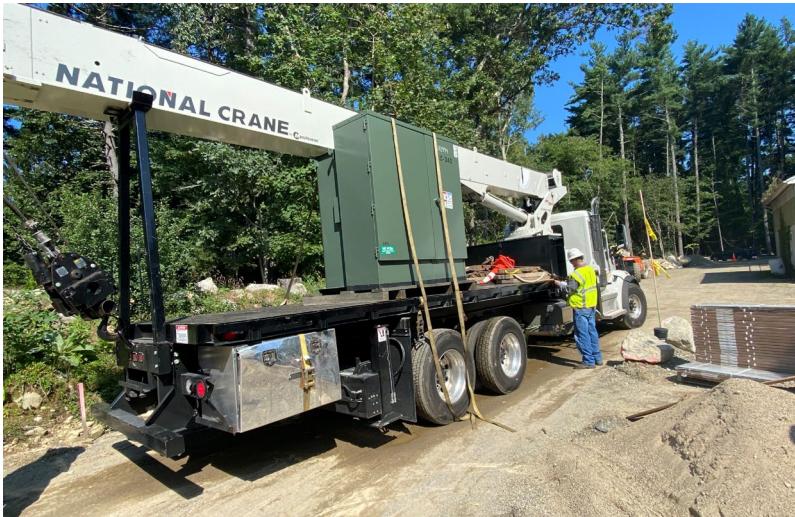
Eversource deliver the transformer

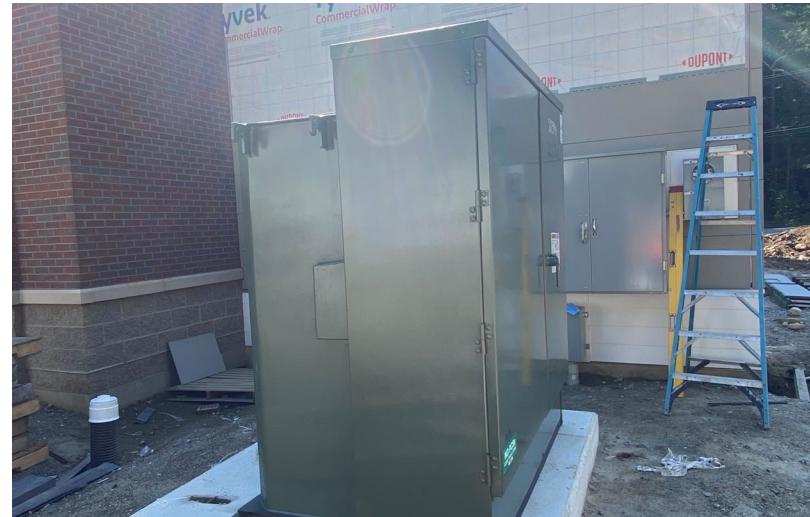
Transformer has been installed

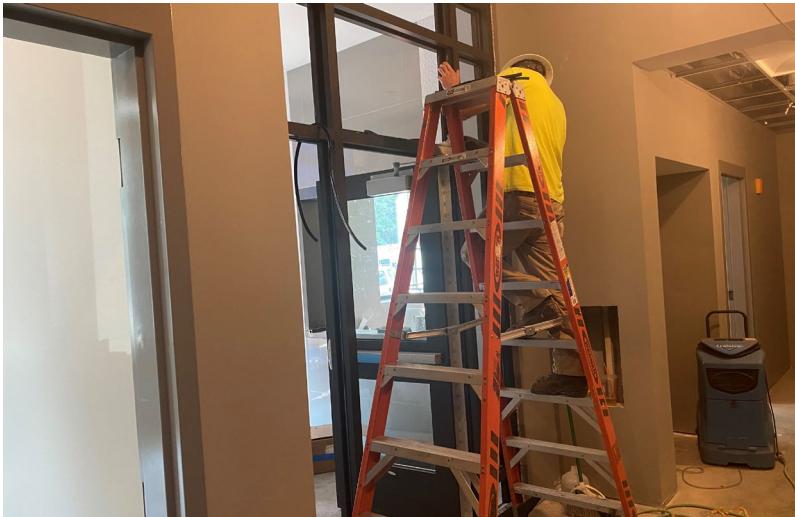
Installing front door glass

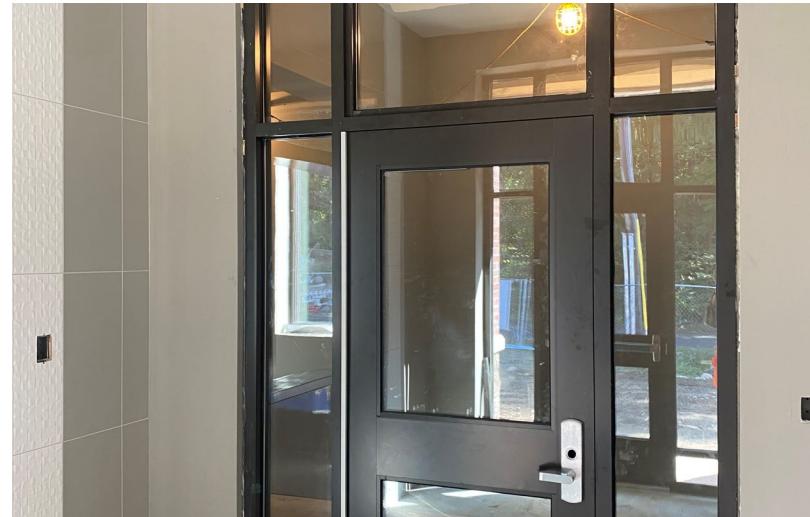
Front door glass has been installed
