CERTIFICATE OF APPROPRIATENESS

Location of Work 48 School Street, Acton, MA District: Center West South X

Description of Proposed work: Partial demolition and reconstruction of barn and attached garage located behind residence.

Project: Barn Renovation
Address: 48 School St
Acton, MA 01720
Date: Wednesday 04/16/2025
Prepared by: Studio InSitu Architects, Inc.
RE:

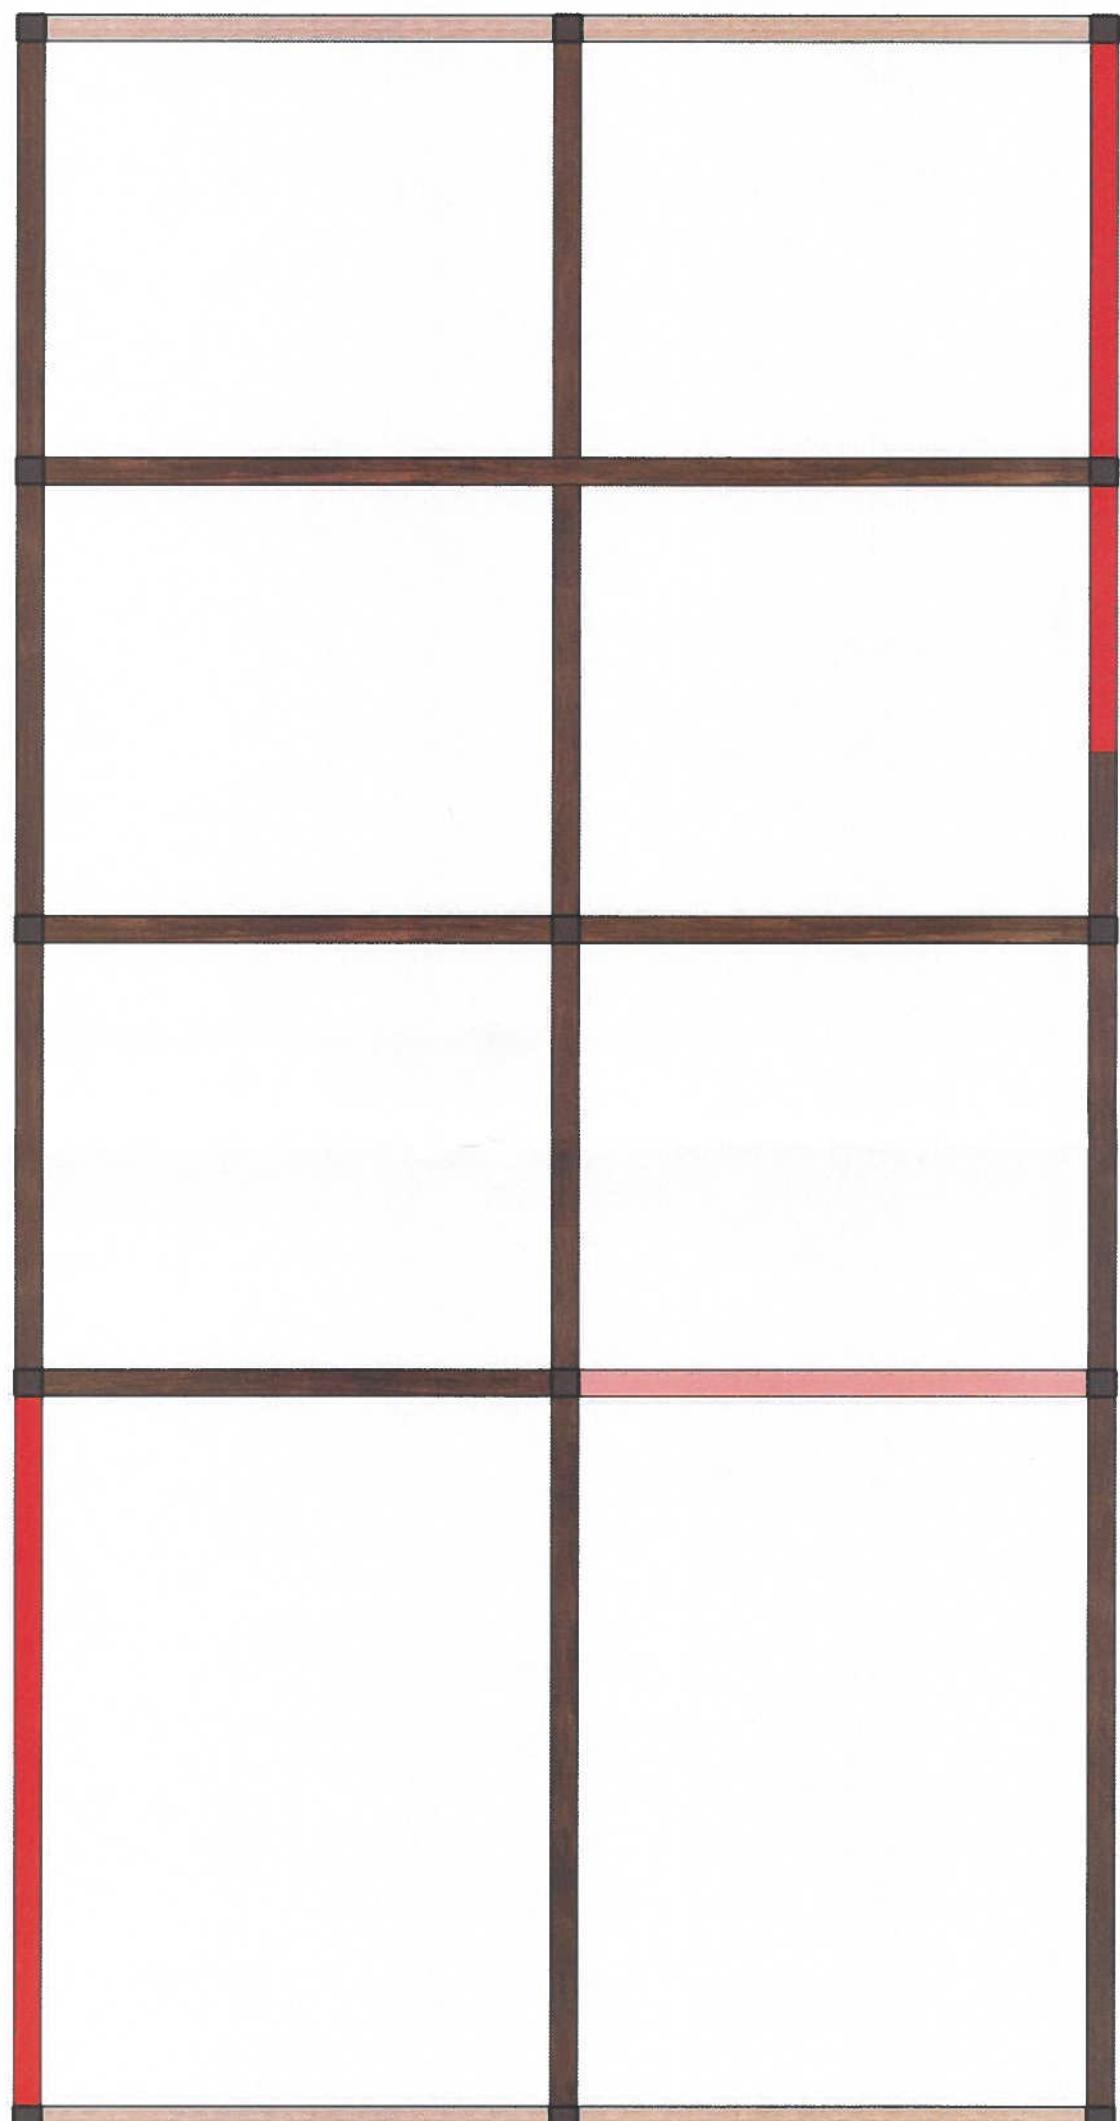
04 EXISTING BARN - STRUCTURAL ANALYSIS

- SOLID WOOD BEAMS/COLUMNS IN FAIR CONDITION
- STANDARD LUMBER IN FAIR CONDITION
- STRUCTURALLY INADEQUATE
- POWDER POST BEETLE DESTRUCTION

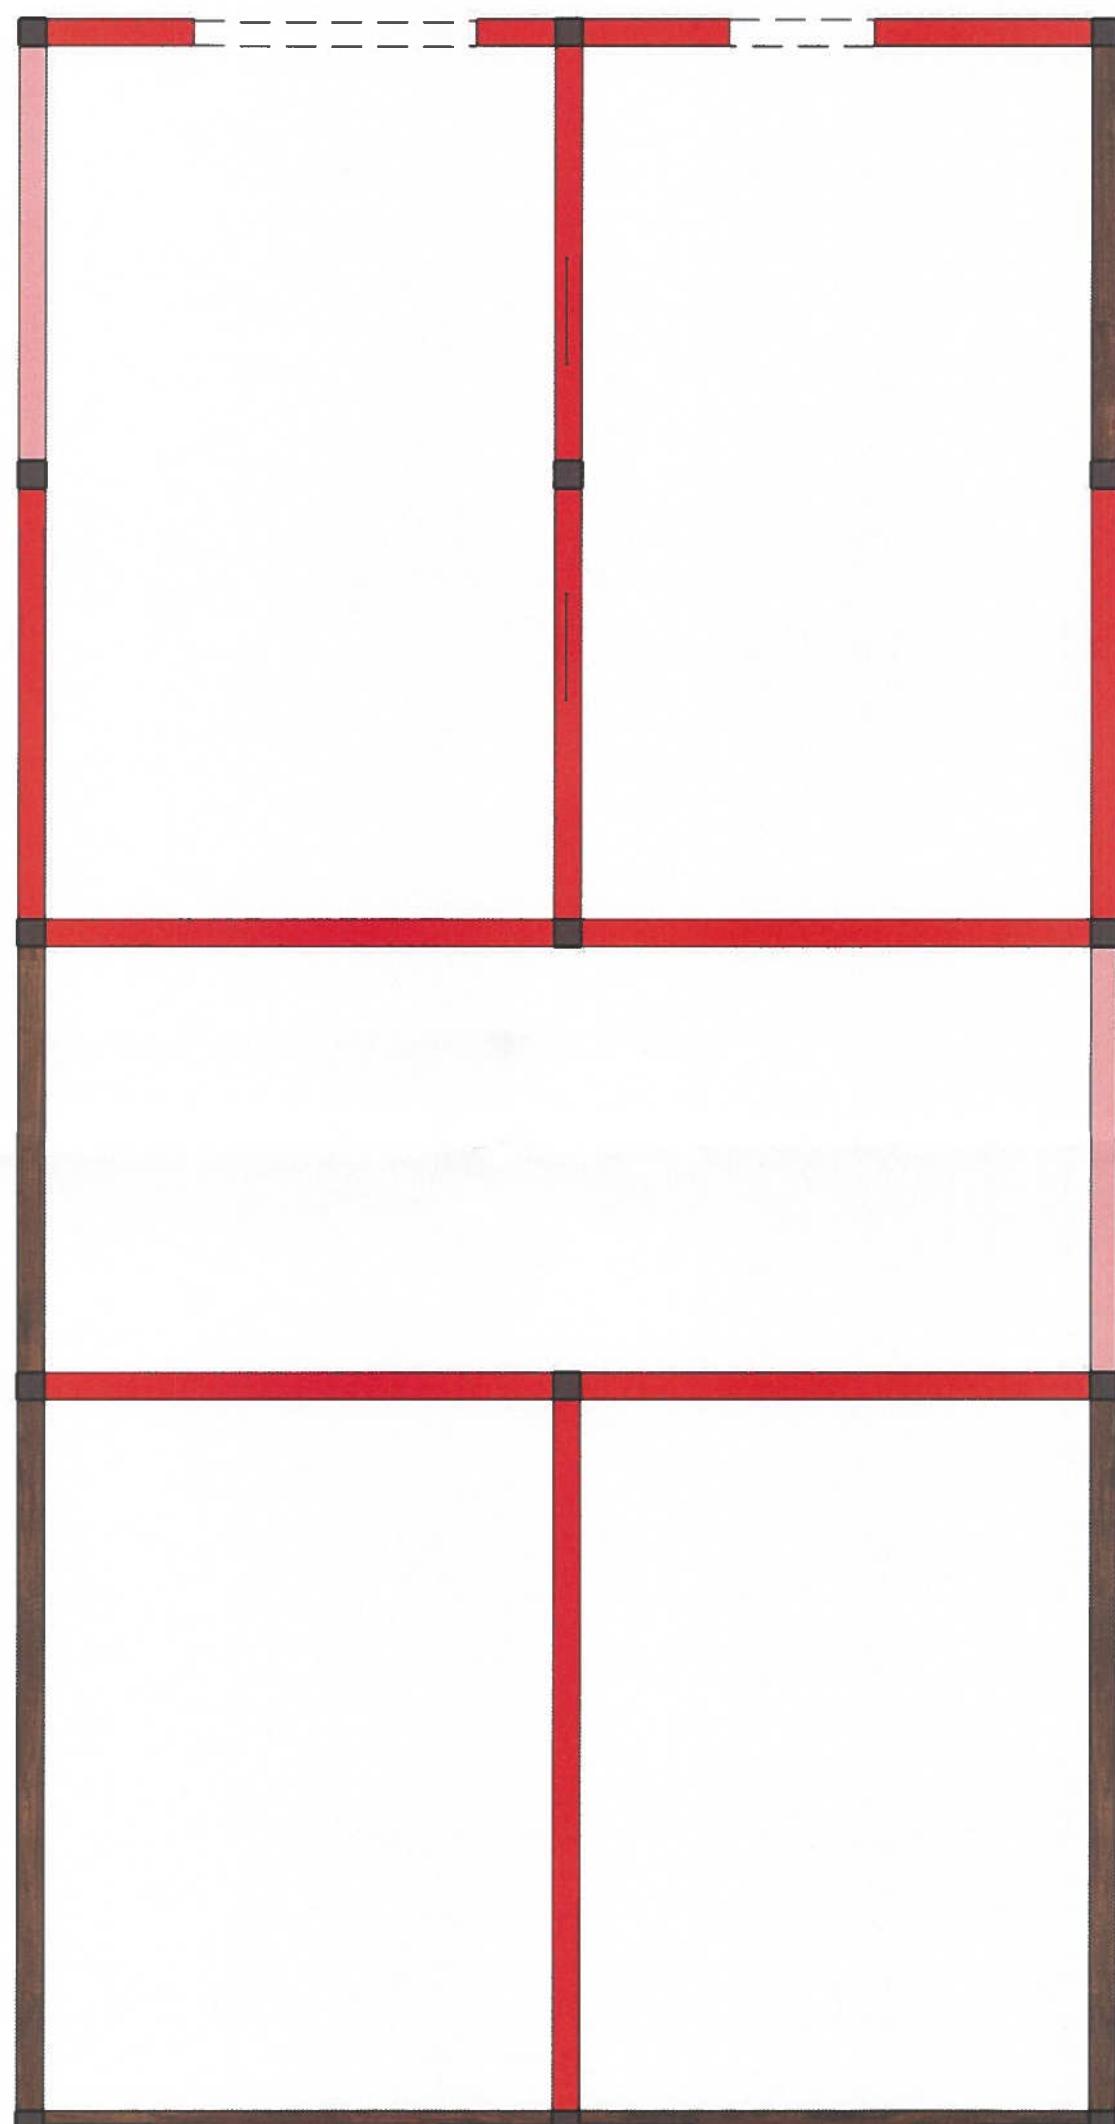
04 EXISTING BARN - STRUCTURAL ANALYSIS

- SOLID WOOD BEAMS/COLUMNS IN FAIR CONDITION
- STANDARD LUMBER IN FAIR CONDITION
- STRUCTURALLY INADEQUATE
- POWDER POST BEETLE DESTRUCTION

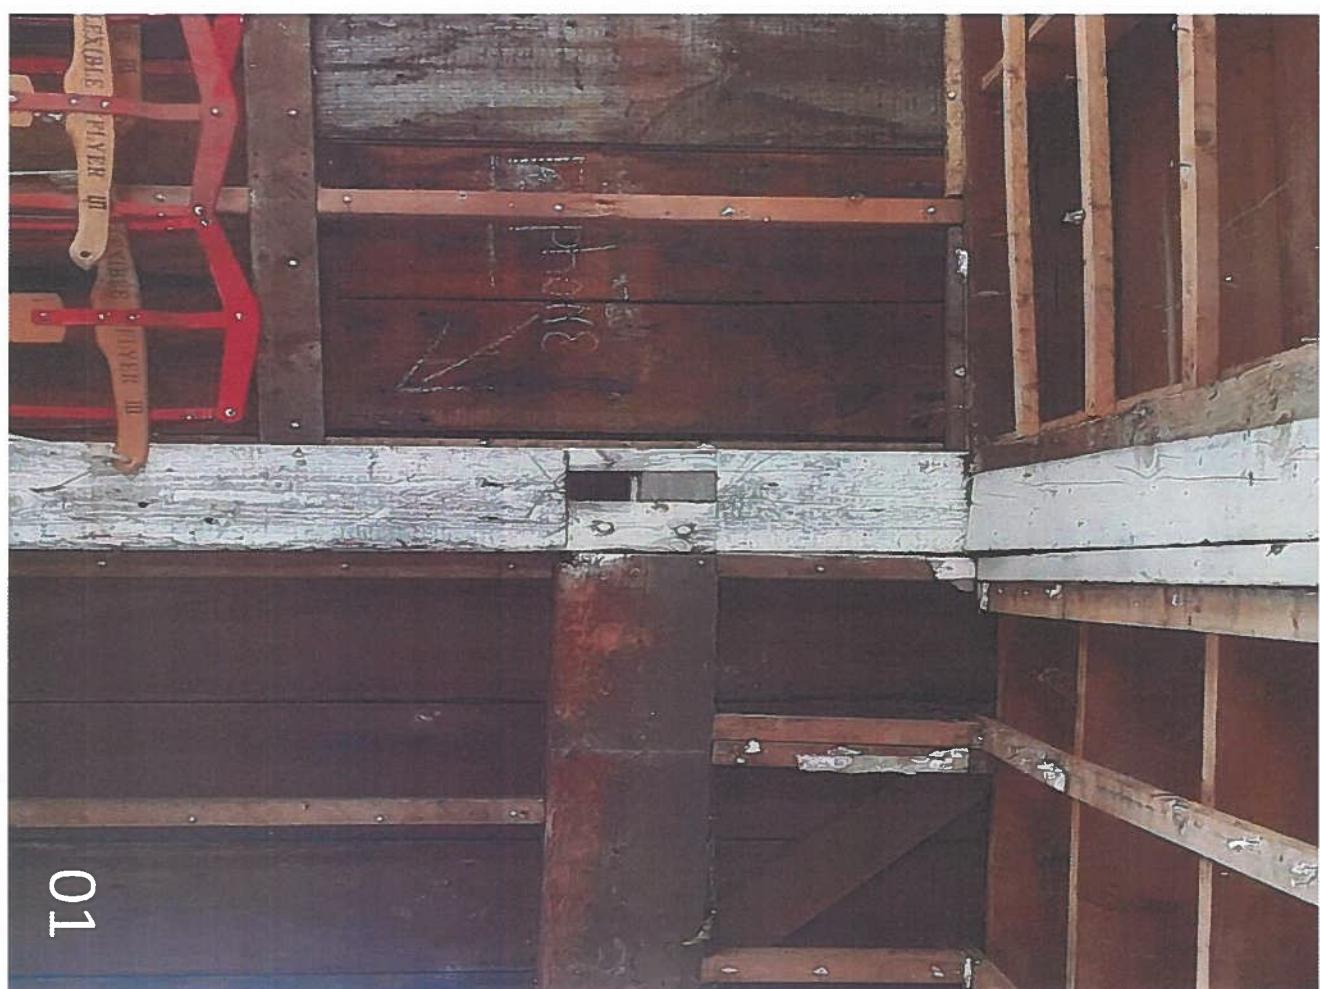
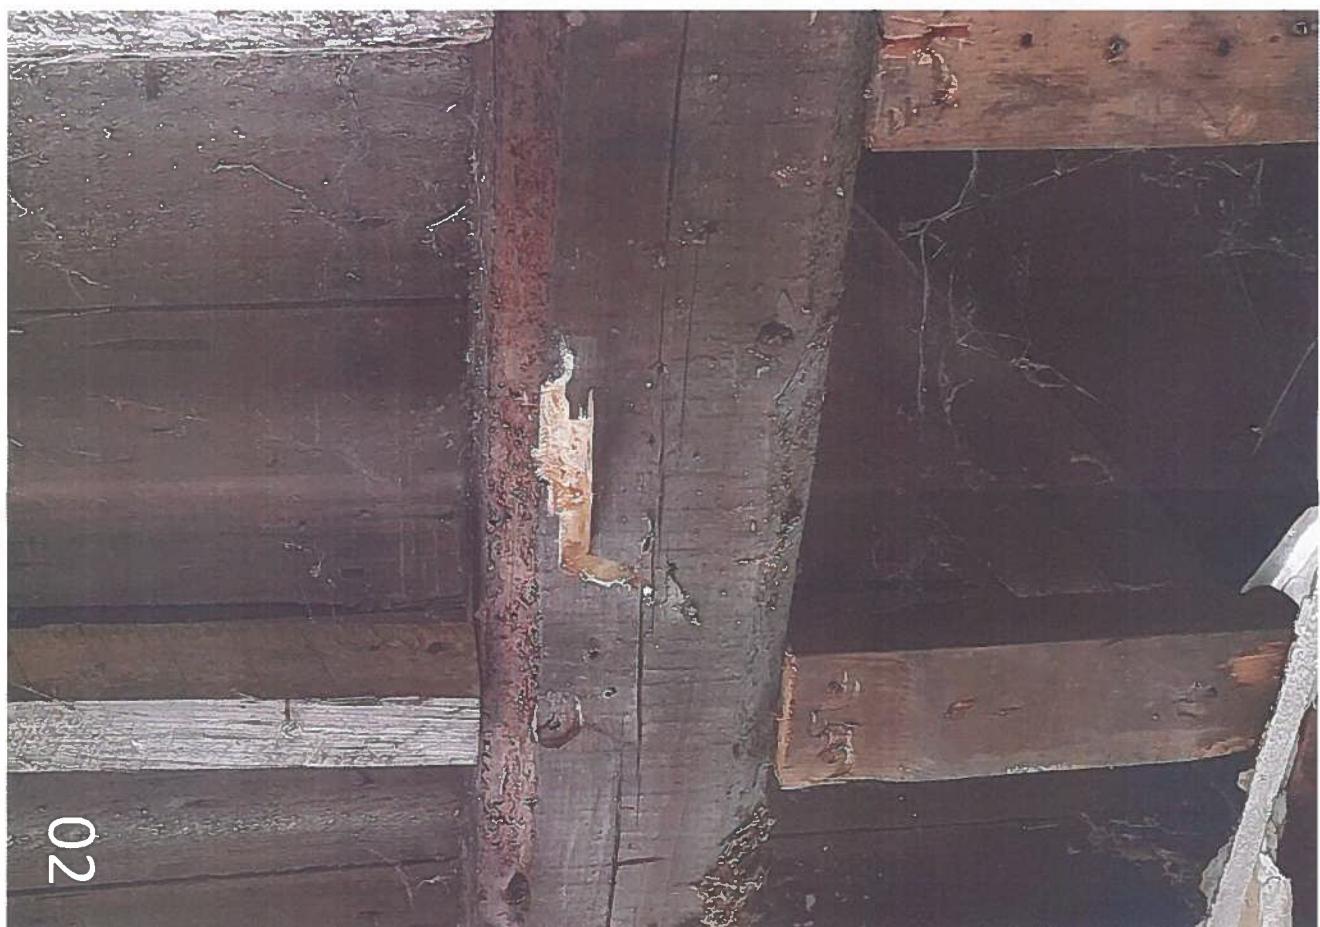
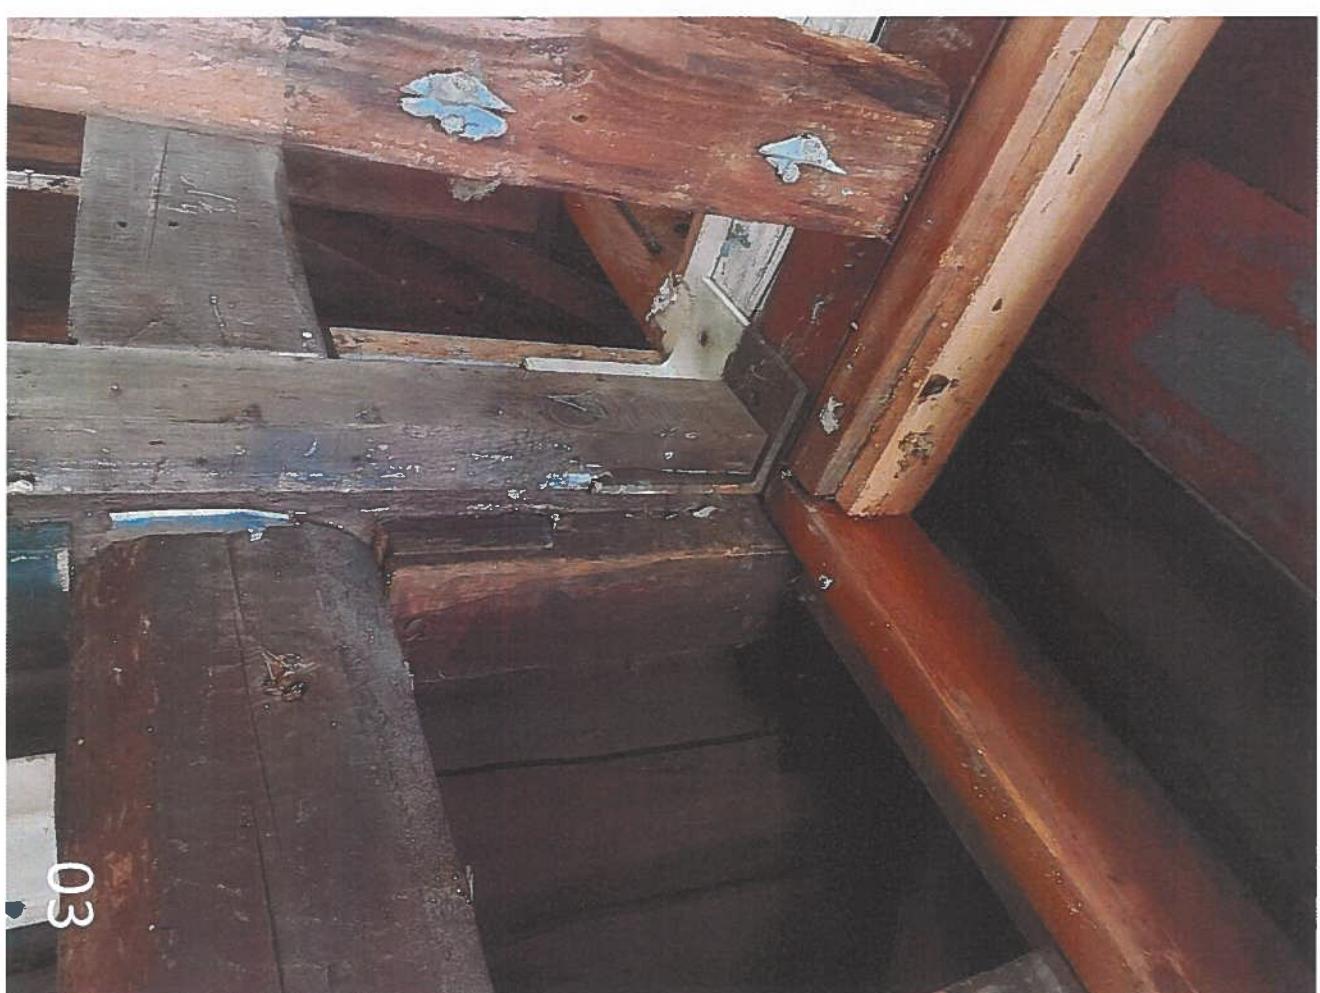
EAST WALL - 1ST FLOOR

SOLID WOOD BEAMS/COLUMNS IN FAIR CONDITION
STANDARD LUMBER IN FAIR CONDITION
STRUCTURALLY INADEQUATE
POWDER POST BEETLE DESTRUCTION
