PROJECT PHOTOS

Town of Acton, MA
North Acton Fire Station

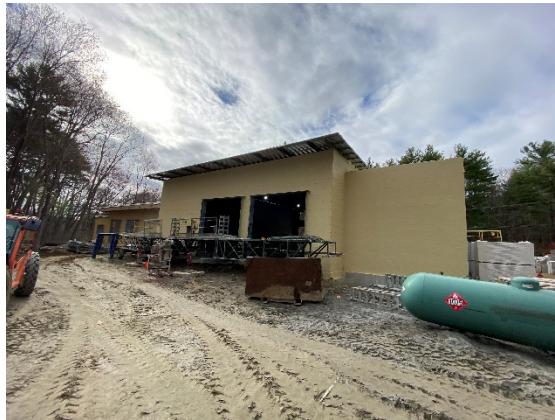
Overview of building from northwest (04/13/2021)

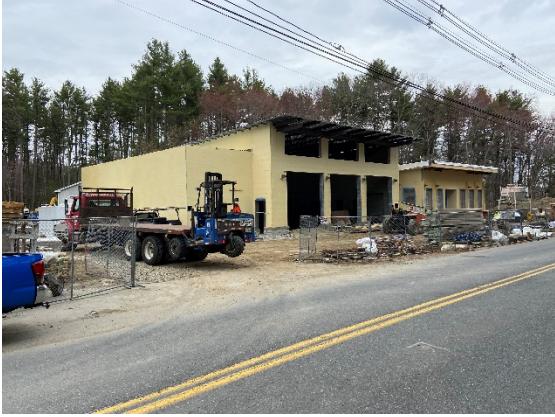
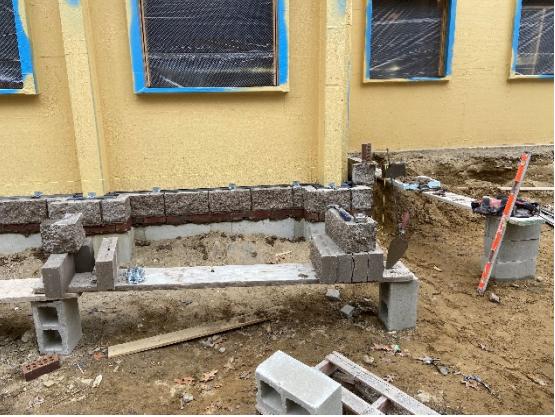
Overview of building from southwest (04/15/2021)	Masonry façade construction on south face (04/15/2021)

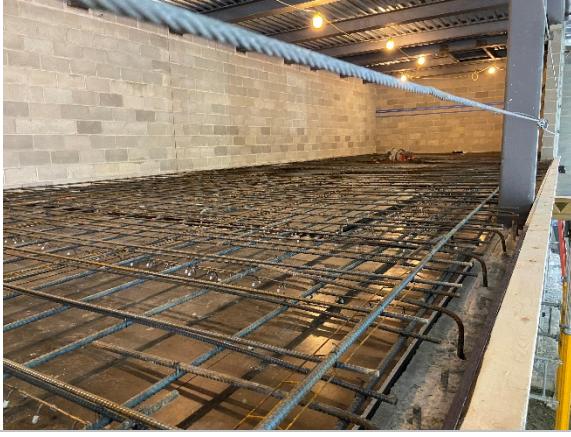
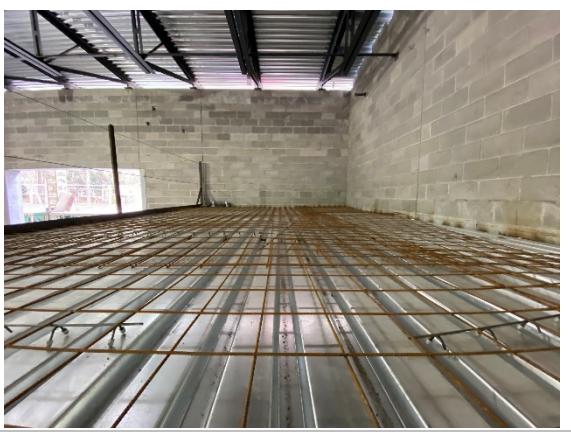
Western mezzanine slab reinforcing installation (04/15/2021)	Reinforcing at dirty laundry room roof (04/15/2021)

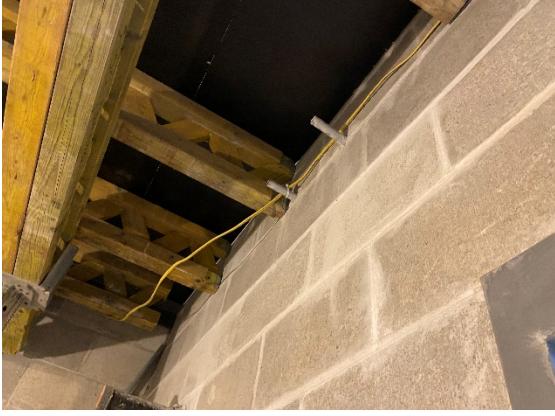
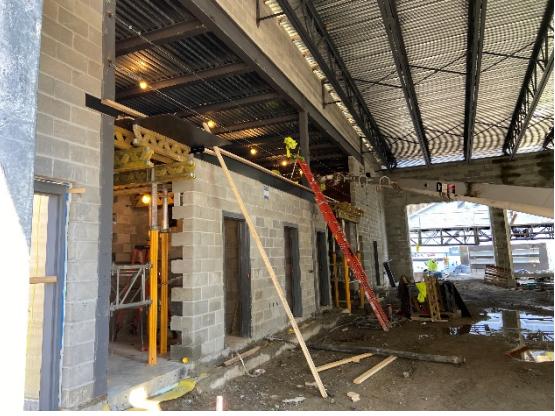
Underside of shoring at western mezzanine (04/15/2021)	Placement of concrete at western mezzanine (04/20/2021)

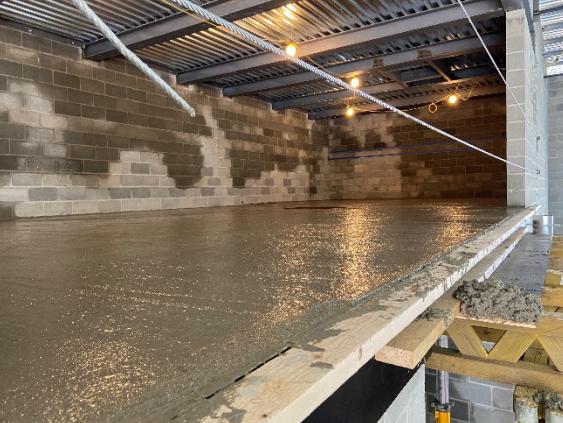
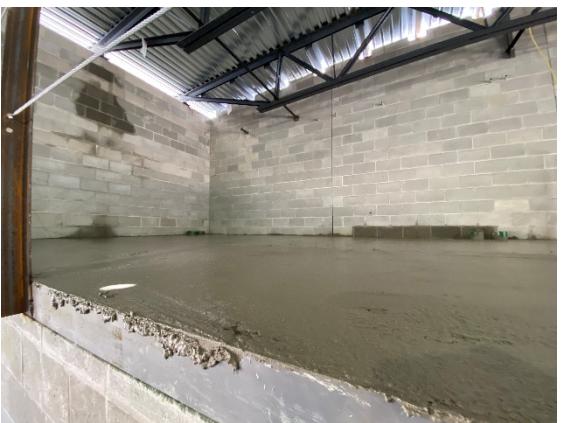
Western mezzanine slab (04/20/2021)	Concrete placed at dirty laundry room roof (04/20/2021)

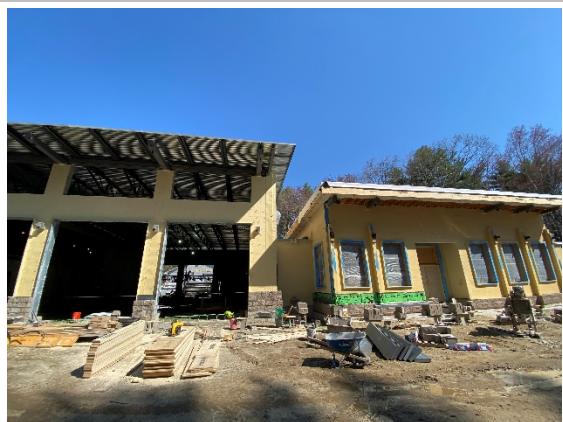
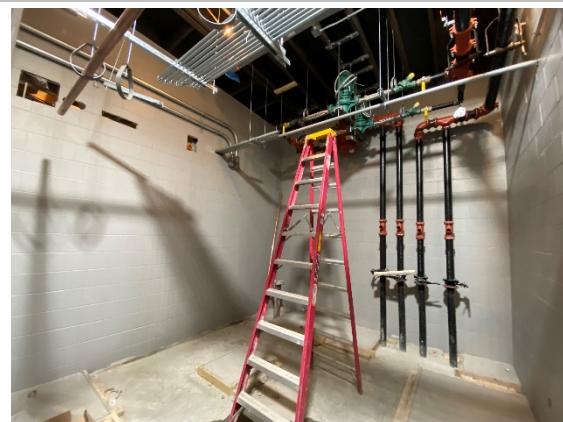
Overview of building south face (04/20/2021)	Mechanical room with mechanical pads (04/20/2021)

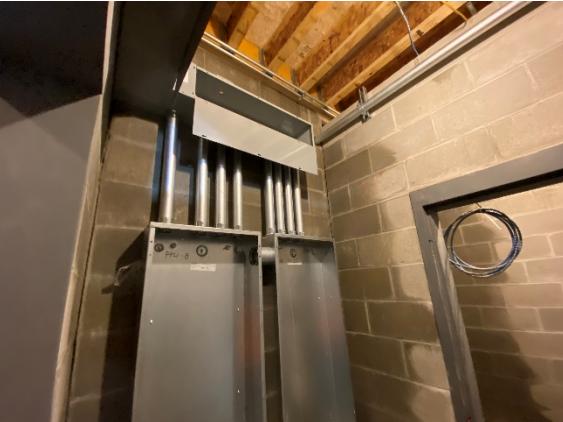
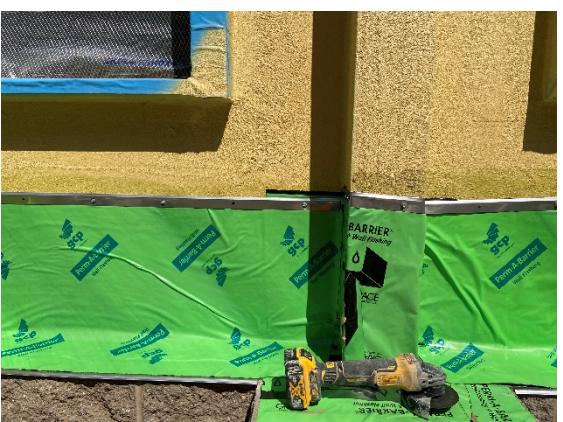
Electrical rough-ins (04/20/2021)	Typical drip edge and rafl installed at south face (04/20/2021)

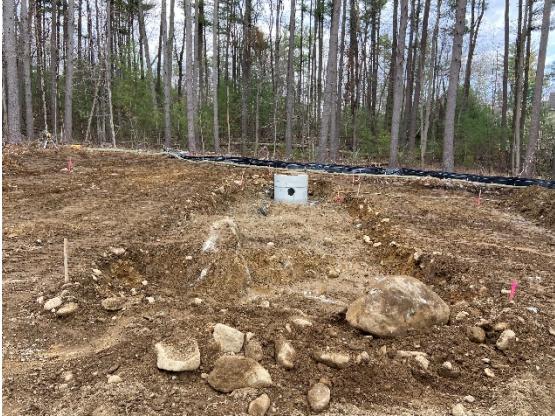
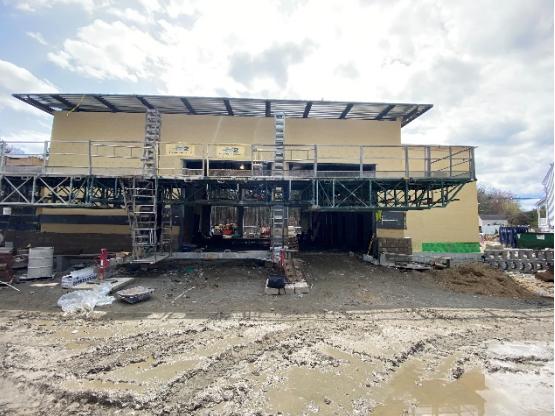
Excavation of infiltration system #1 (04/21/2021)	Masonry façade on north side of apparatus bay (04/21/2021)

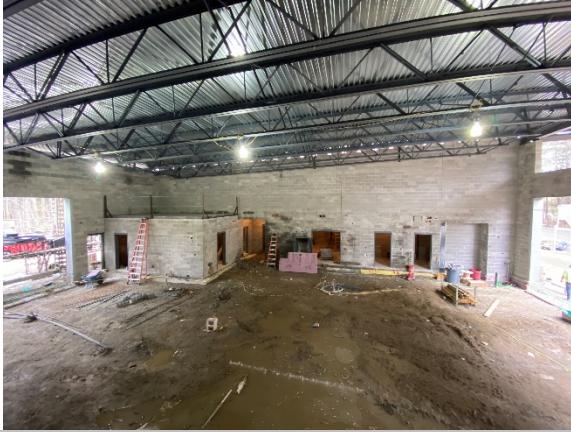
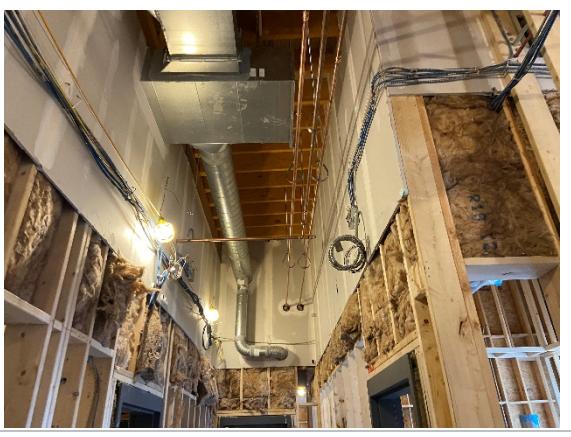
Overview of east side of apparatus bay (04/21/2021)	MEP rough-ins on east side (04/21/2021)

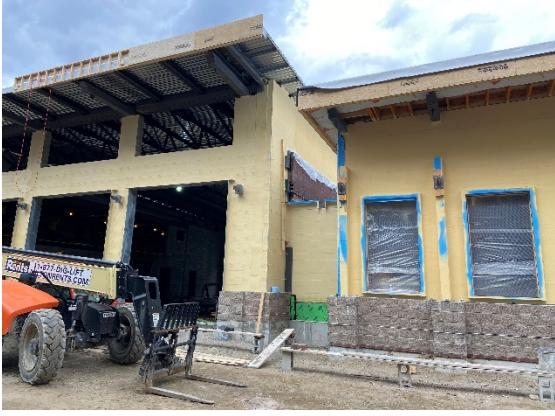
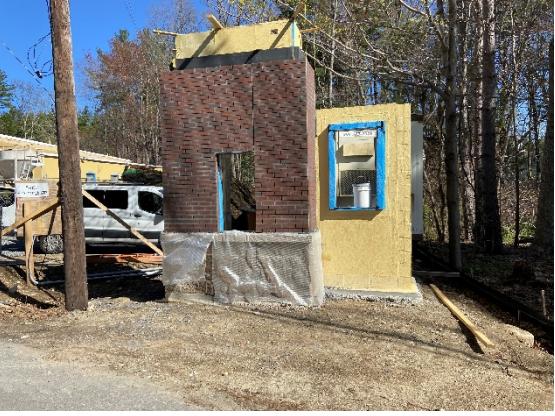
Masonry façade on south face and transition roof (04/21/2021)	Mock-up (04/23/2021)

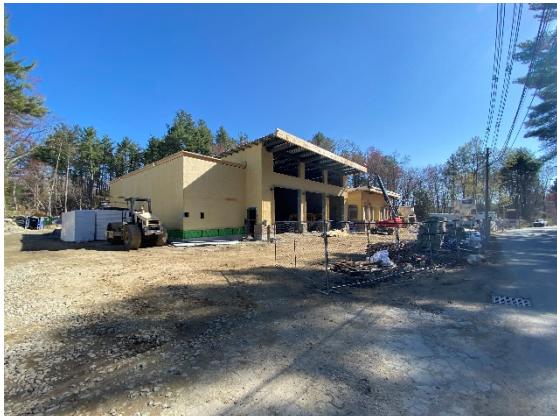
Overview of building from southwest (04/23/2021)

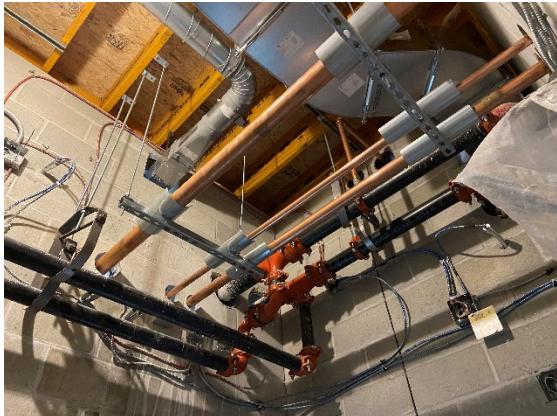
MEP rough-ins on east side (04/23/2021)

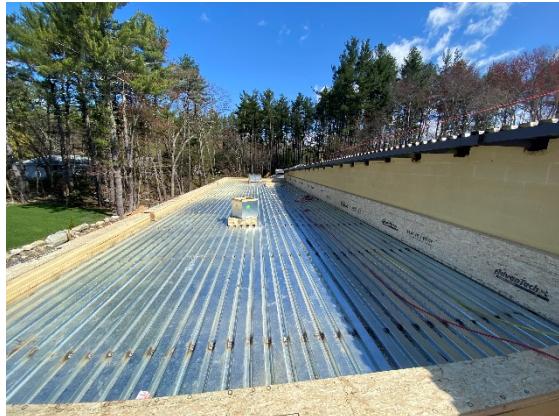
Overview of western mezzanine roof (04/23/2021)

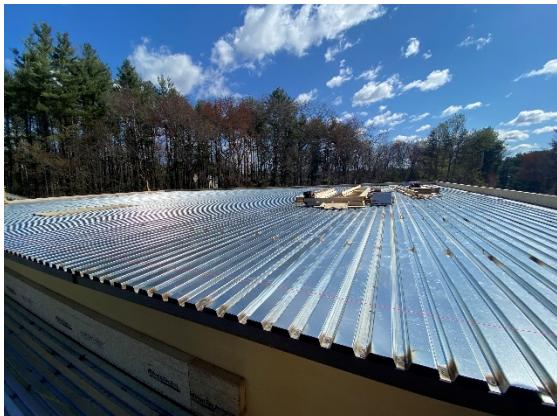
Overview of apparatus bay roof (04/23/2021)

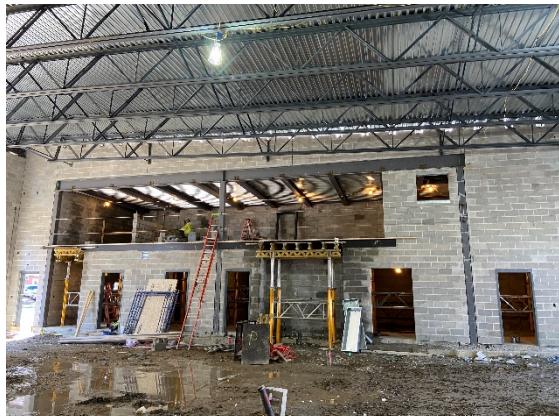
Overview of western mezzanine (04/23/2021)

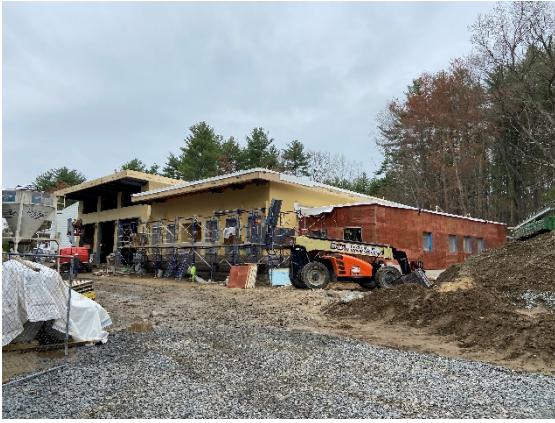
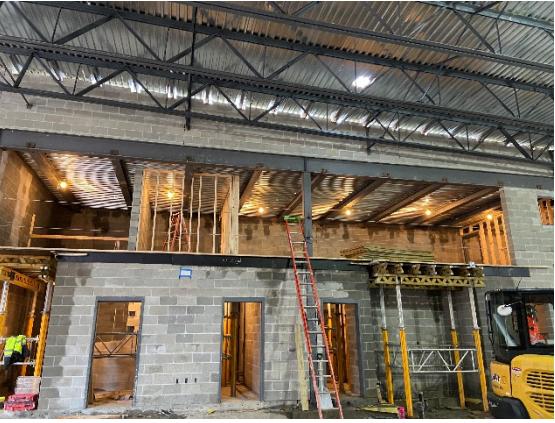
Overview of building from southeast (04/29/2021)	Overview of western mezzanine (04/29/2021)

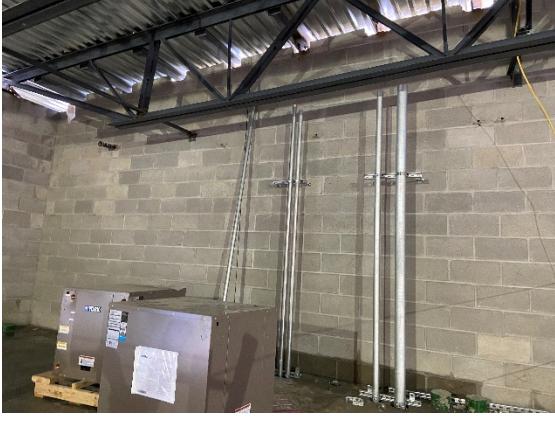
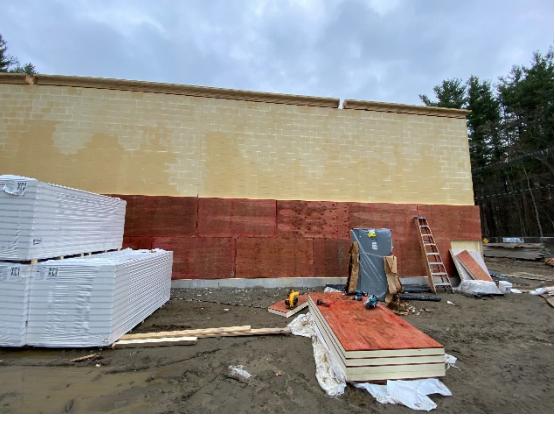
Electrical rough-ins above dirty laundry room (04/29/2021)	West side of building (04/29/2021)

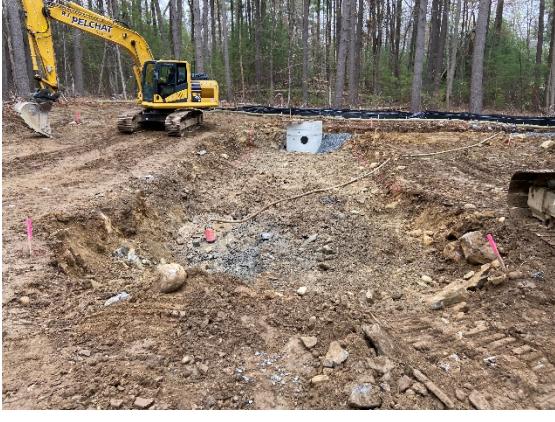
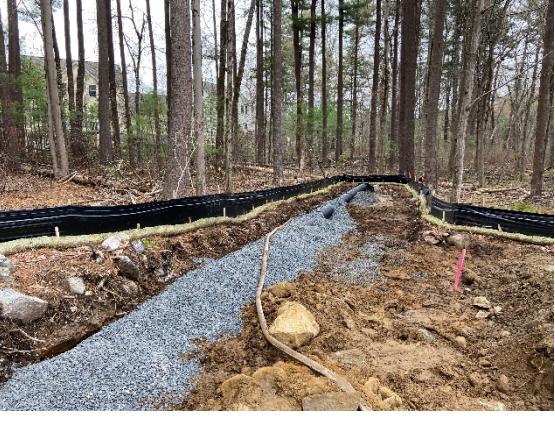
Overview of excavation for infiltration system #1 (04/29/2021)	Overview of OCS#1 outlet pipe (04/29/2021)

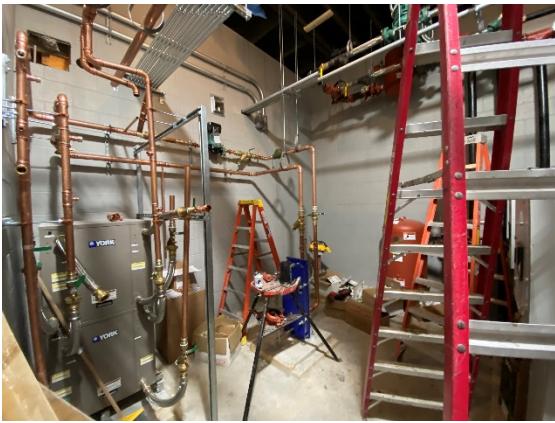
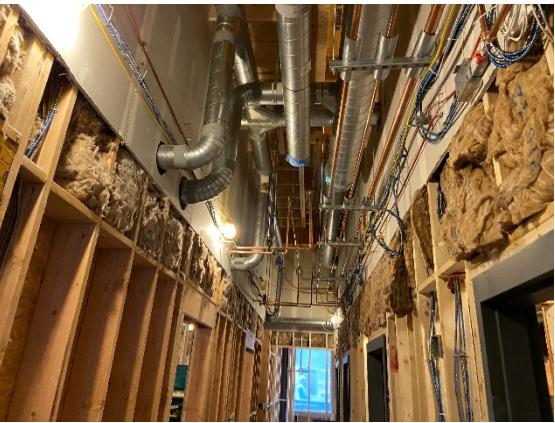
<p>Mechanical room (04/29/2021)</p>	<p>MEP rough-ins on east side (04/29/2021)</p>

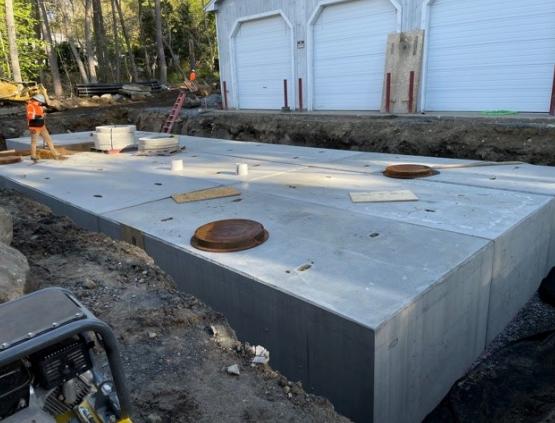
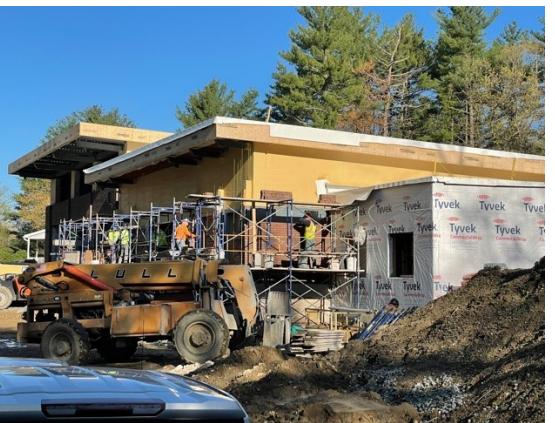
<p>Installation of stormwater infiltration system 2 (05/07/2021)</p>	<p>Installation of masonry façade on south side (05/07/2021)</p>

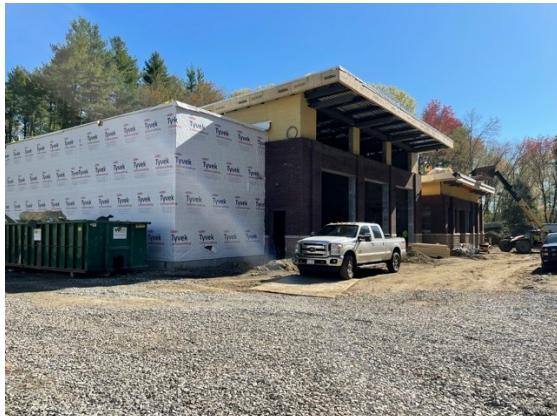
Overview of site from southwest (05/13/2021)

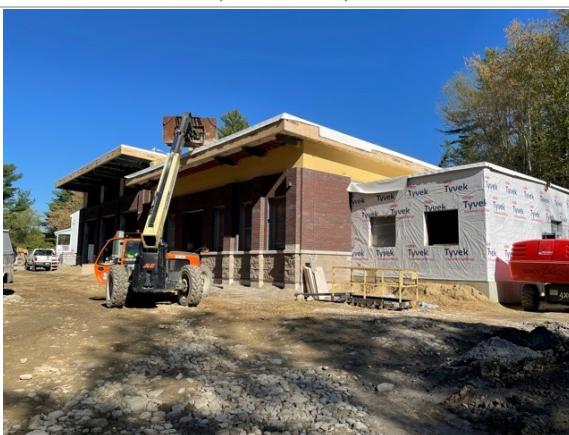
Overview of site from southeast (05/13/2021)

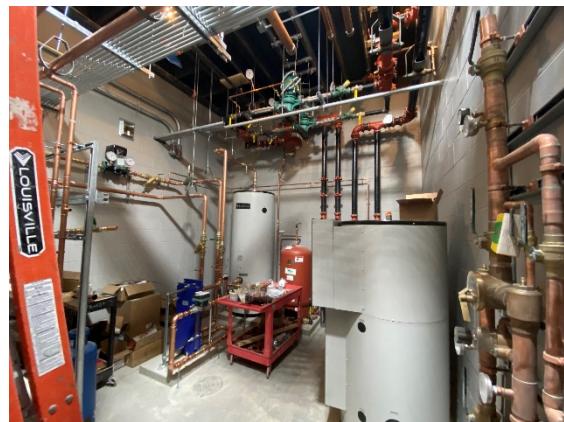
Overview of mechanical room (05/17/2021)

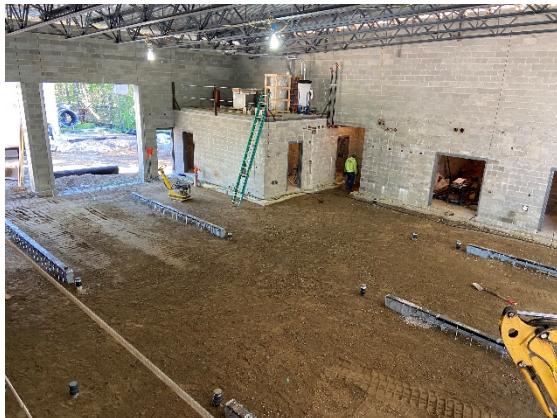
Overview of apparatus bay (05/17/2021)

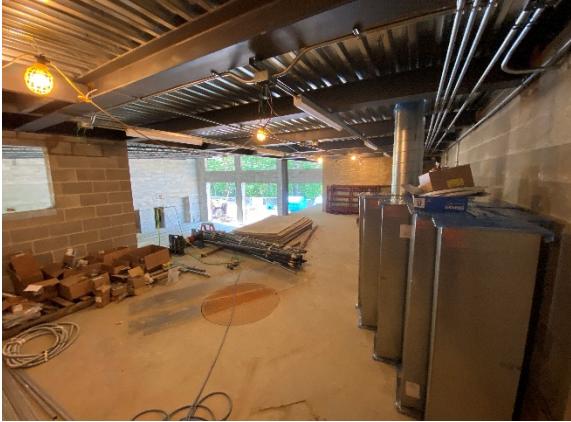
Overview of mezzanine (05/27/2021)	GSI tanks to be installed (05/27/2021)

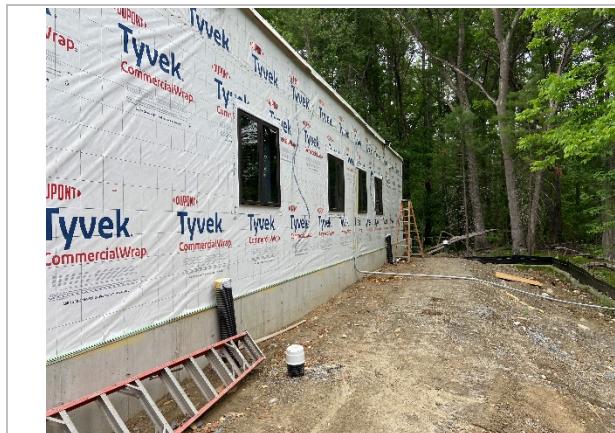
Windows installed on bunk room side (05/28/2021)

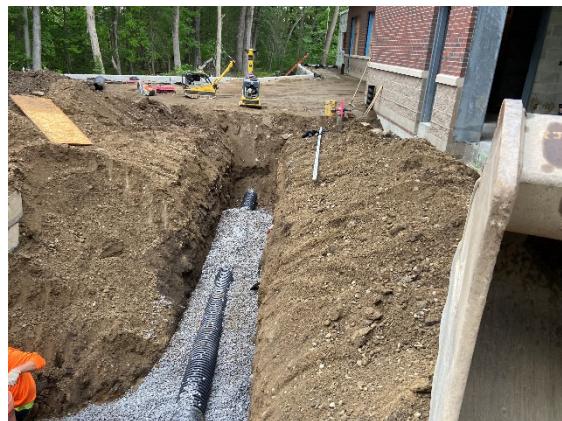
Installation of area and roof drains on north side (05/28/2021)

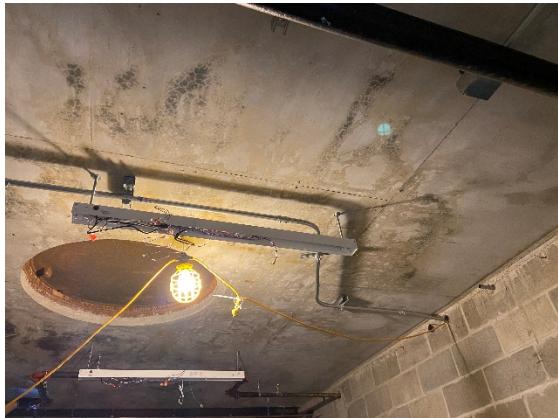
Installation of lights on west side (05/28/2021)

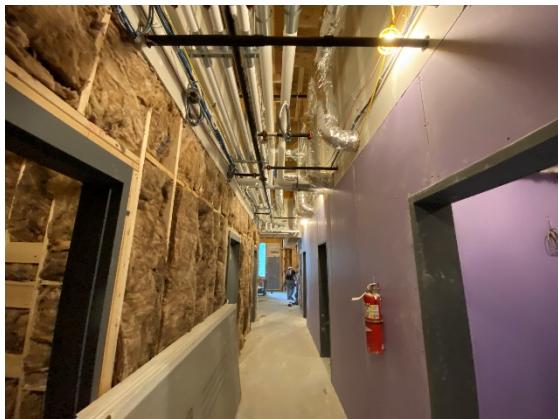
Hallway between bunk rooms and showers (05/28/2021)

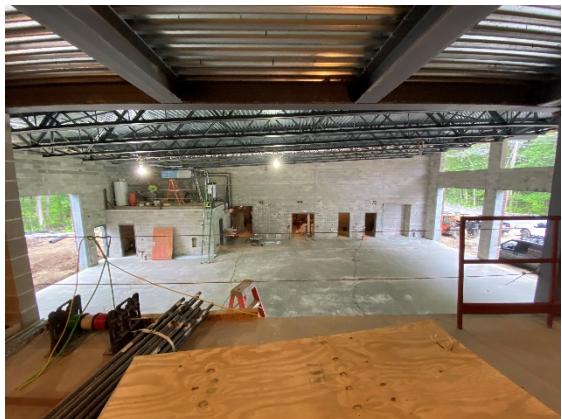
Overview of apparatus bay from mezzanine (05/28/2021)

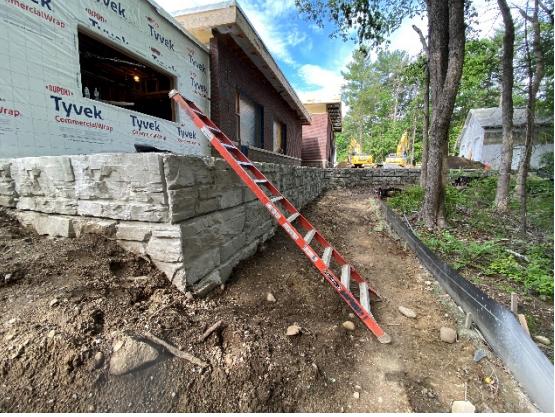
Removal of rock mass at CB 2 (05/28/2021)	Retaining wall installed (05/28/2021)

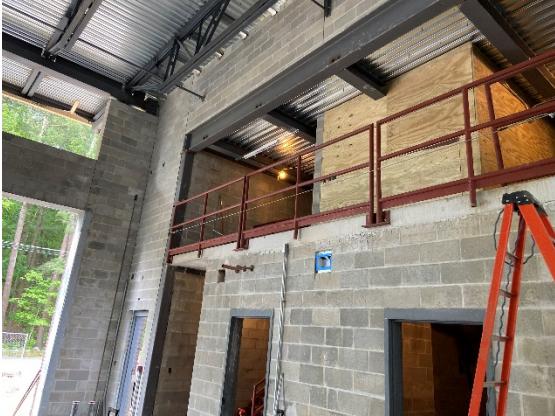
Installation of mezzanine railing (05/28/2021)	MEP rough-ins outside of conference room (05/28/2021)
